Community Assessment

El Sobrante Landfill: Community Assessment

Date: December 19, 2023 Arrival time: 10:00 am Prepared by: Katherine Avila/Kinika Hesterly, RCDWR

El Sobrante Landfill Quarterly Mitigation Monitoring Report

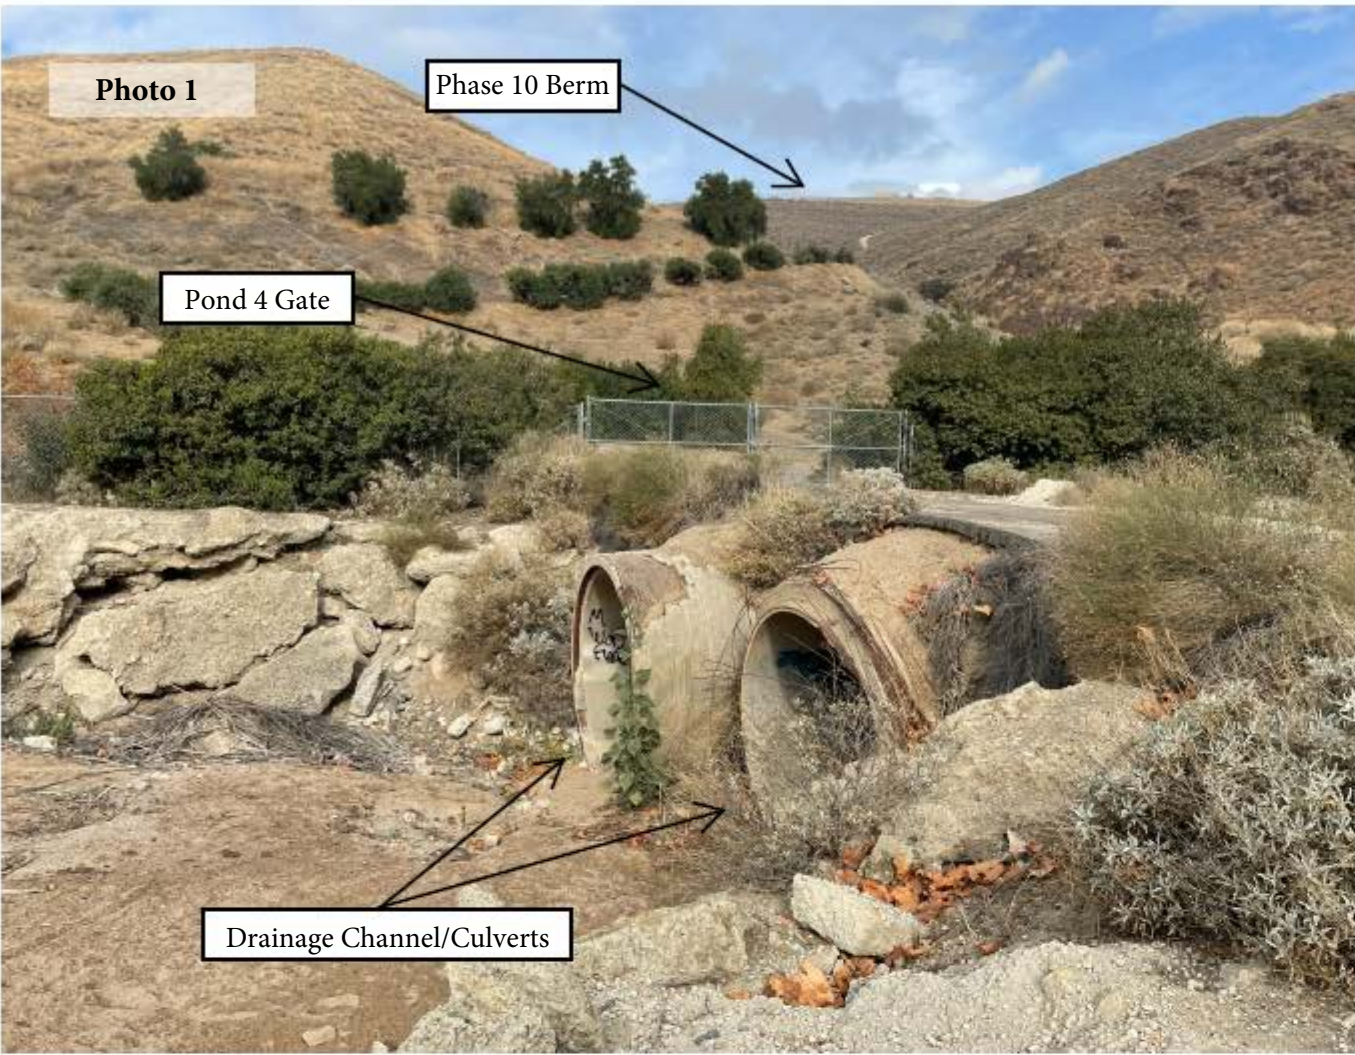
- Pond 4 visual inspection:
 - Pond 4 gate and fencing - good condition, no litter (photo 1).
 - Pond 4 outside slope - good vegetative cover.
 - Green park table with bench is still damaged.

- Culvert chipping and graffiti (photo 1 and 2).
- Dawson Canyon Road condition:
 - The dirt section subject to quarterly grading by WMI is serviceable. The road was graded for 4th quarter on December 12, 2023.

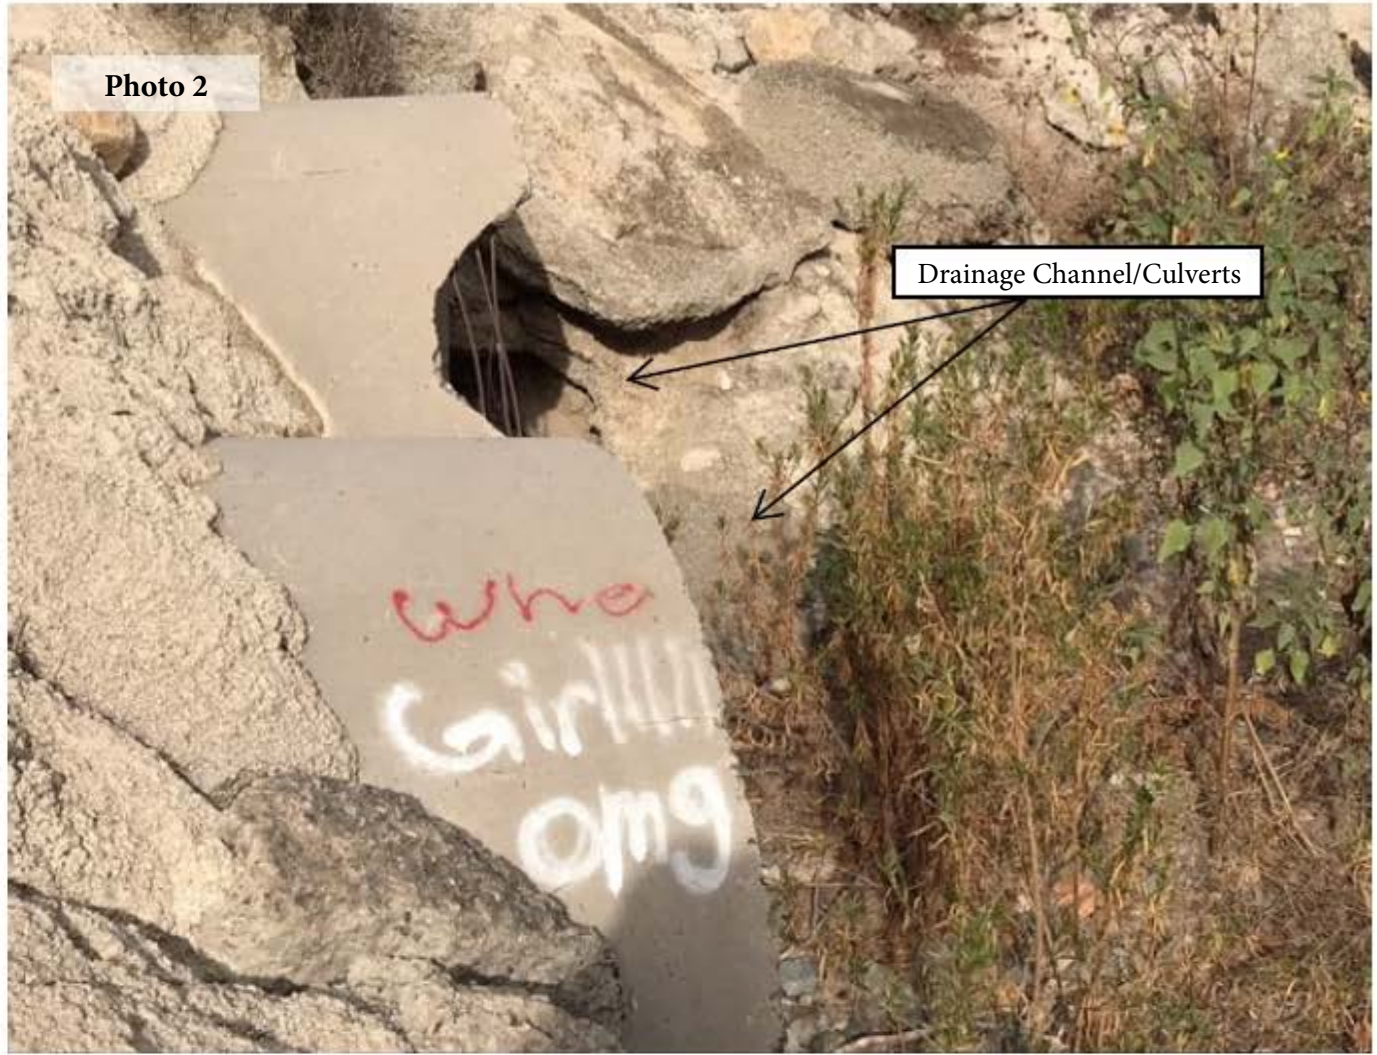
- Drainage channel/culverts:
 - Vegetation growth in the drainage channel east of the Pond 4 gate, but does not cause major debris or blockage (photo 2).

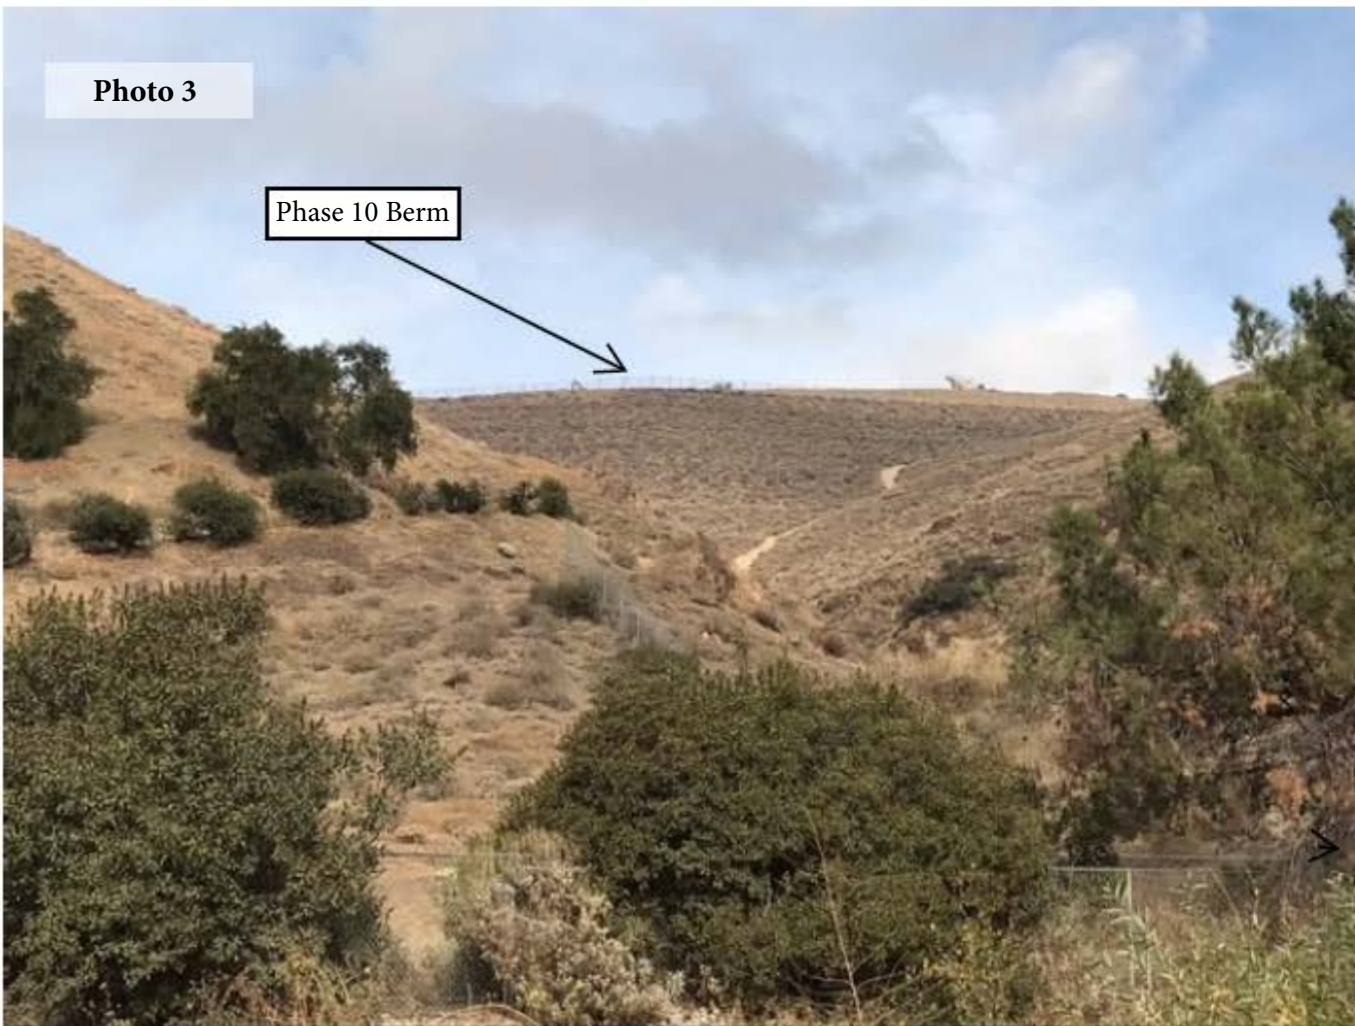
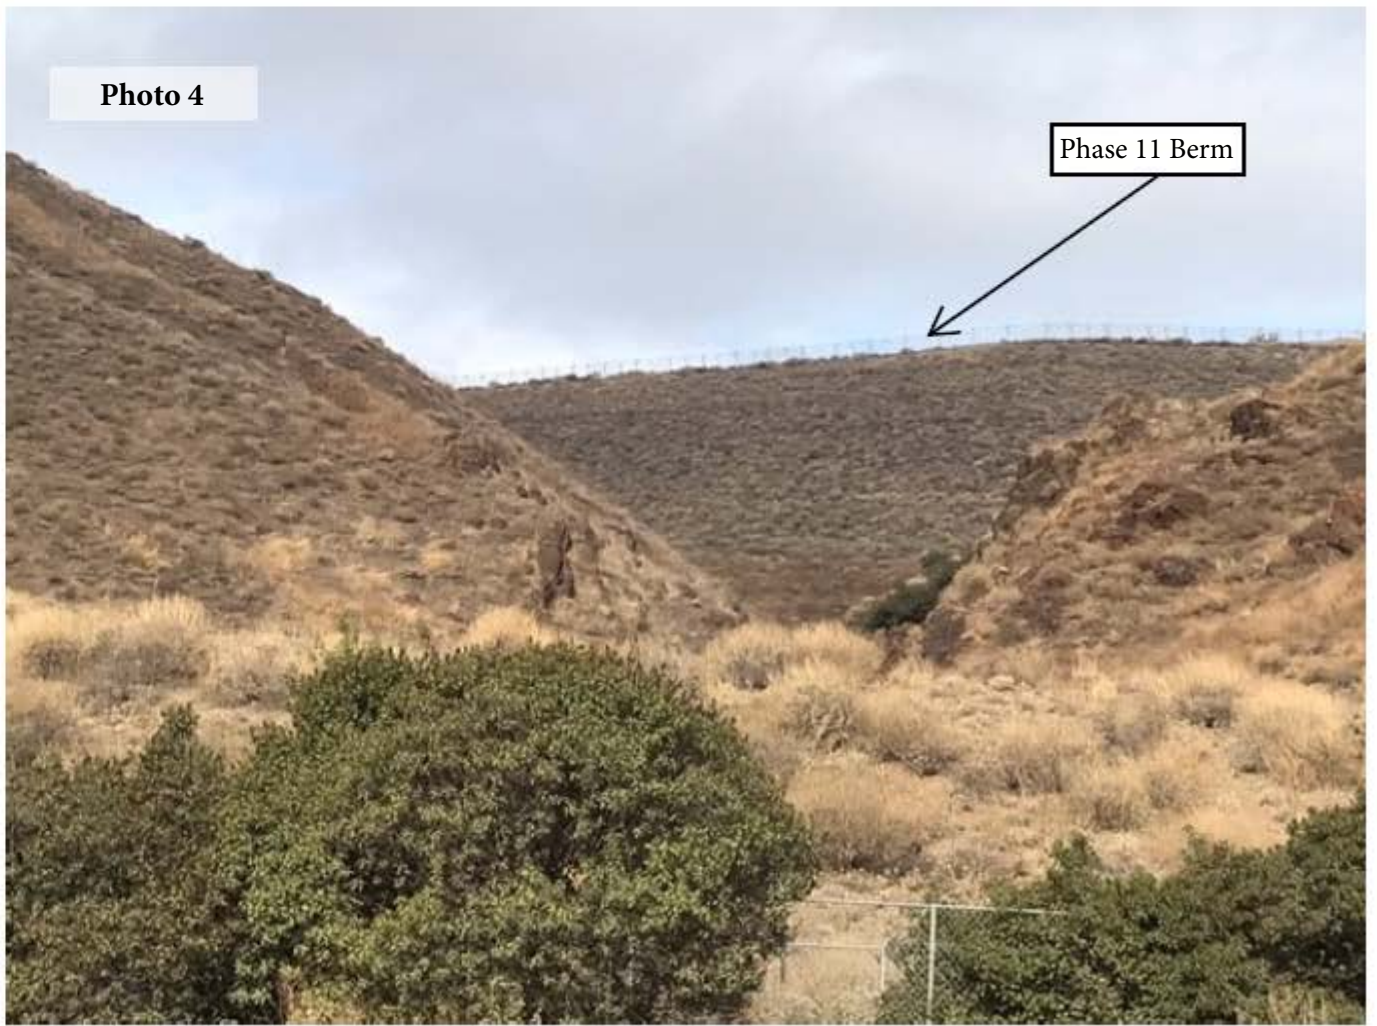
- Berm 10/11:
 - No visible litter, good vegetative cover (photo 3 - Berm 10; photo 4 - Berm 11).
- Landfill operations:
 - Not visible from Dawson Canyon area or Spanish Hills/Trilogy area.

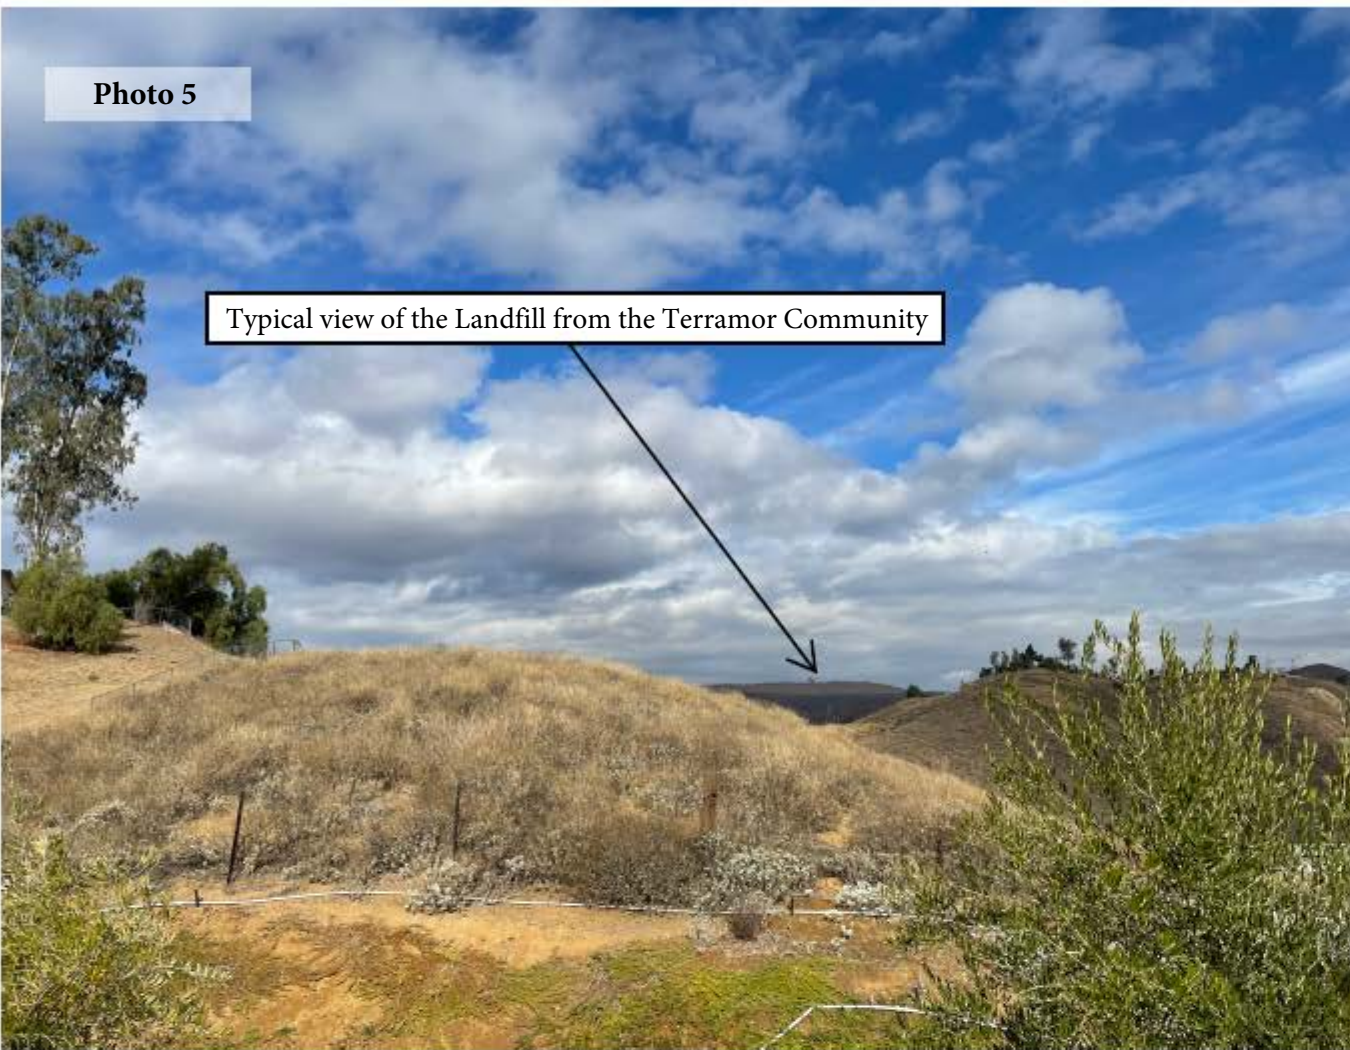
Photo 5

- Slight odor in Dawson Canyon (near Pond 4)
 - No odor in Spanish Hills/Trilogy area.
 - Noticeable odor in the Terramor Community. Landfill operations slightly visible from the Terramor Community, located south of the Landfill (photo 5).

Typical view of the Landfill from the Terramor Community

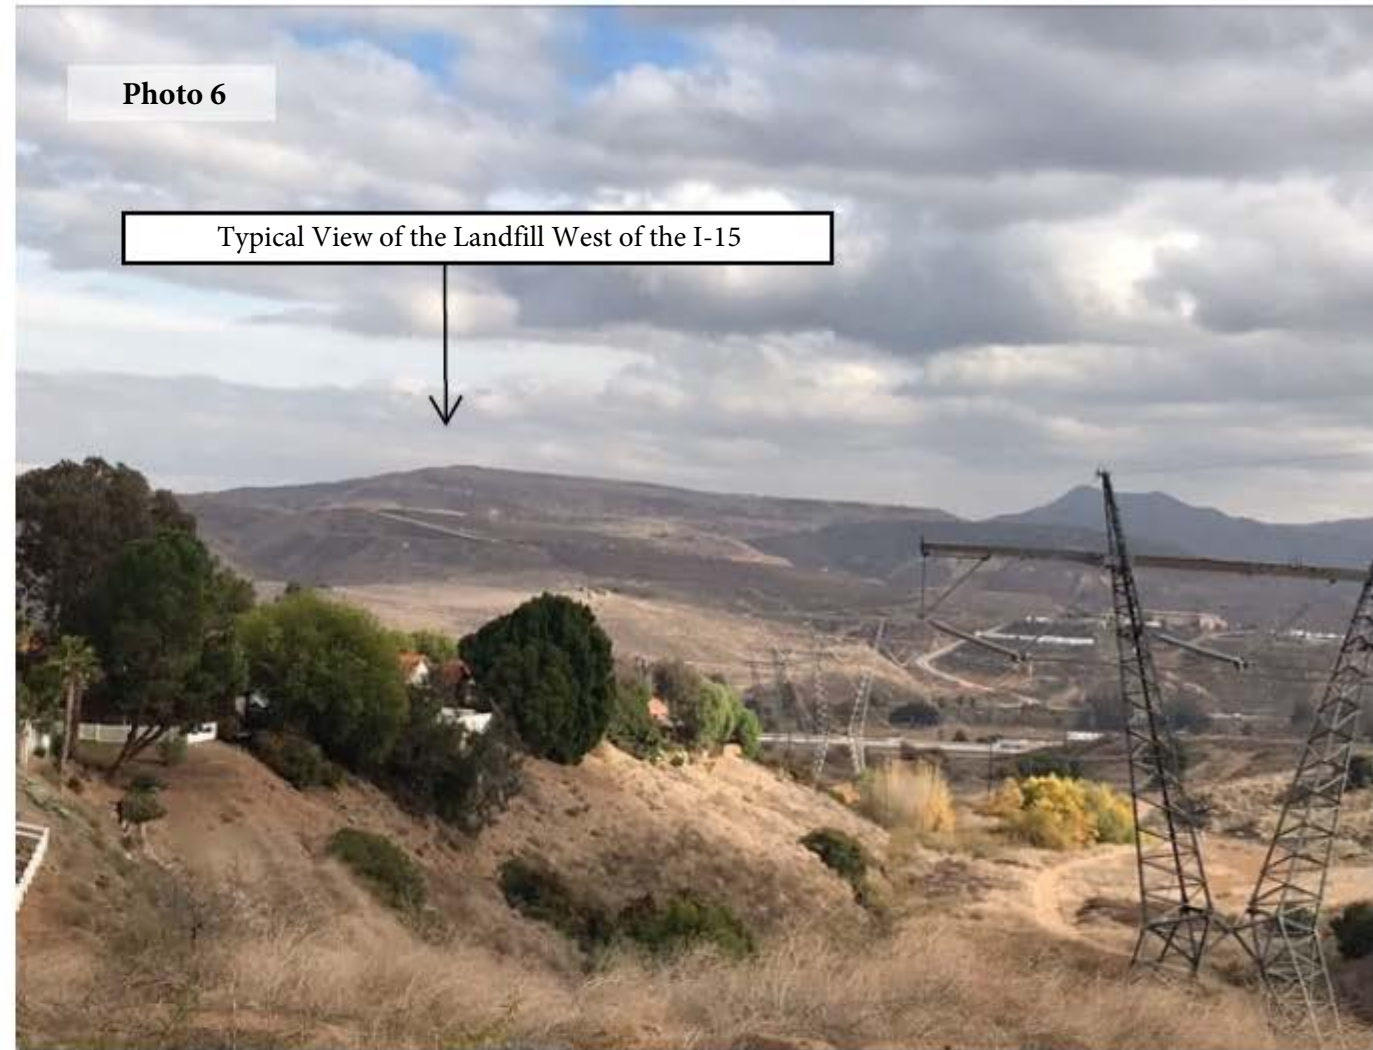
Photo 6

- Landfill operations not visible from communities west of I-15 (photos 6 and 7); bare outside slopes; USA Waste/WMI implementing plan to address the bare slopes.

Typical View of the Landfill West of the I-15

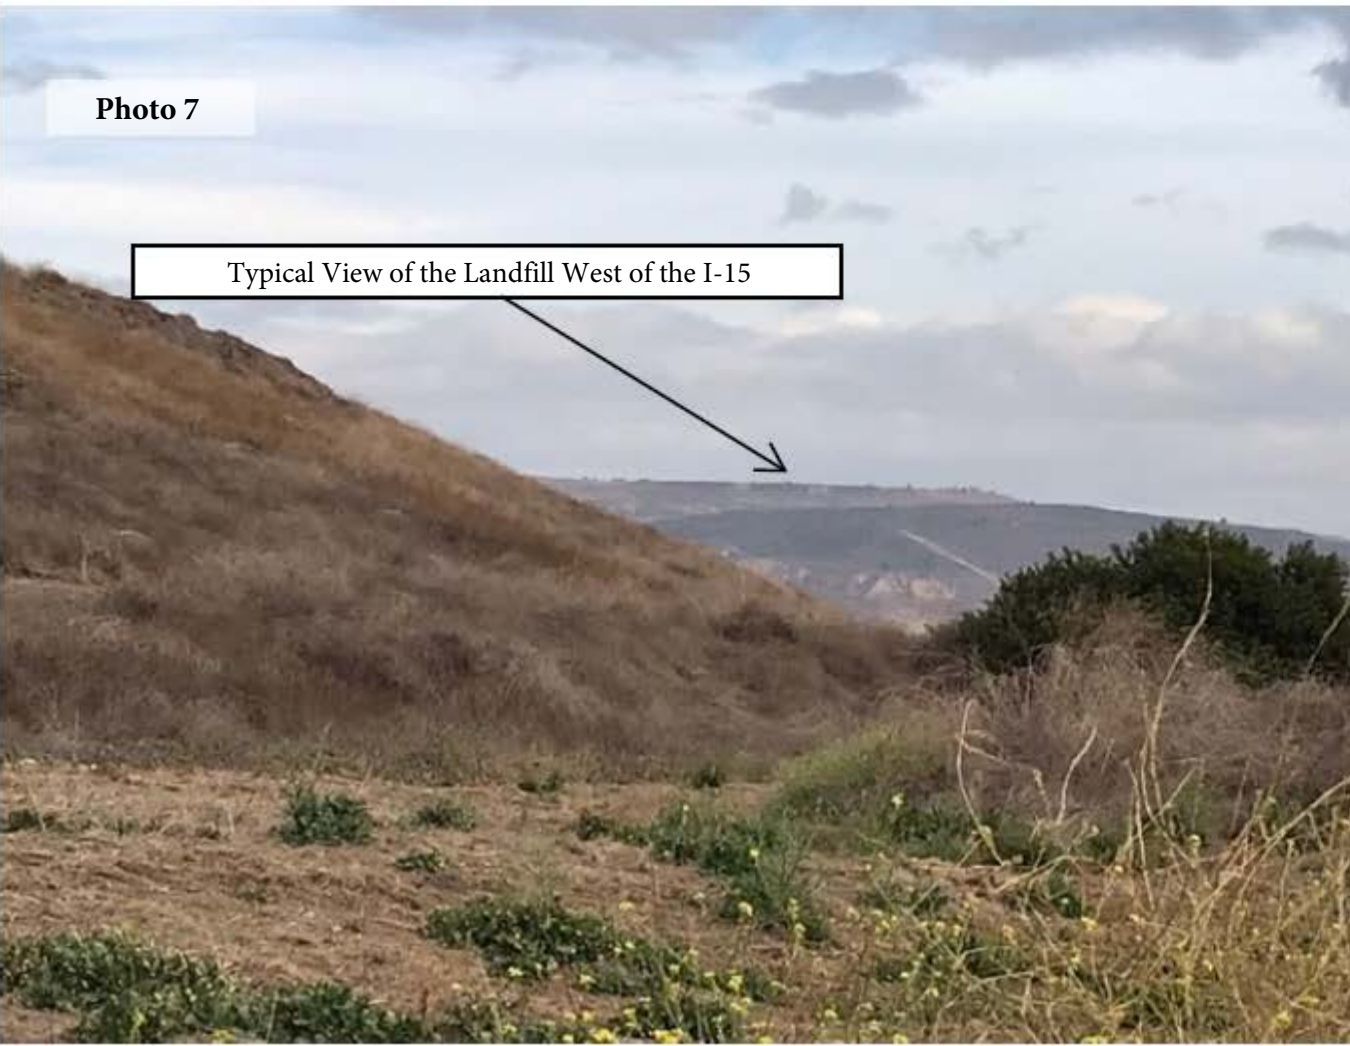
Photo 7

Typical View of the Landfill West of the I-15

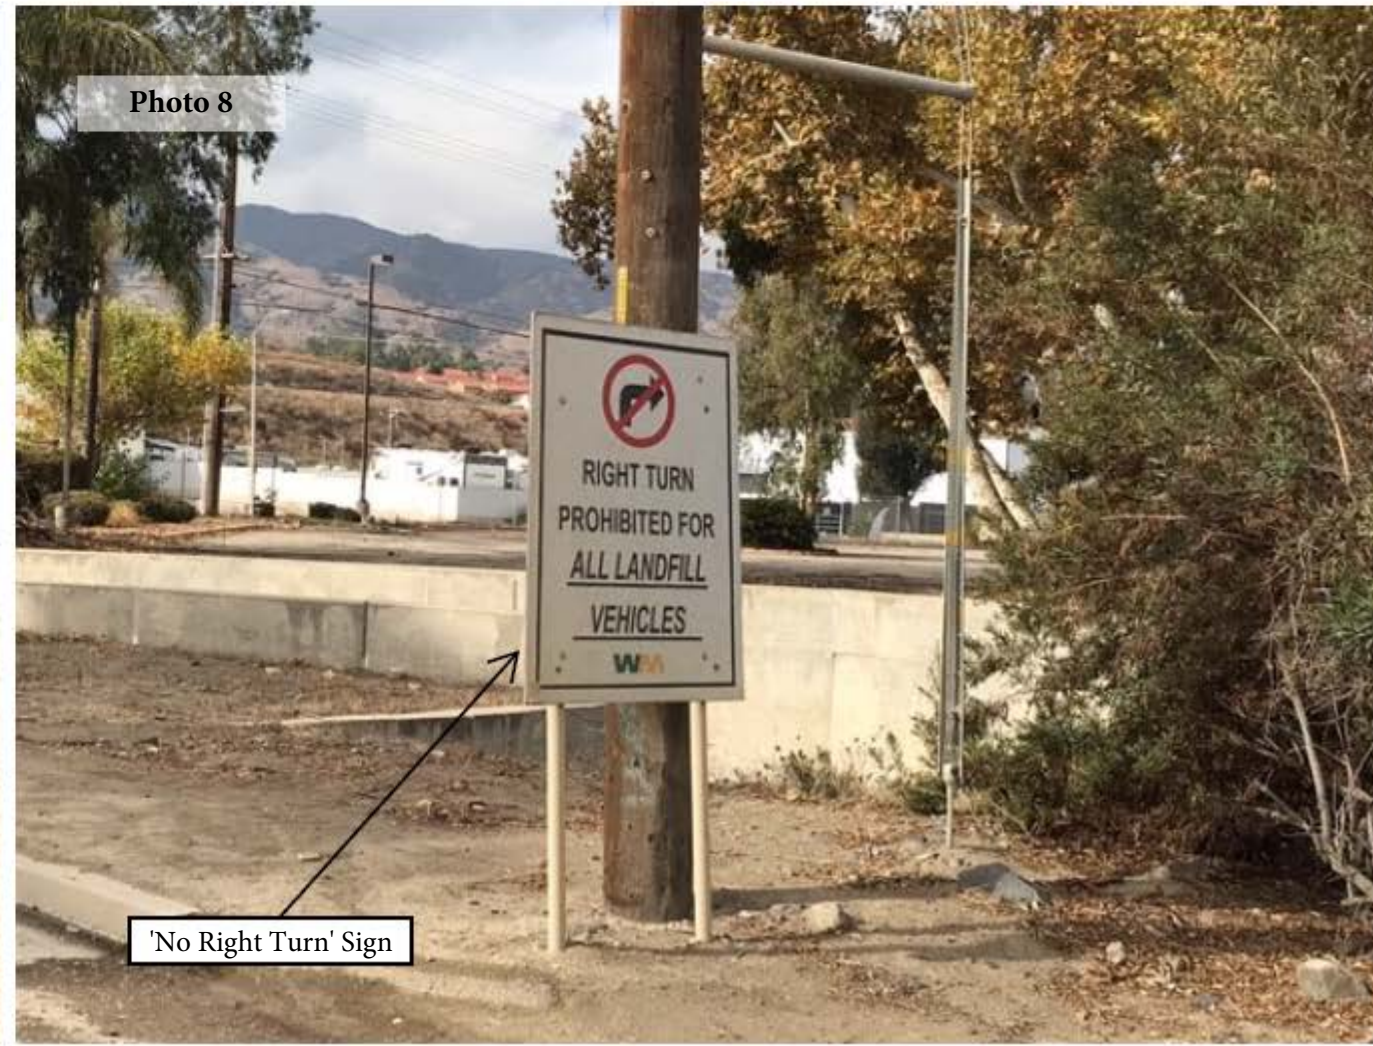
Photo 8

- 'No Right Turn' on Temescal Canyon Road (TCR) from Dawson Canyon:
 - No violations observed. No illegal right turns made by landfill trucks.
 - 'No Right Turn' sign is fully visible and in good condition (photo 8).

'No Right Turn' Sign

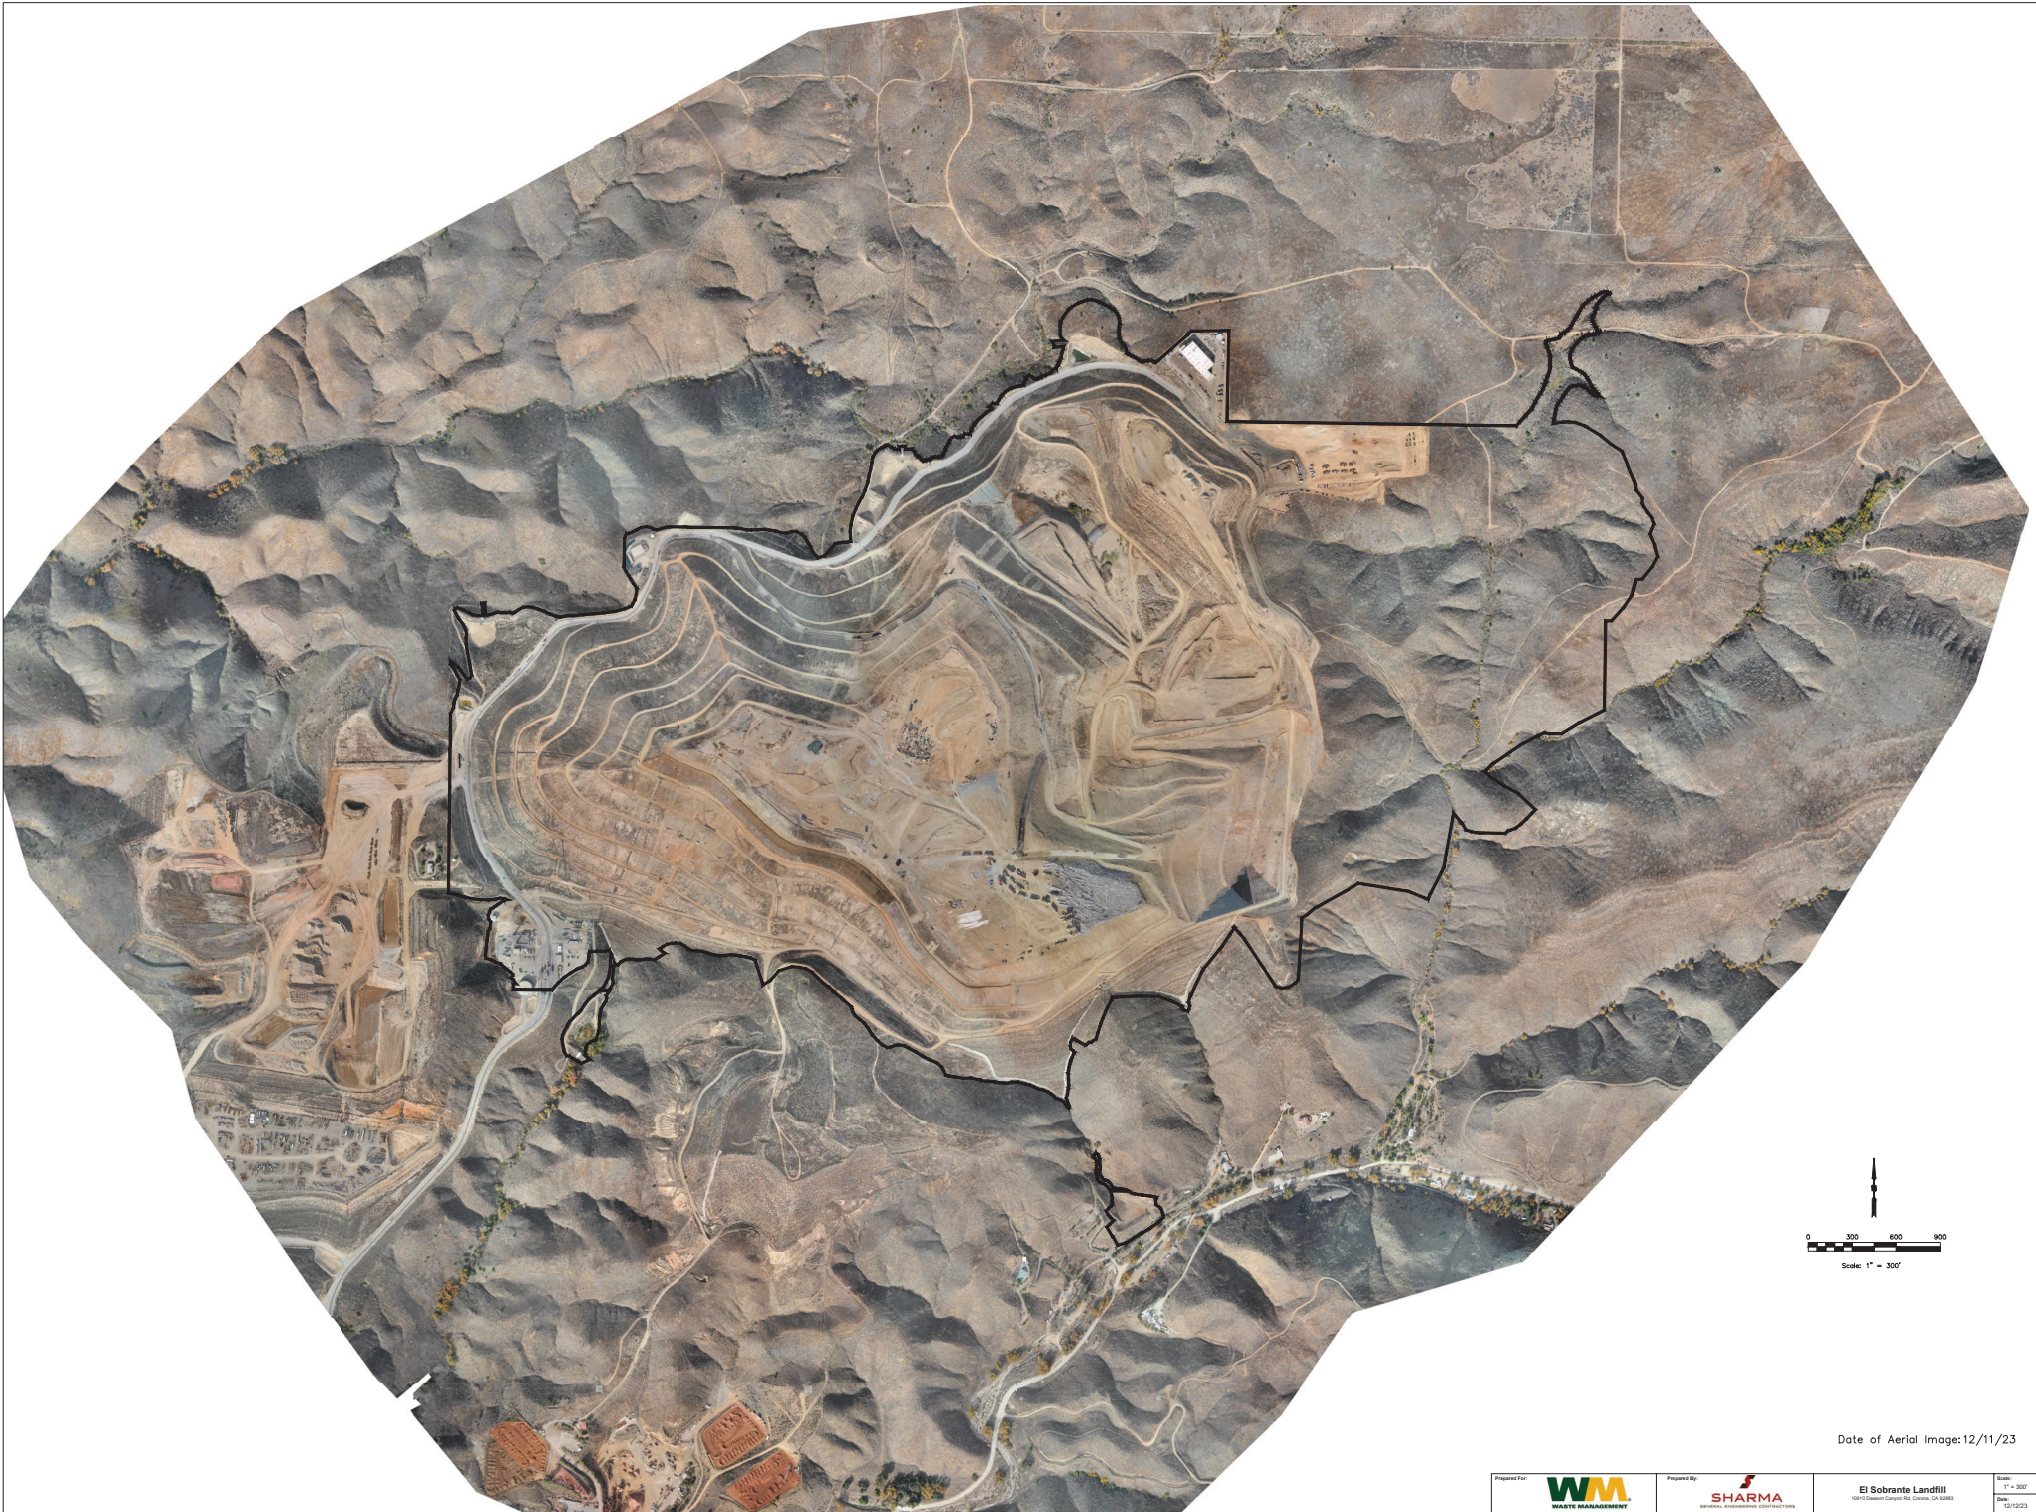
Date of Aerial Image: 12/11/23

- An updated aerial was taken on December 11th and showed no areas of offsite grading or operations.
