Dawson Canyon Road Bridge over Temescal Wash

TECHNICAL MEMORANDUM

Project: Dawson Canyon Road Bridge over Temescal Wash **DSC Project Number:** 01039:19001

Subject: Bridge Inspection and Recommendations

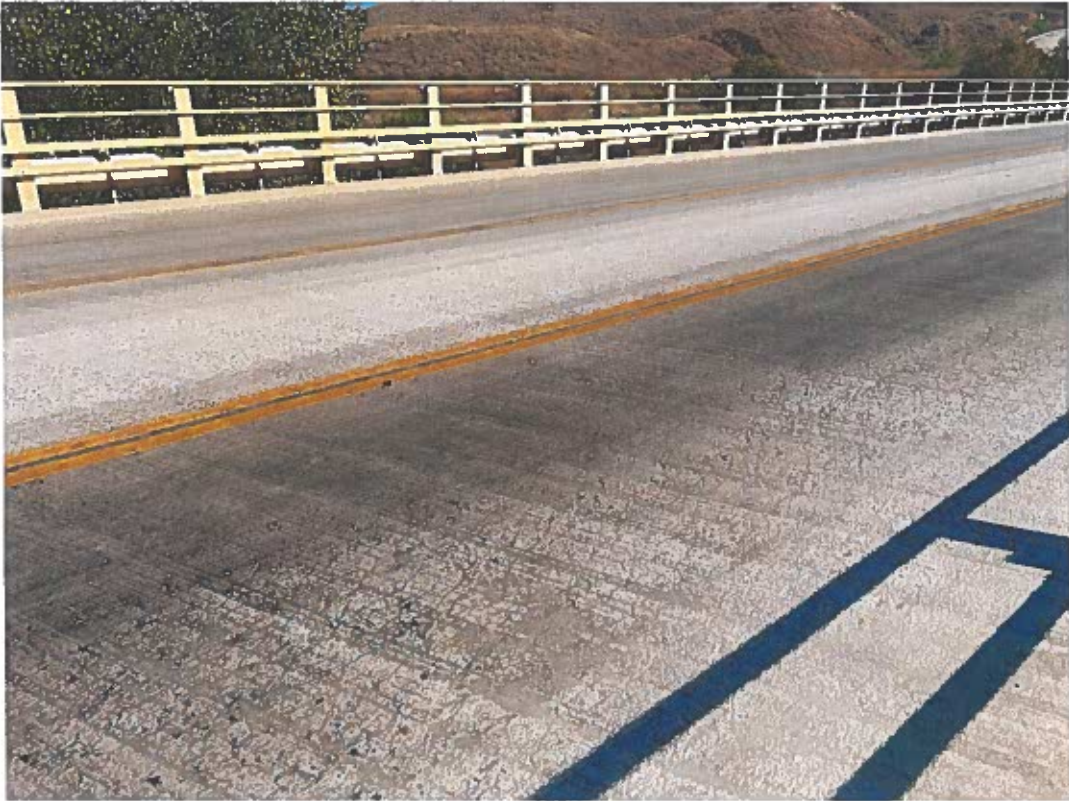
Picture 1: Concrete Bridge Deck with Methacrylate Deck Treatment

Condition: The existing methacrylate deck treatment that was completed in June 2020 is in fair condition (Picture 1). Some areas of the deck treatment are beginning to show signs of distress, most areas are sound and in good condition. The repairs completed in June 2020 at the areas of spalling are in good condition.

Recommended Work: Deck shall be reinspected annually. It is anticipated that in 2 years, near the end of the expected life of the methacrylate deck treatment, that additional deck treatment or deck overlay may be recommended at that time.

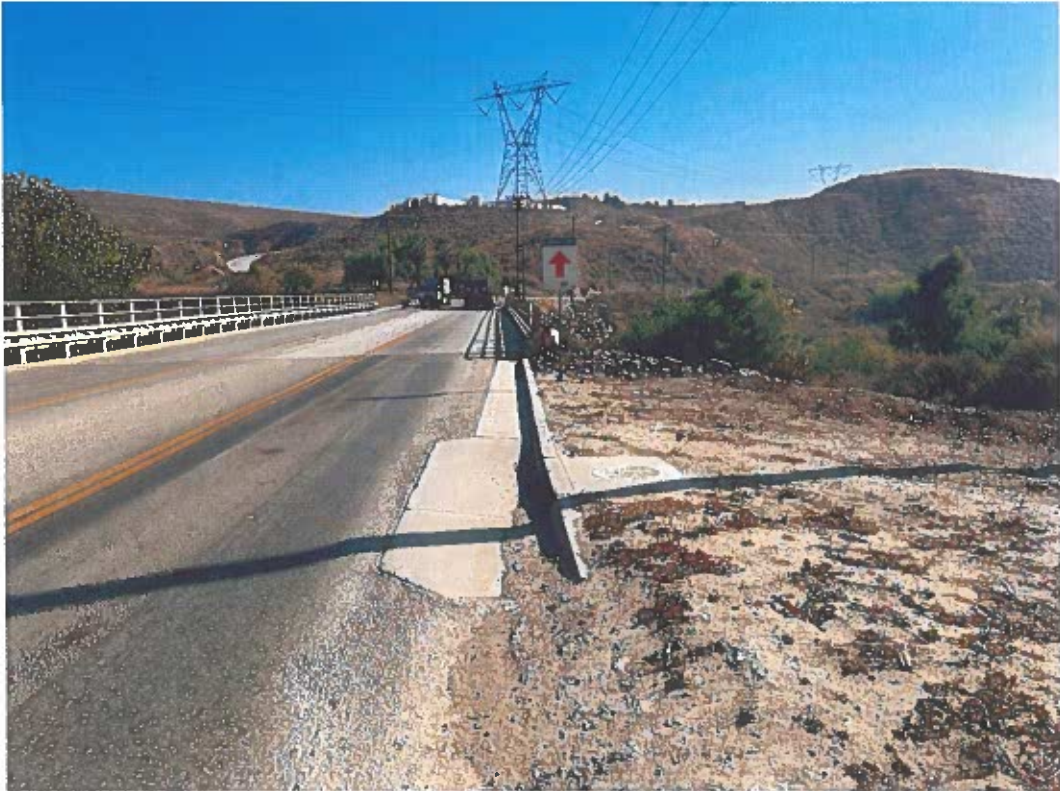
Picture 2: West Approach

Condition: There is no approach guardrail protection on the west end of the bridge (Picture 2). Per the record drawings, a wood post metal beam guard railing system was to be installed at each end and side of the bridge to provide for structure protection and driver safety. The approach appears to have never been installed. The guardrail would restrict traffic from a direct vehicle impact to the bridge.

Recommended Work: Provide Caltrans standard wood post metal beam guardrail protection at each side of the west end of the bridge.

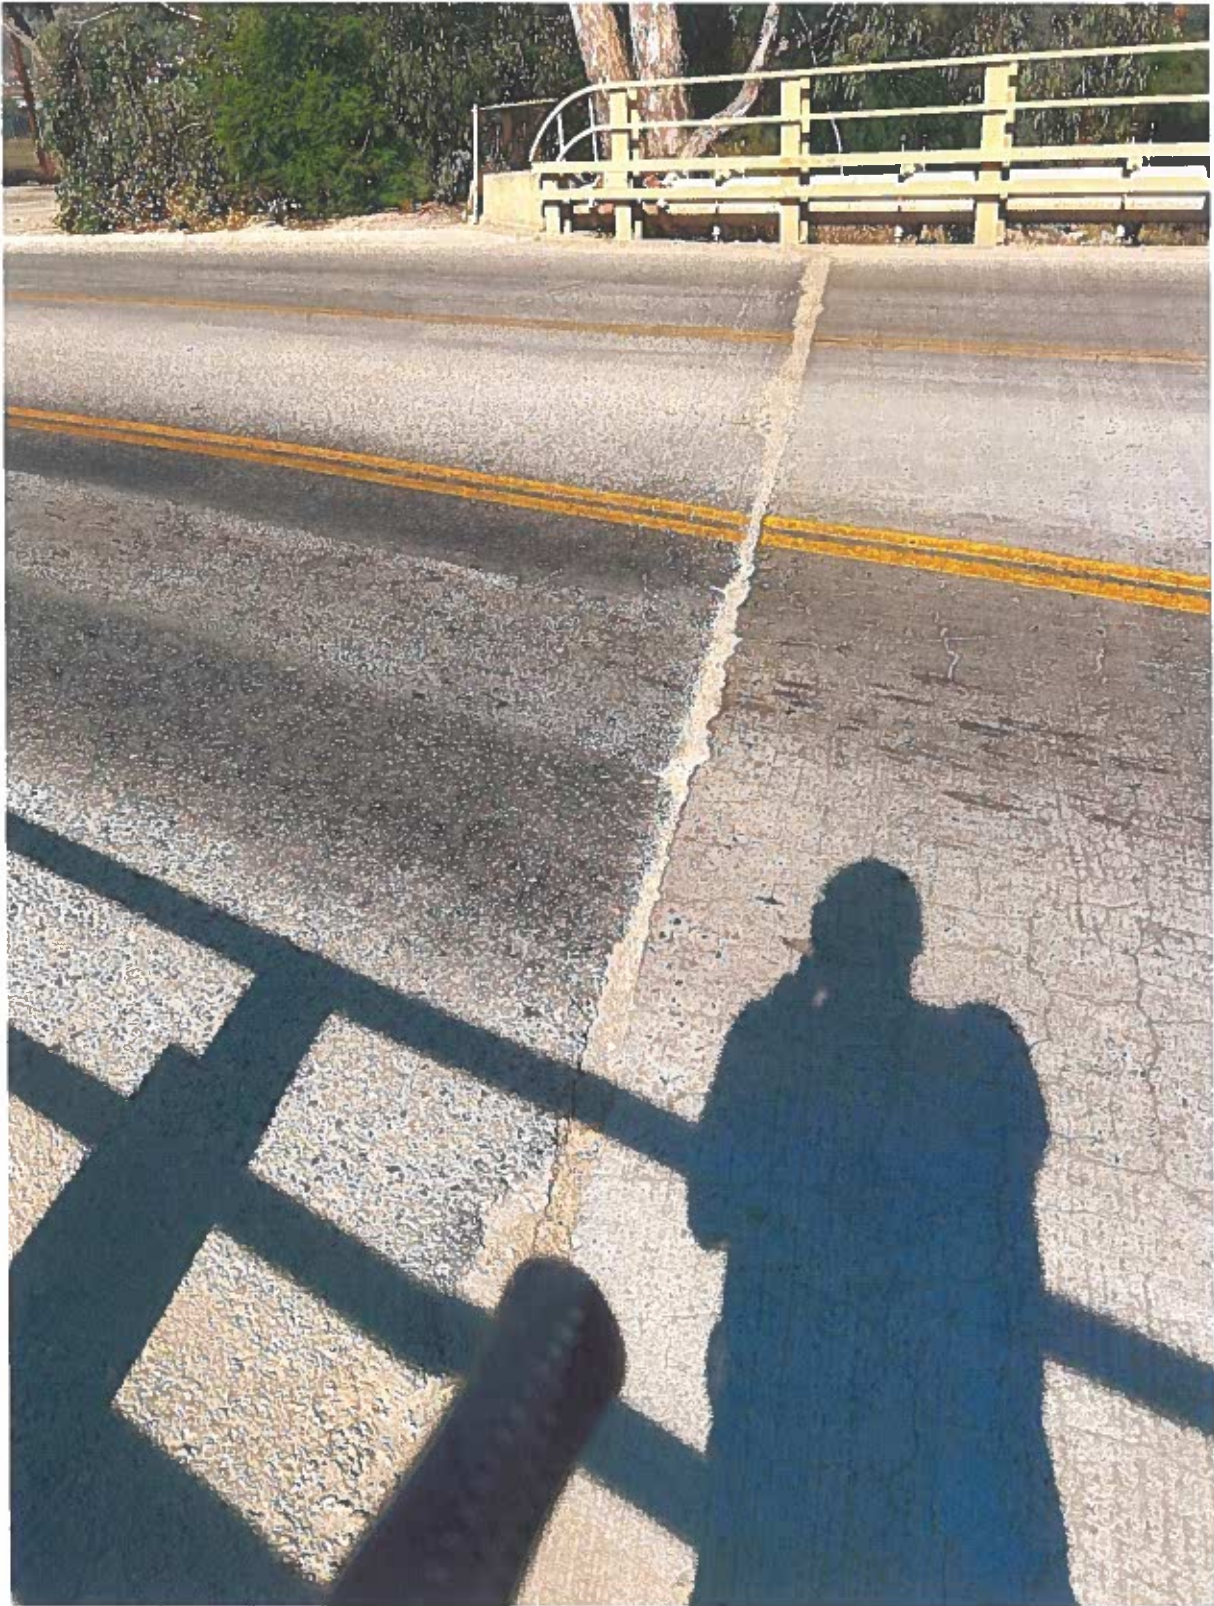
Picture 6: West End of Bridge Deck

Condition: There are no approach slabs or joints at each end of the bridge (Picture 6). The asphalt roadway on either end of the bridge is placed directly against the concrete bridge deck. Some minor spalling at the concrete bridge deck edge is present. Modern bridge design utilizes such approach slab design to better transfer loads to the bridge and reduce wear/spalling at the bridge deck edge.

Recommended Work: Install concrete approach slabs and repair edge of concrete deck. Given that only minor spalling has occurred, the installation of the bridge deck approach slab should be considered when other major maintenance on the bridge deck, such as an overlay, is needed.

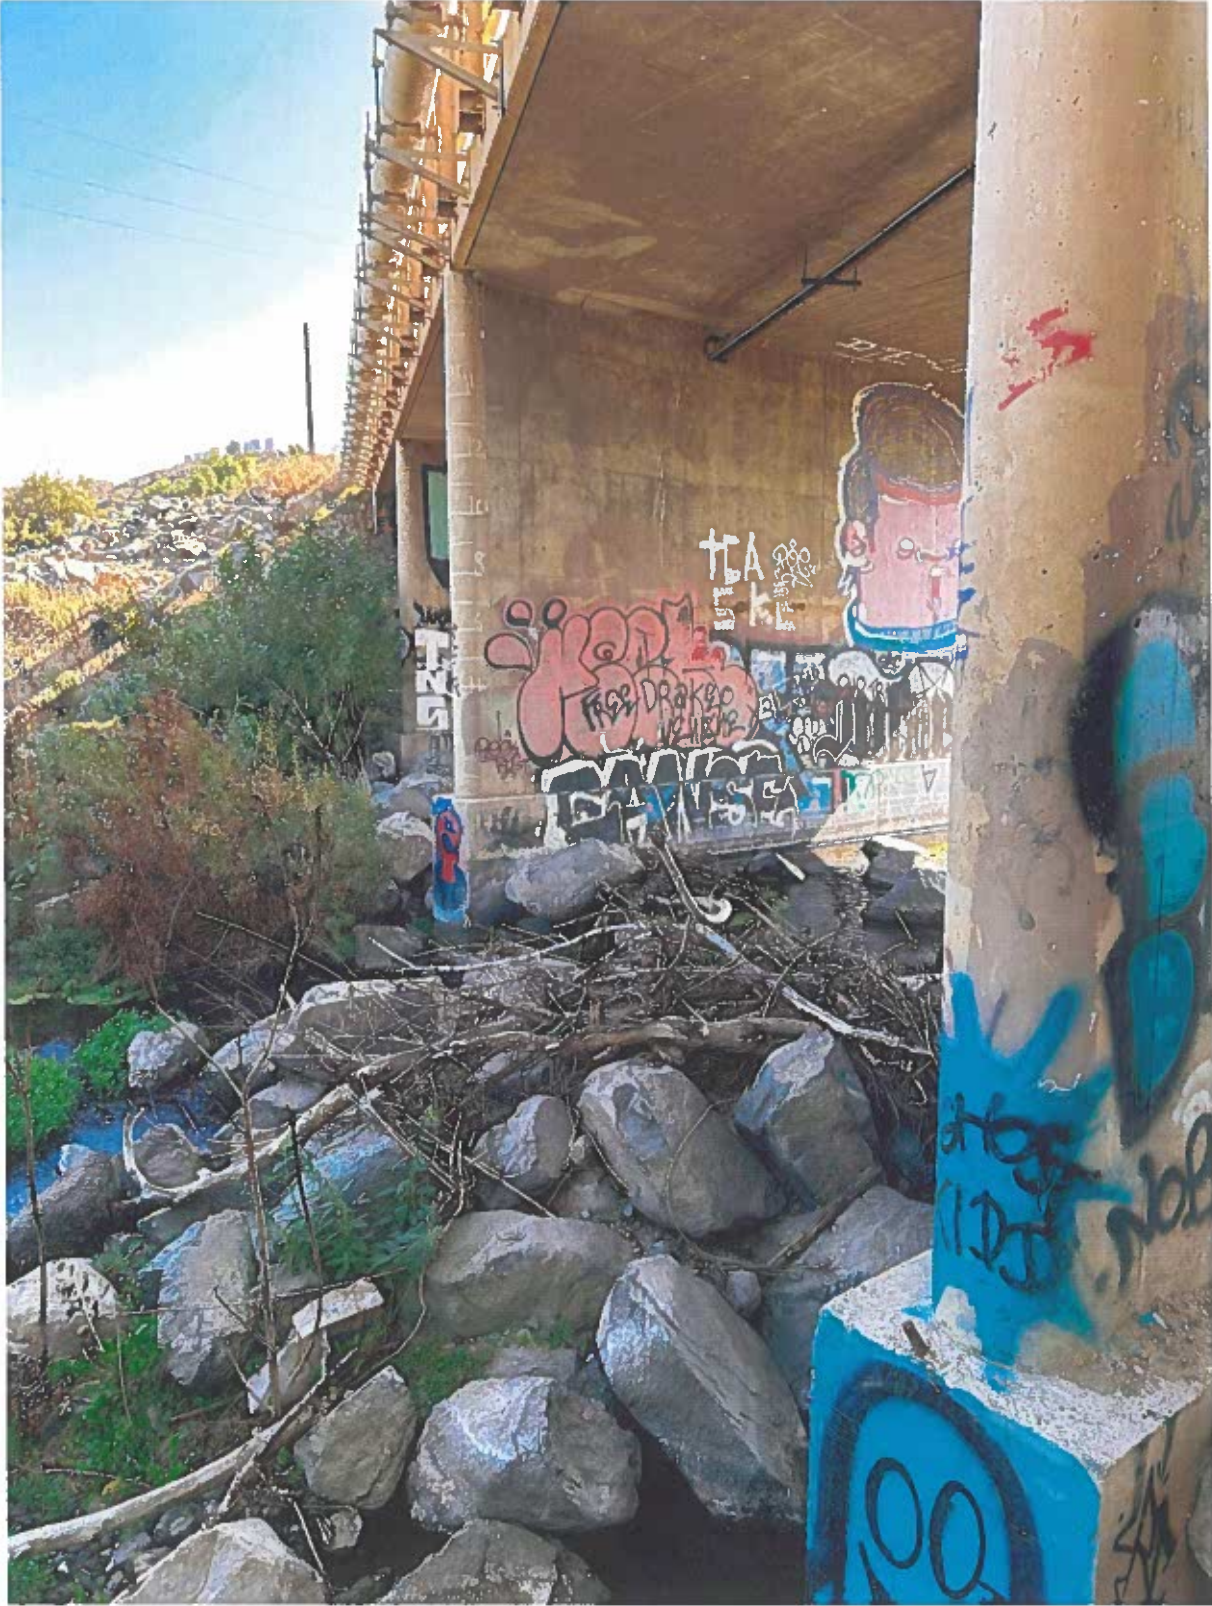
Picture 7: Channel Invert

- Based on the Record Bridge Drawings, the existing Temescal Wash has incised and lowered approximately 14 feet in some areas exposing the concrete pile caps.
- If significant scour below the pile cap occurs, there is a loss of skin friction on the piles which support the bridge. If there is a significant loss, there may be settlement. The settlement would result in settlement of the bridge deck (on the order of an inch or so). Cracking of the bridge deck would likely occur.
- Overturning from the lateral forces is not a concern.

Condition: Based on the Record Bridge Drawings, the existing Temescal Wash has incised and lowered approximately 14 feet in some areas (Picture 7 & 8) exposing the concrete pile caps. Since the previous inspection in 2019, the Temescal Wash invert has lowered an additional 1' between pier walls 2 & 3. See attachment 1 for the approximate invert elevation of the Temescal Wash at the north side of the bridge.

Regarding the channel invert, large diameter angular rock should be placed along the entire length and width of the soft bottom channel under the bridge. WM is working with adjacent property development TVCC (Temescal Valley Commerce Center) and County of Riverside to complete this work. To complete the channel invert repair, permits from California Department of Fish and Wildlife (CDFW), California Regional Water Quality Control Board (RWQCB) and US Army Corps of Engineers (USACE) will be needed. The Section 1600 Lake or Streambed Alteration Agreement to CDFW was submitted on 6/9/2021. The work is anticipated to be completed Q4 of 2024. It should be noted permitting with various resource agencies for this work may take several years.

Recommended Work: Place large diameter angular rock along the entire length and width of the soft bottom channel under the bridge. The rock should be placed so that the top of the new rock scour protection is level with the top of the concrete pile caps, refer to the 2022 Bridge Report for additional recommendations. Until the rock scour protection is installed, a routine bridge monitoring program should be initiated as well as during significant rain events. The suggested monitoring program would include developing photographic documentation of the stream channel and the pile caps so that comparisons can be made. DSC will review the documentation during annual inspections and after large storm events. Based on discussions with Waste Management, the process to install the additional scour protection has been initiated but may require a significant amount of time for permitting with various agencies.
