Community Assessment

El Sobrante Landfill: Community Assessment

Date: May 12, 2022 Arrival time: 12:29 pm Prepared by: Jose Merlan, RCDWR

2022
AESTHETICS REPORT
FOR THE
EL SOBRANTE LANDFILL

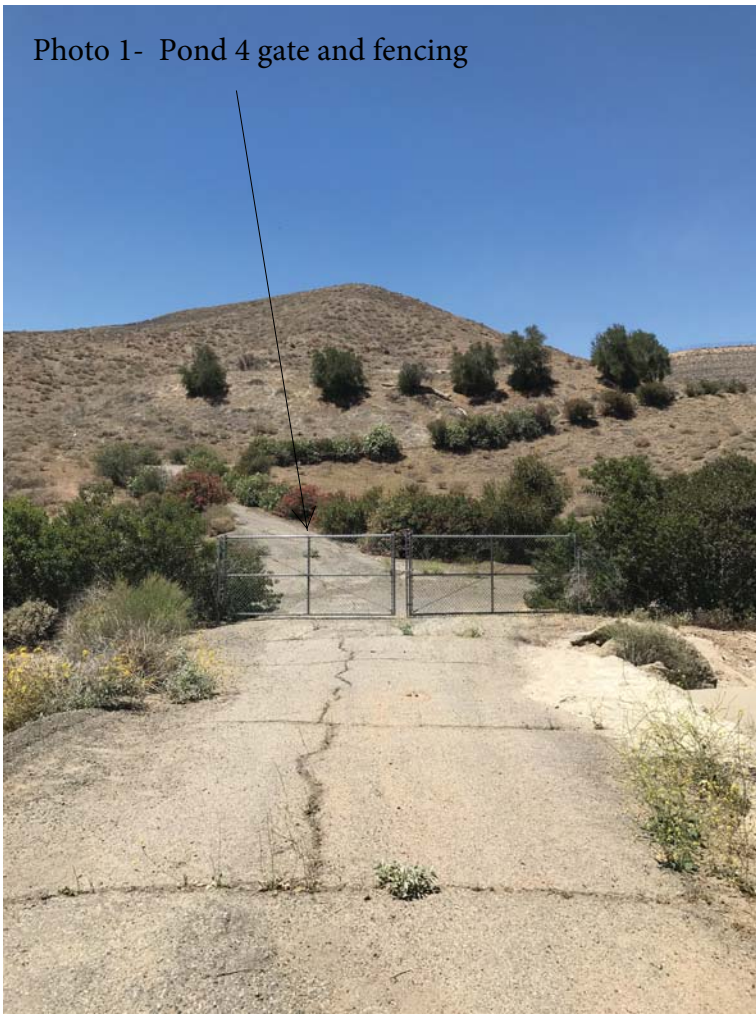
Photo 1- Pond 4 gate and fencing

- Pond 4 visual inspection:
 - Pond 4 gate and fencing - good condition, no litter (photo 1).
 - Pond 4 outside slope - good vegetative cover (photo 2).
- Drainage channel/culverts:

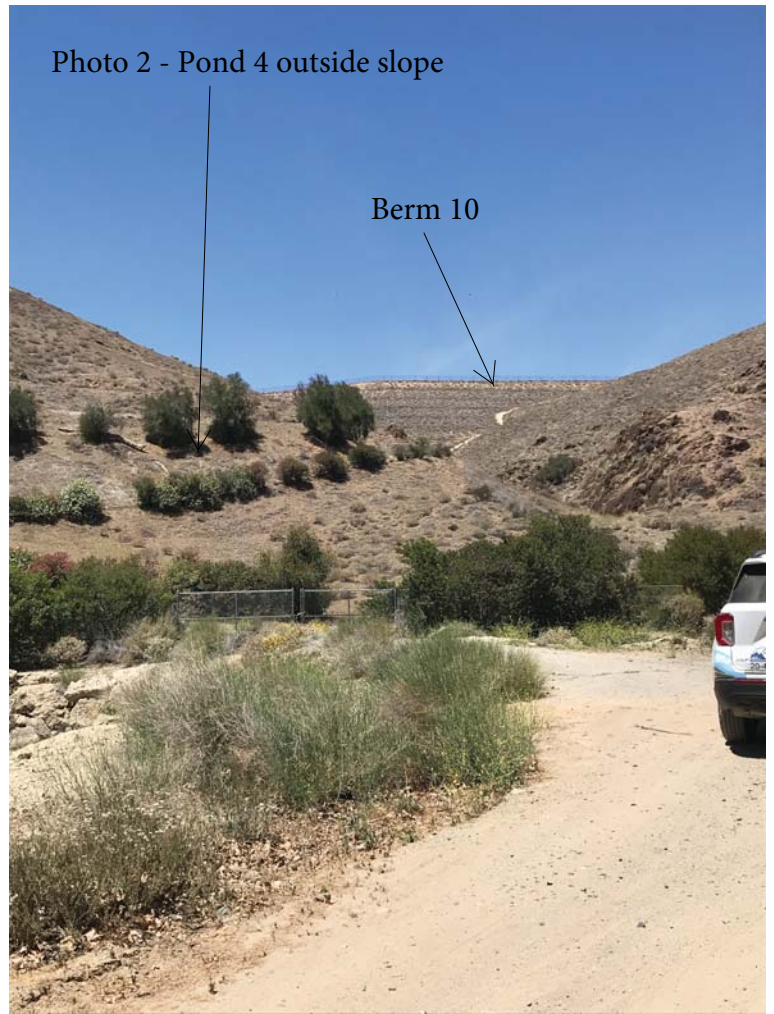
Photo 2 - Pond 4 outside slope

- Berm 10/11:
 - No visible litter, good vegetative cover (photo 2-Berm 10; photo 3-Berm 11).
- Landfill operations:
 - Not visible from Dawson Canyon area.

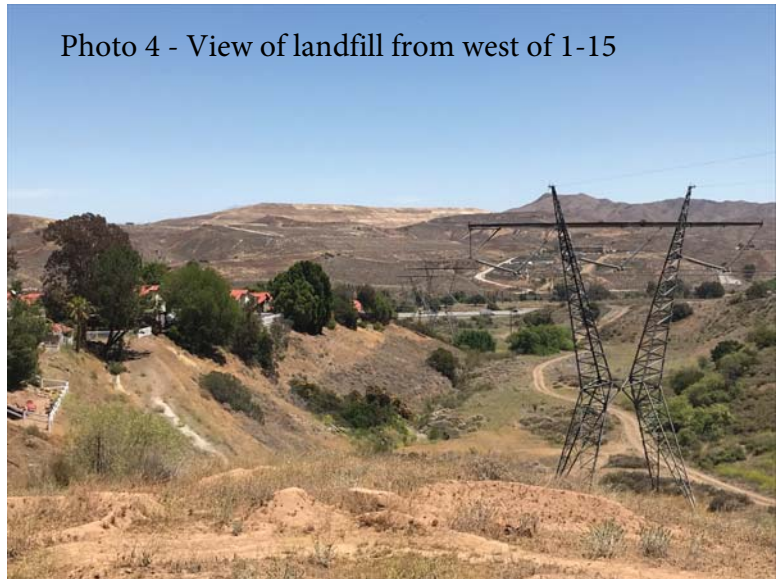
Photo 4 - View of landfill from west of 1-15

- No landfill operations visible from communities west of I-15; bare outside slopes (photo 4); USA Waste/WMI implementing plan to address the bare slopes

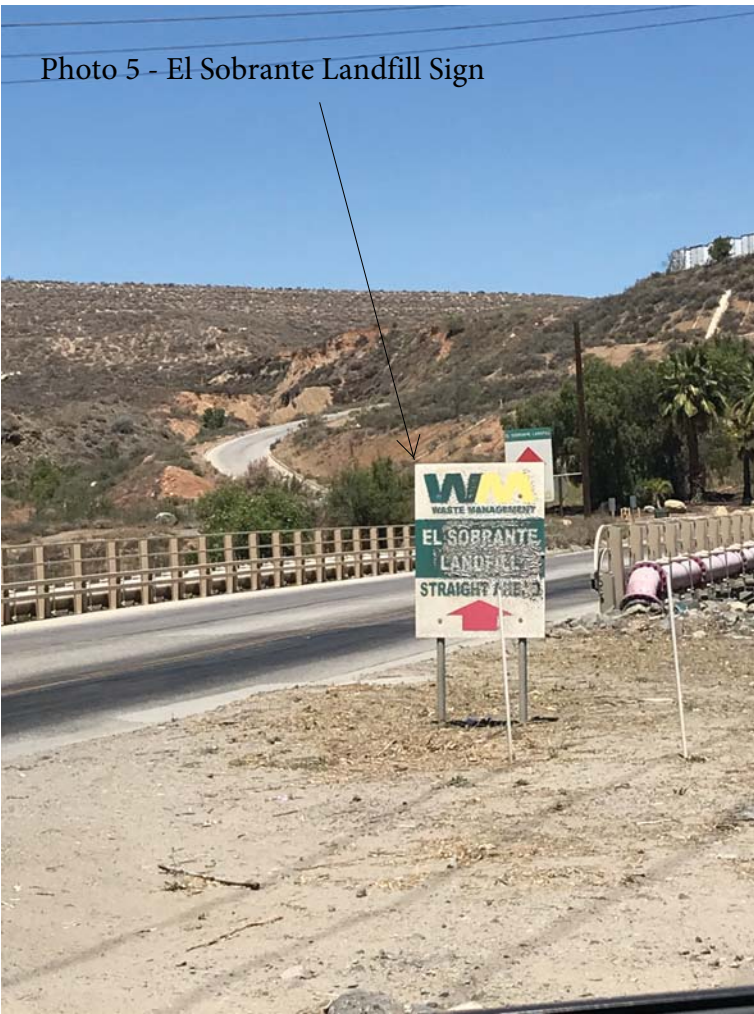
Photo 5 - El Sobrante Landfill Sign

- No visible off-site litter.
- Signage:
 - Inspected landfill address and directional signs. Sun damaged El Sobrante "Straight Ahead" sign needs replacing (photo 5). All other signs are in good condition; visible and placed at numerous locations along Dawson Canyon Road.

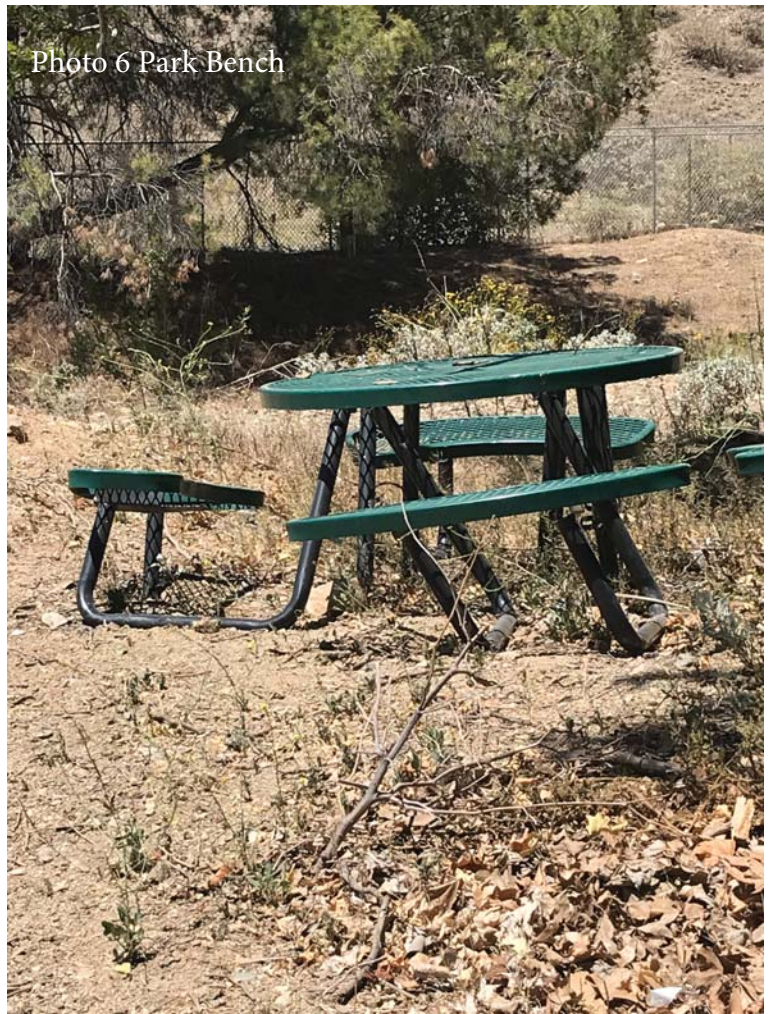
Photo 6 Park Bench

- Community Amenities condition (park bench, table, gate/fencing, signage):
 - Park bench showing signs of damage (photo 6).

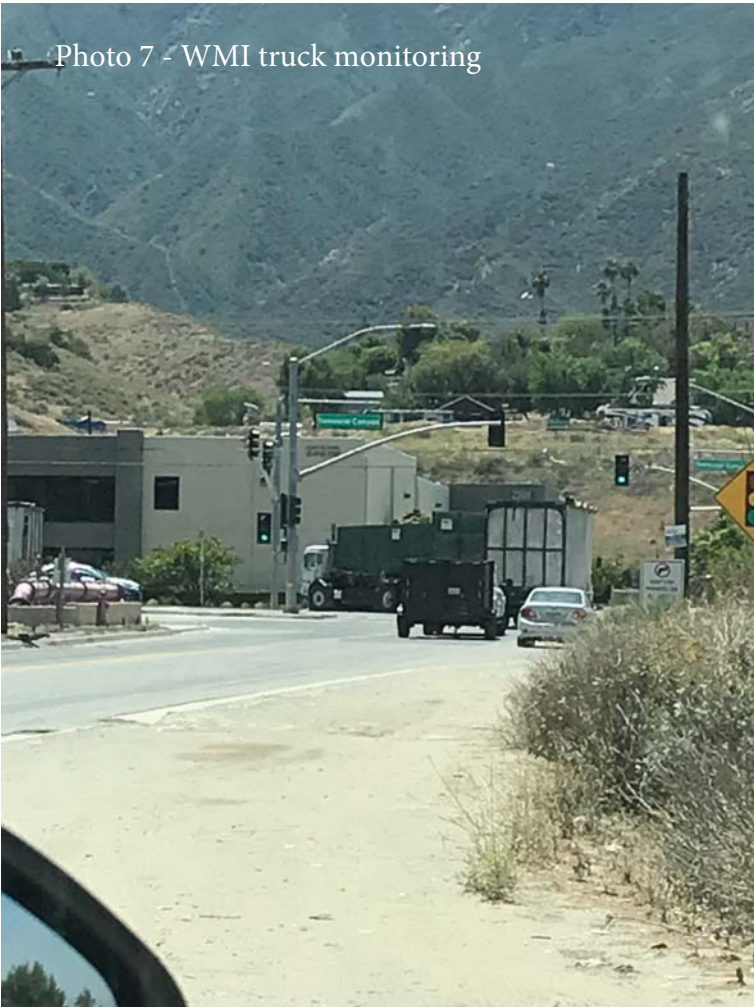
Photo 7 - WMI truck monitoring

- 'No Right Turn' on Temescal Canyon Road (TCR) from Dawson Canyon:
 - No violations observed. Monitored for 20 minutes, total of 10 trucks (photo 7).
 - 'No Right Turn' sign in good condition and fully visible.

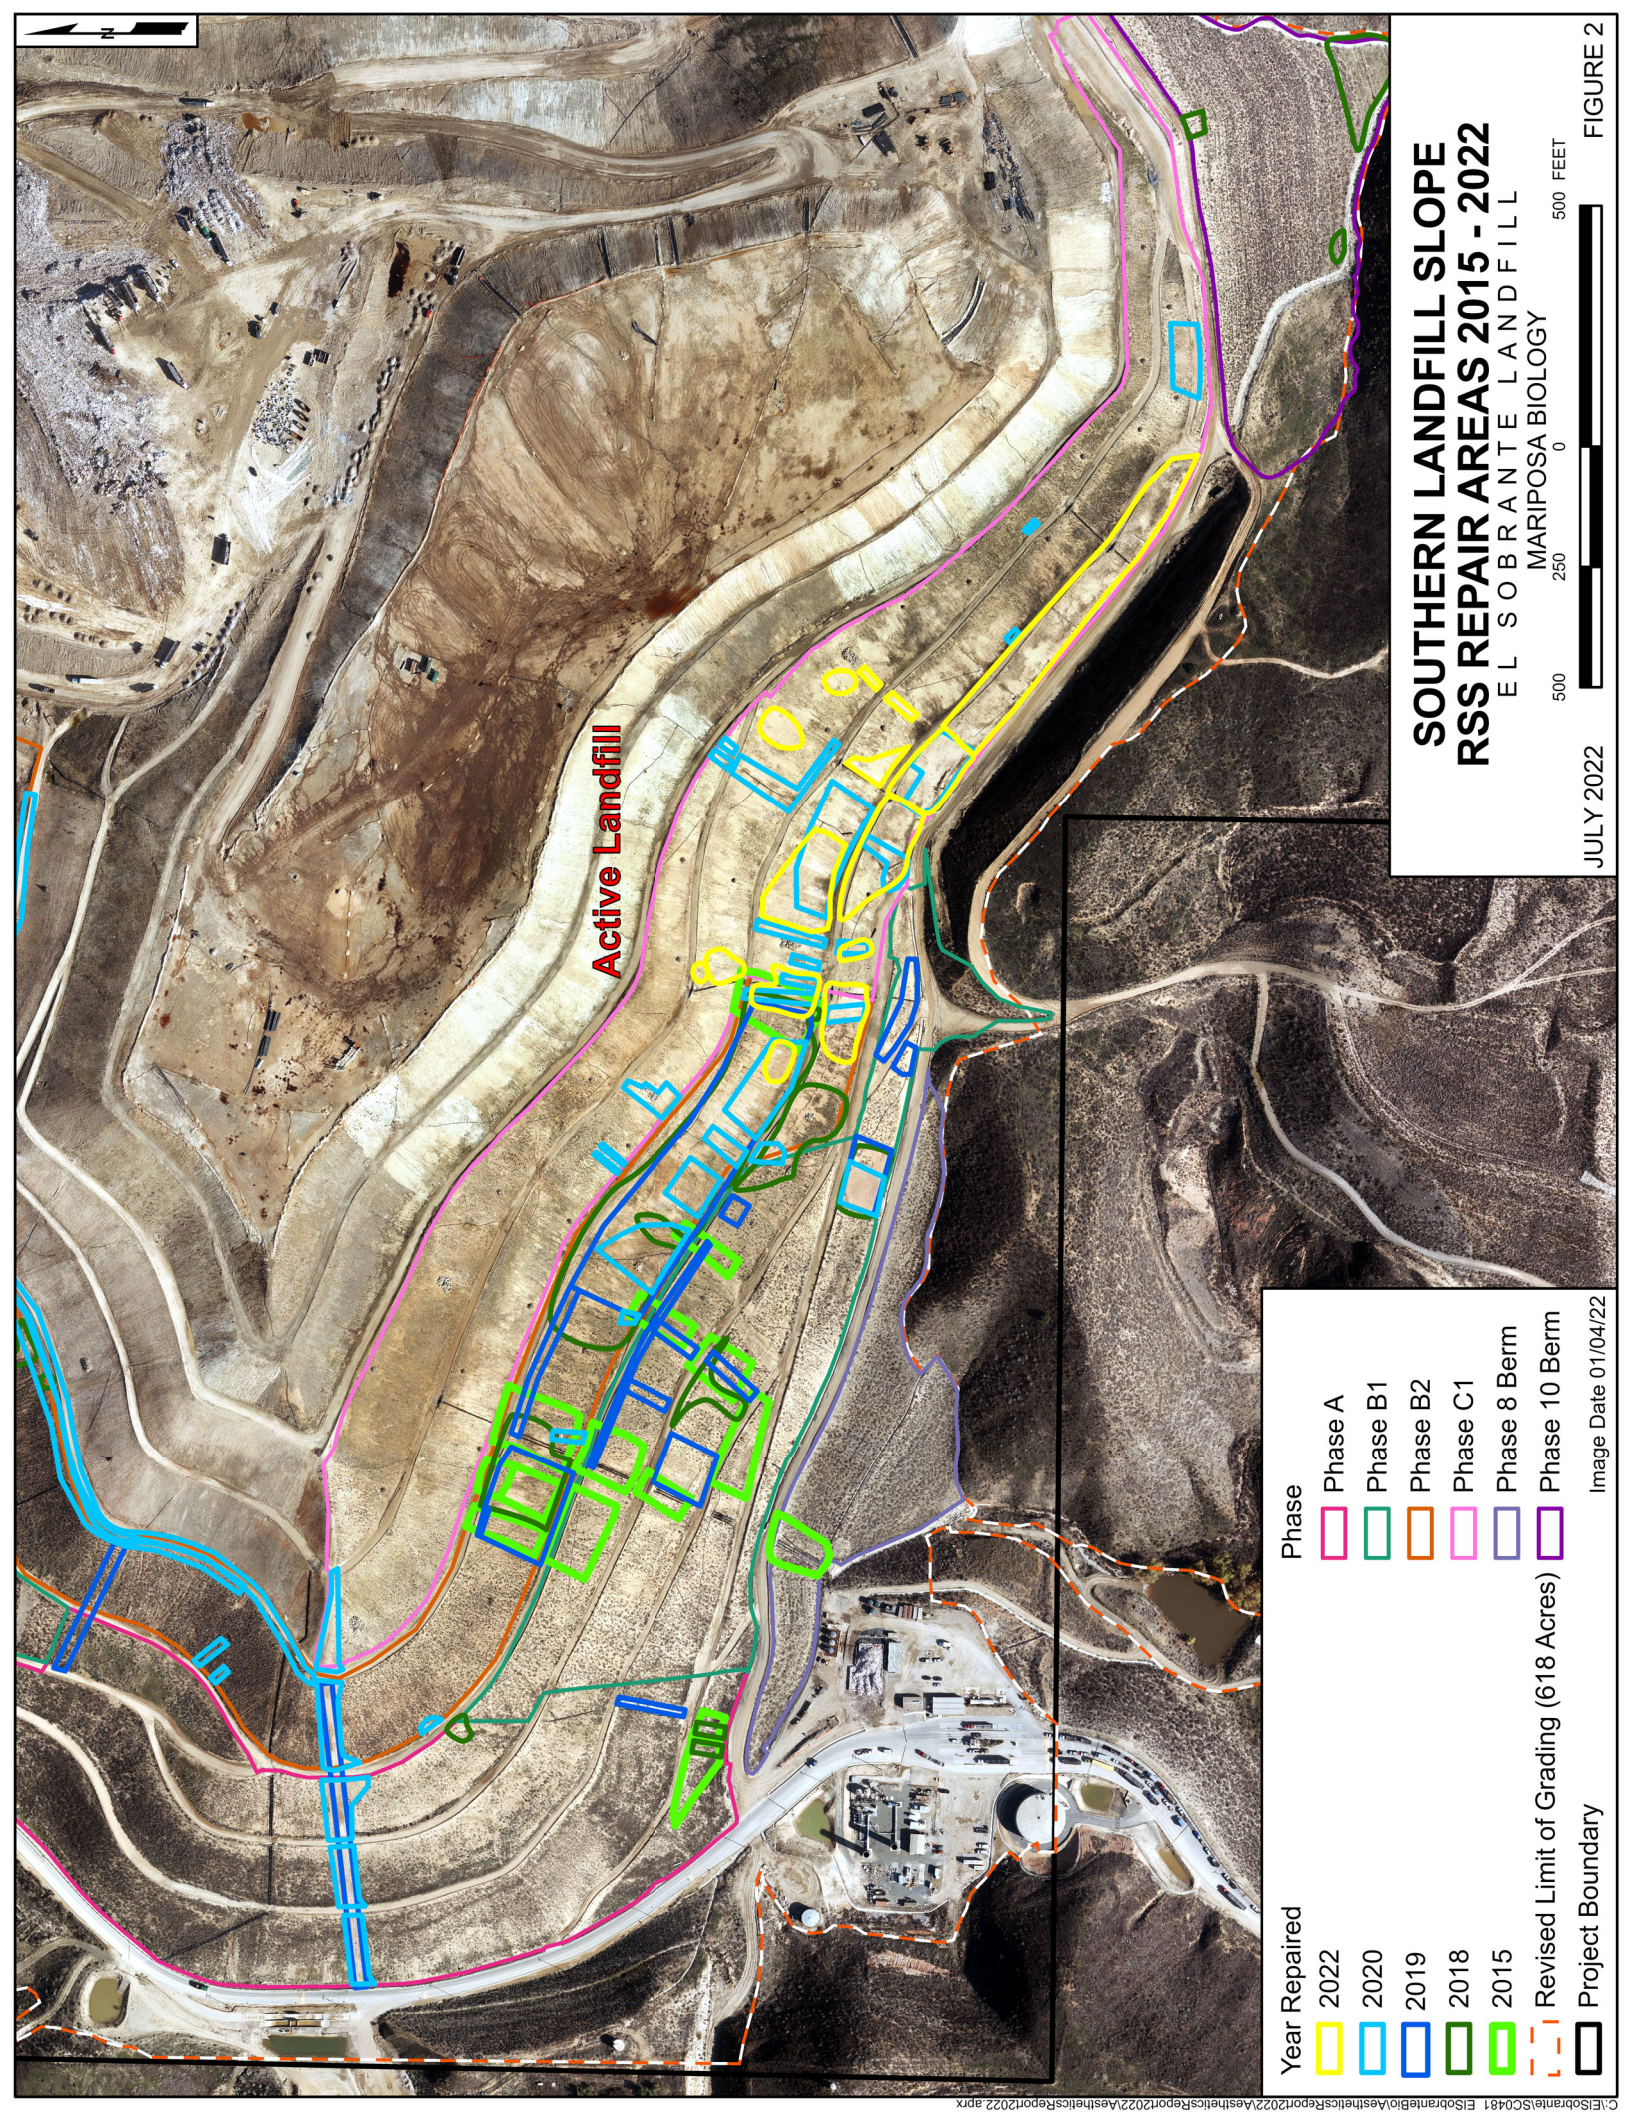
SOUTHERN LANDFILL SLOPE
RSS REPAIR AREAS 2015 - 2022
 EL SOBRANTE LANDFILL
 MARIPOSA BIOLOGY
 JULY 2022
 500 250 0 500 FEET
 FIGURE 2

Erosion repairs were needed on some of the south slopes in 2022. Repairs require using earth-moving equipment to repair the soil surface and the vegetation is also removed. Repair areas are obvious in the photographs because all vegetation is missing. Differing sizes of shrubs in the photographs show where repairs have taken place in the past. Figure 2 shows the repairs that have been done since 2015.

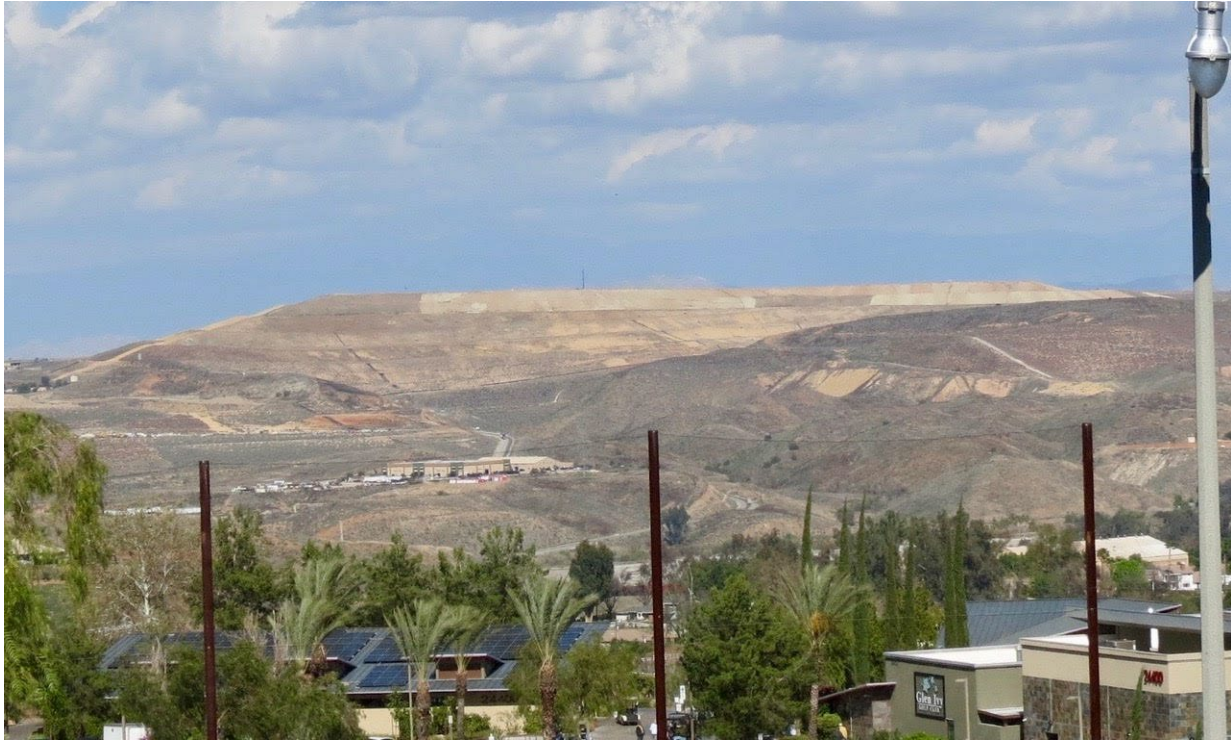
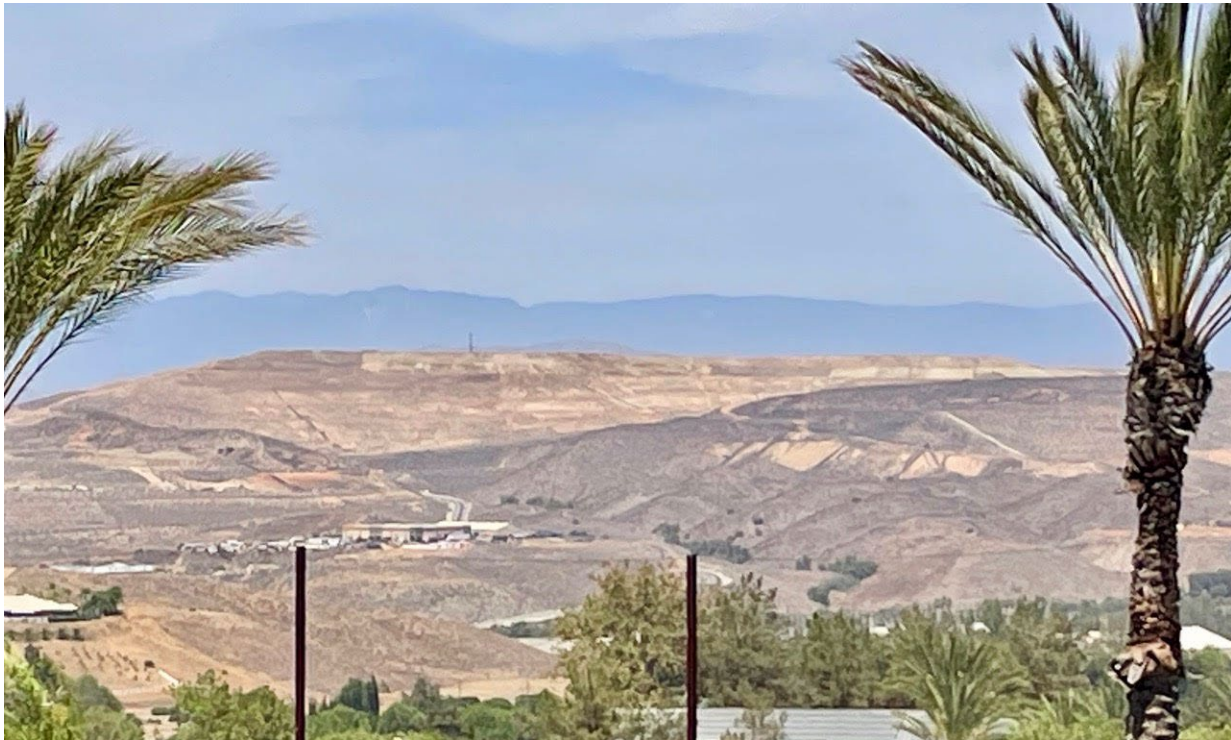
Photographs 1 and 2 show the southern face of the landfill from the Trilogy Club House parking lot from 2021 and 2022. There is no obvious difference in the photographs from this distance.

Photograph 1. The view from Trilogy, March 2021.

Photograph 2. View from Trilogy, July 2022.

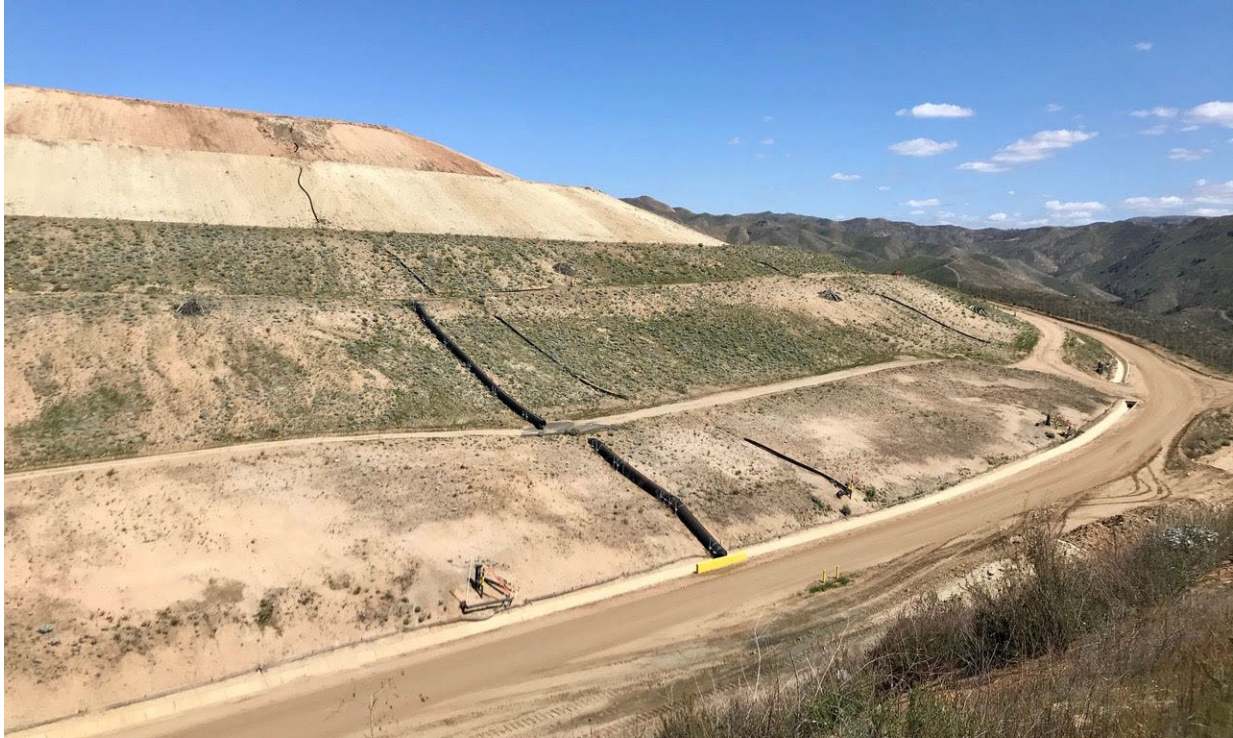
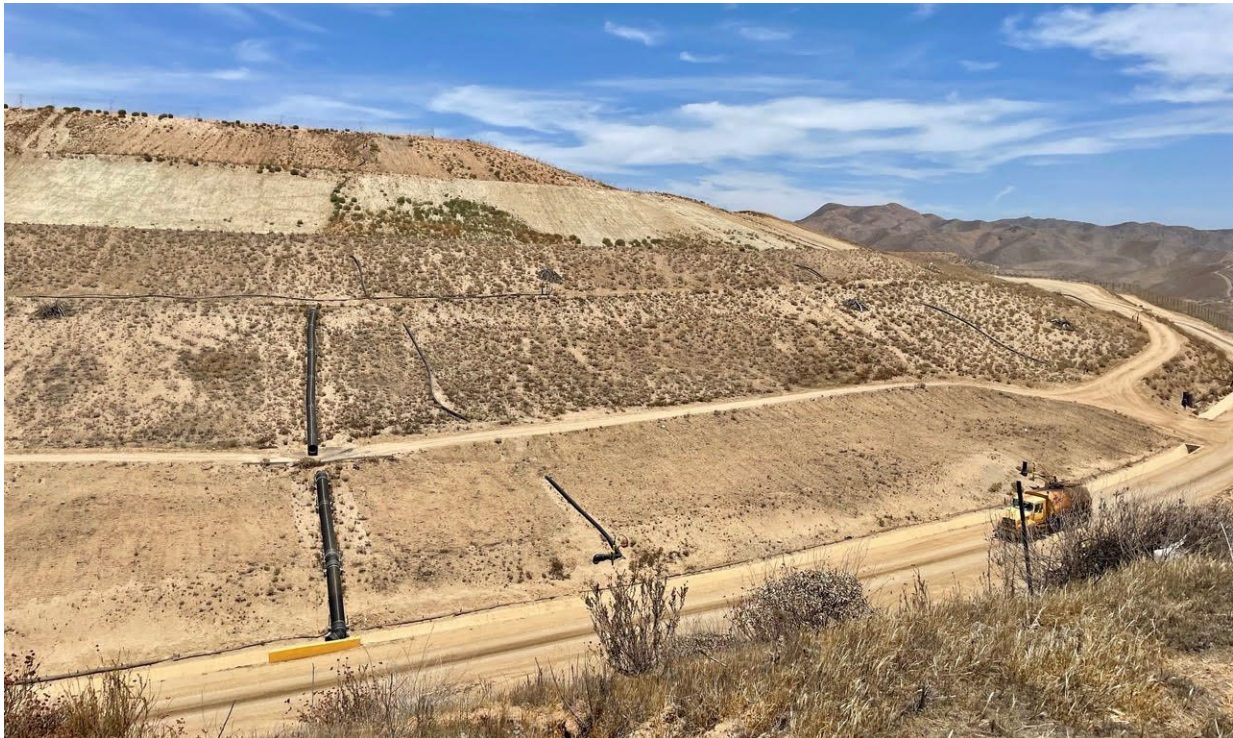
Photographs 3 and 4 show the eastern part of Phase C1 with three vegetated slopes below two slopes of active landfill. Phase C1 was seeded in December 2019. The photographs are similar except the 2022 photograph shows growth around and beyond the distant stick pile in the middle slope of C1.

Photograph 3. The eastern part of Phase C1, March 2021.

Photograph 4. The eastern part of Phase C1, July 2022.

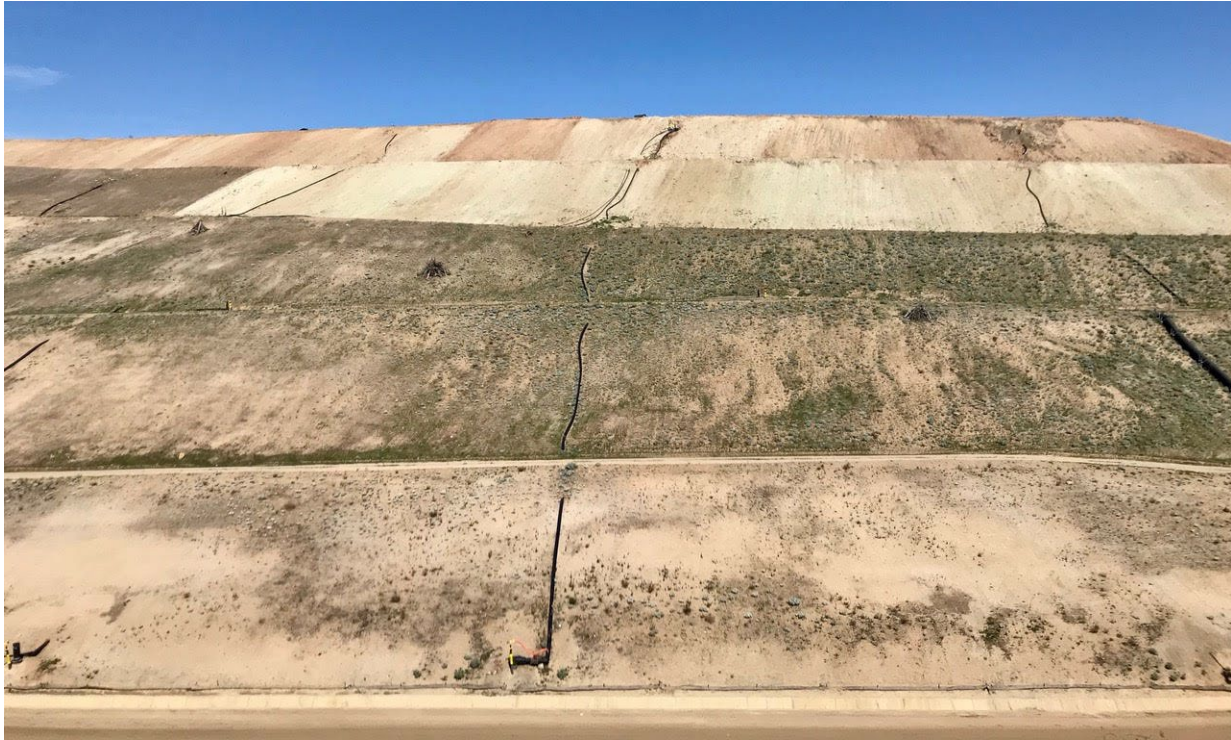
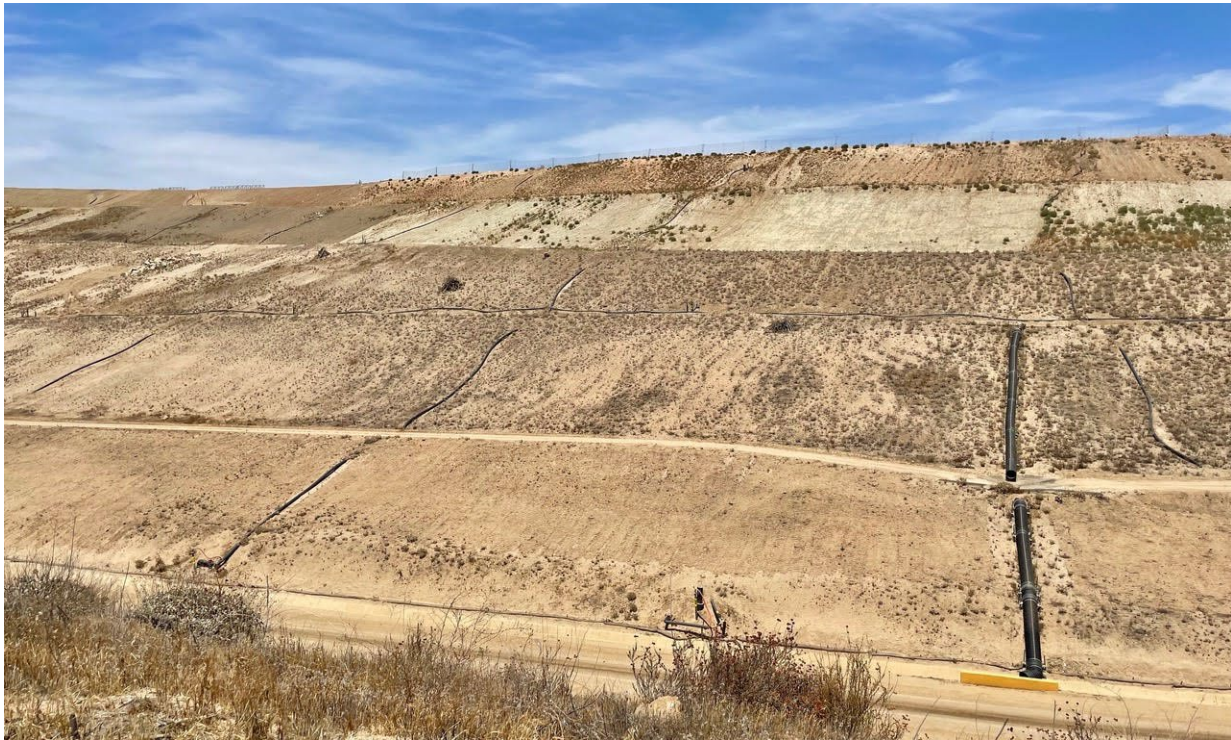
Photographs 5 and 6 show the slopes of Phase C1 to the moving in a westerly direction. The top two slopes look similar with good vegetation. The lower slope shows tracks from a slope repair and are not as densely vegetated as the top two slopes.

Photograph 5. Moving west, Phase C1, March 2021.

Photograph 6. Moving west, Phase C1, July 2022.

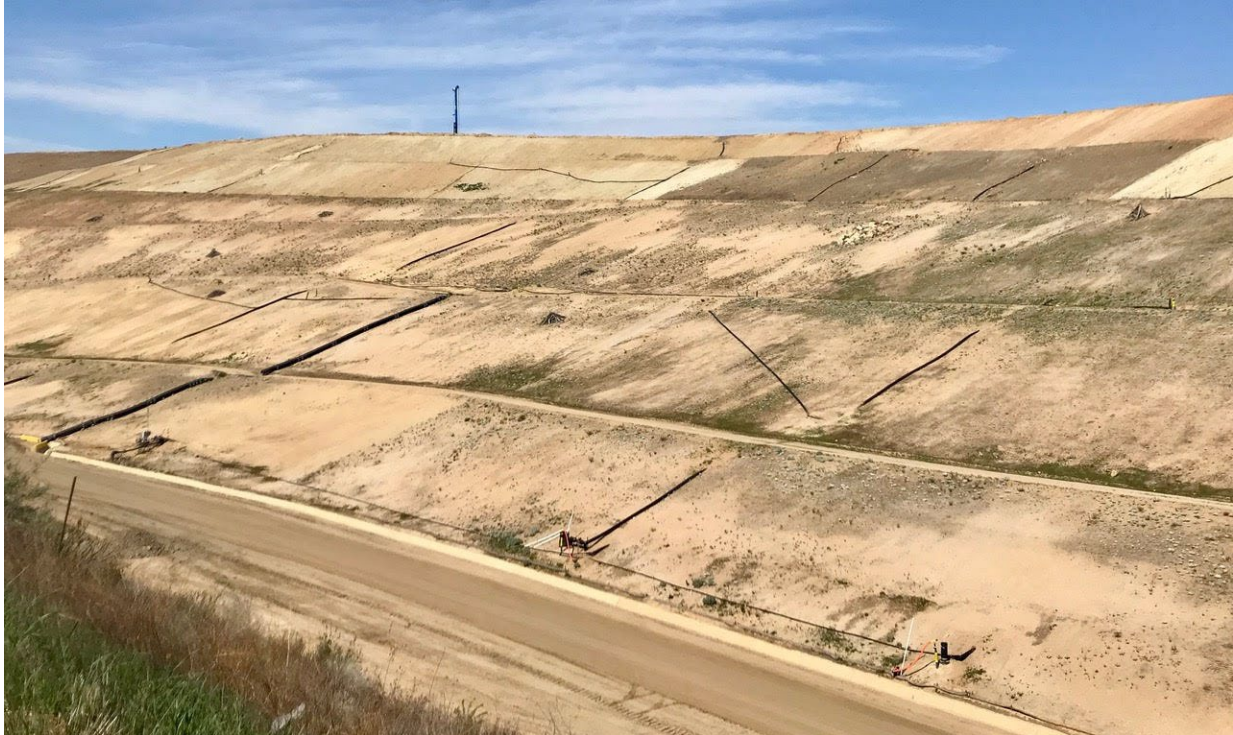
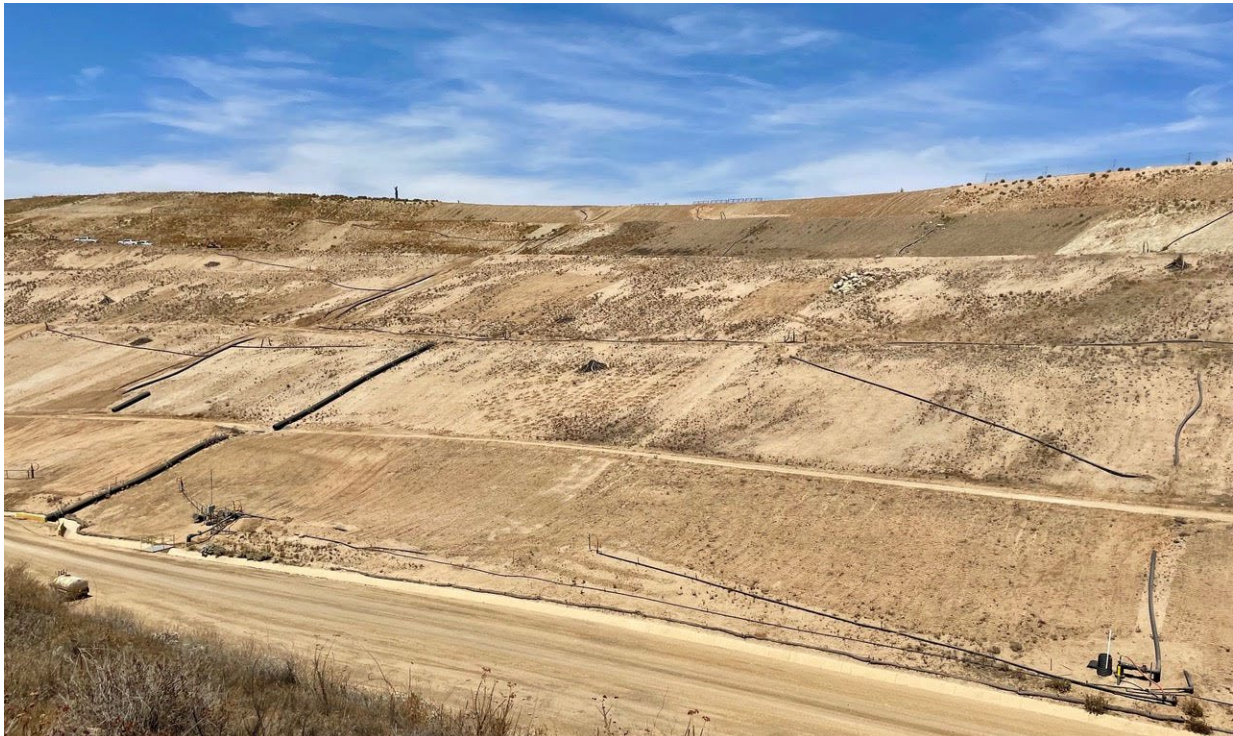
Photographs 7 and 8 show the center of Phase C1. There are visible signs of slope repairs where vegetation is missing or much shorter than nearby vegetation. On the top slope near and left of the rock outcrop, the 2022 photograph shows a darkening of vegetation growth. On the middle slope near the stick piles, there are also signs of vegetation growth between 2021 and 2022.

Photograph 7. The center of Phase B1, March 2020.

Photograph 8. The center of Phase B1, July 2022.

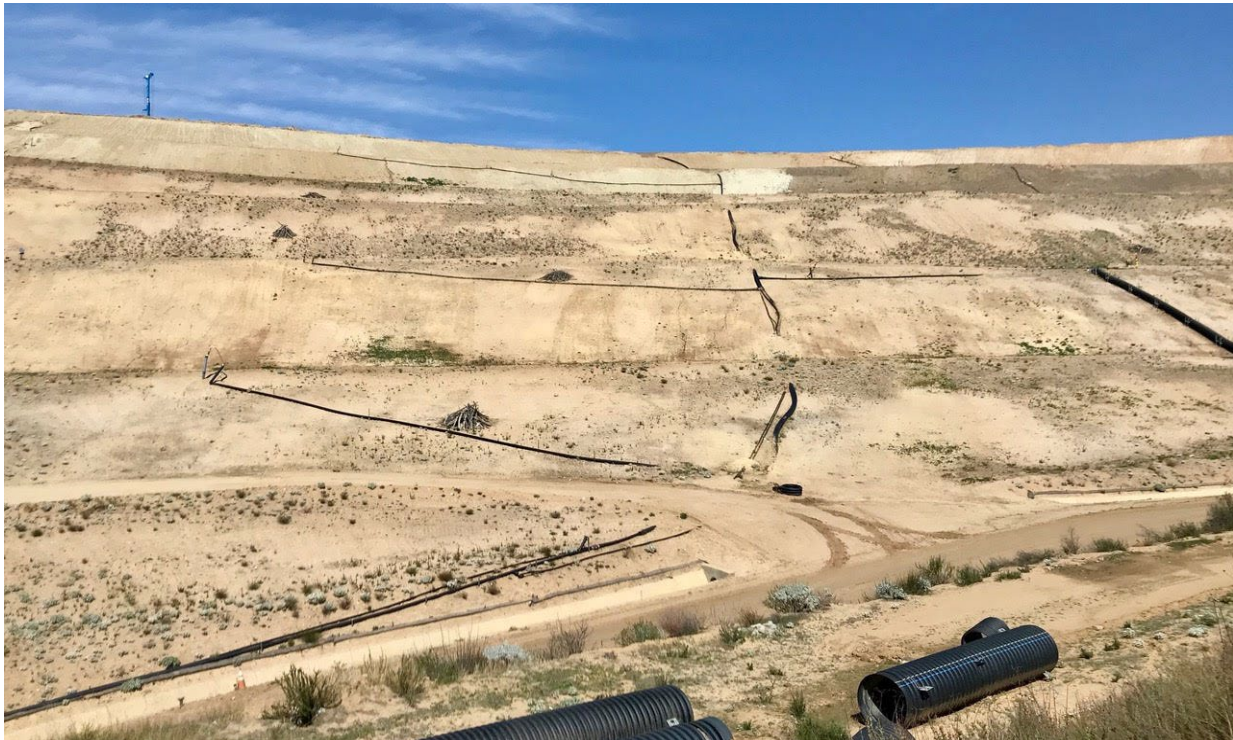
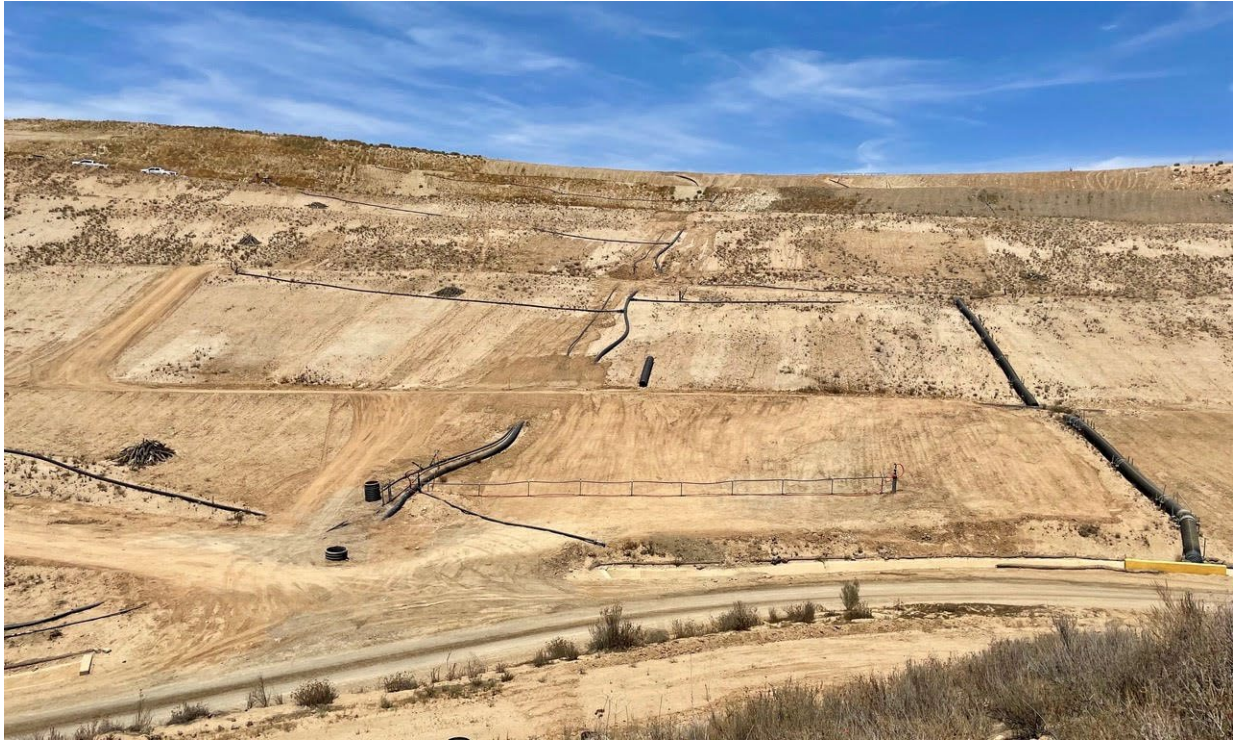
Photographs 9 and 10 show four slopes at the center of Phase C1. The top slope is narrow. Both photographs show signs of erosion repair on the lower slopes. The 2022 photograph shows a new gas or water removal pipe system had been installed resulting in the loss of vegetation. On the upper slopes, the bald spots between shrub clusters are gradually filling in and the shrubs show growth.

Photograph 9. Four slopes of Phase C1, March 2021.

Photograph 10. Four slopes of C1 with trucks above the top slope, July 2022.

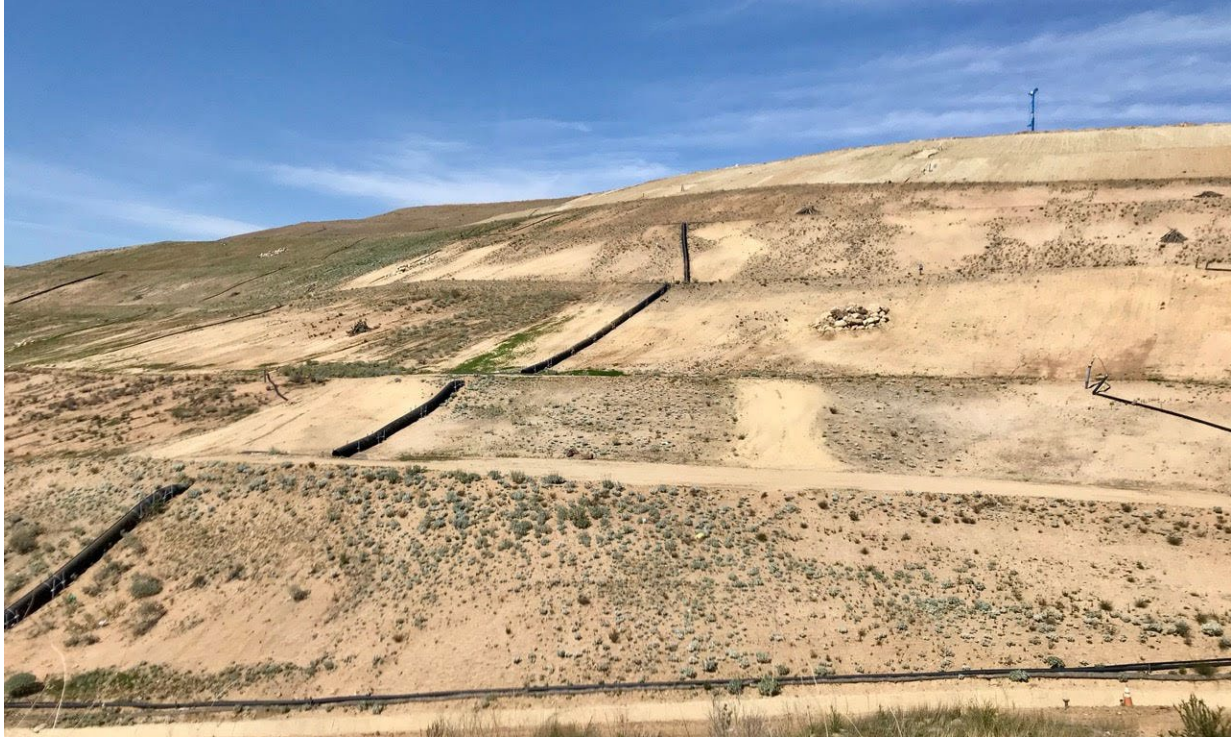
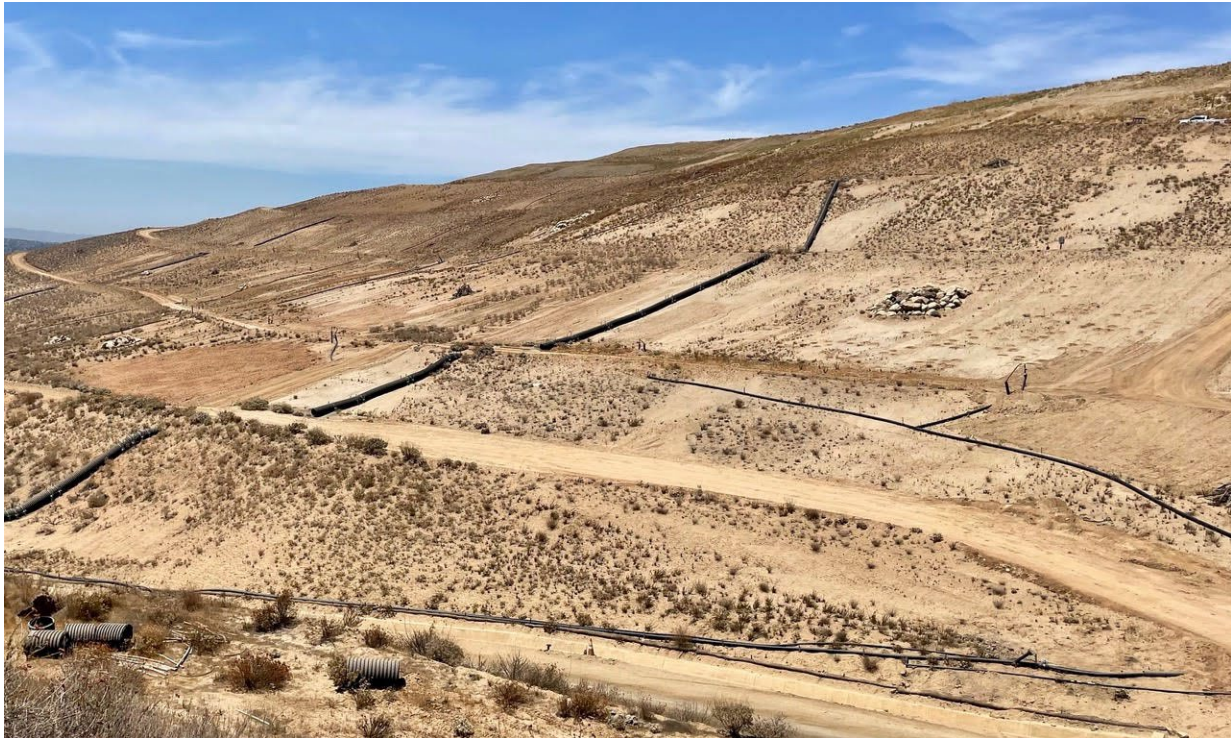
Photographs 11 and 12 show details on portions of Phases C1, B1, and B2. Phase A is in the far left. The top two slopes above the rock outcrop are Phase C1 and show growth over the past year. The bald spots are also filling in. The lower slopes show damage from past erosion repairs, including repairs in 2022. These show as bare areas near and left of the large black pipes. The area near the rock outcrop shows sparse new plant growth in 2022.

Photograph 11. Slopes of C1 (top), B2 (middle), and B1 (lower), March 2021.

Photograph 12. Slopes of C1 (top), B2 (middle), and B1 (lower), July 2022.

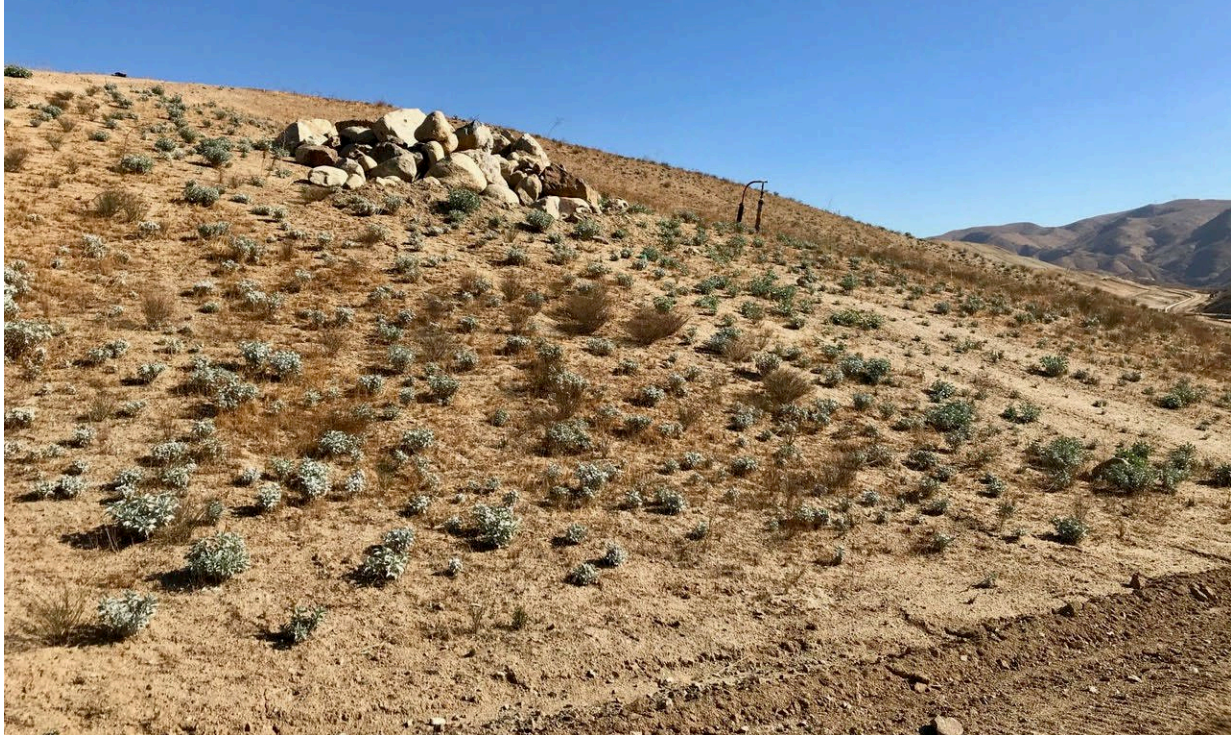
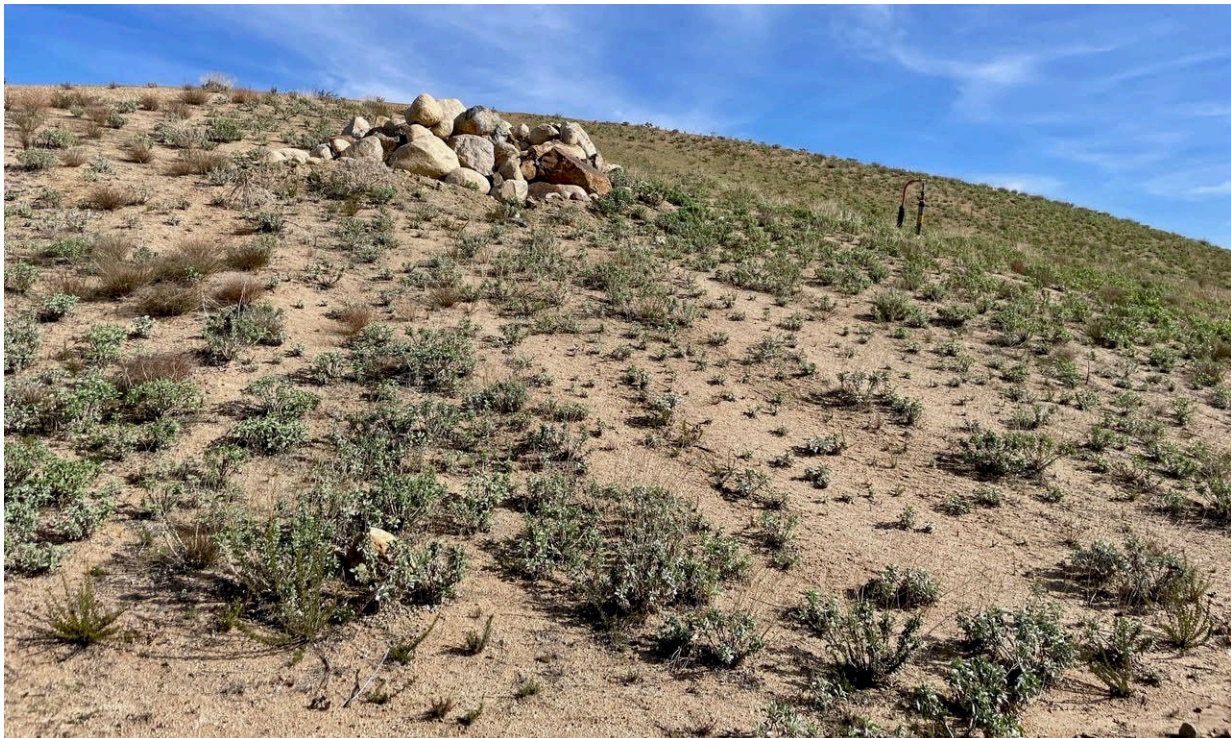
Photographs 13 and 14 show the same rock outcrop at the west end of Phase C1. Photograph 13 is from December 2020 and Photograph 14 is from January 2022. These photographs were taken approximately one year apart. The 2020 photograph shows bare areas between the outcrop and the gas pipe to the right. The 2022 photograph shows that this area has filled in and has few bare areas visible. The area above the rock outcrop also shows an increase in vegetation. The number of newly germinated shrubs is higher in the 2022 photograph, with young California buckwheat seedlings growing between the maturing brittlebush shrubs. In the 2020 photograph, the dark brown deerweed shrubs are the tallest plants on the slope. By 2022, the silvery-leaved brittlebush shrubs had grown to the same height as the deerweed. Brittlebush is the most common shrub on the south slopes.

Photograph 13. Rock outcrop on Phase C1, December 2020.

Photograph 14. The same rock outcrop on C1, January 2022.
