Community Assessment

El Sobrante Landfill: Community Assessment

Date: September 15, 2021 Arrival time: 10:00 am Prepared by: Jose Merlan, RCDWR

El Sobrante Landfill
Quarterly Mitigation Monitoring Report

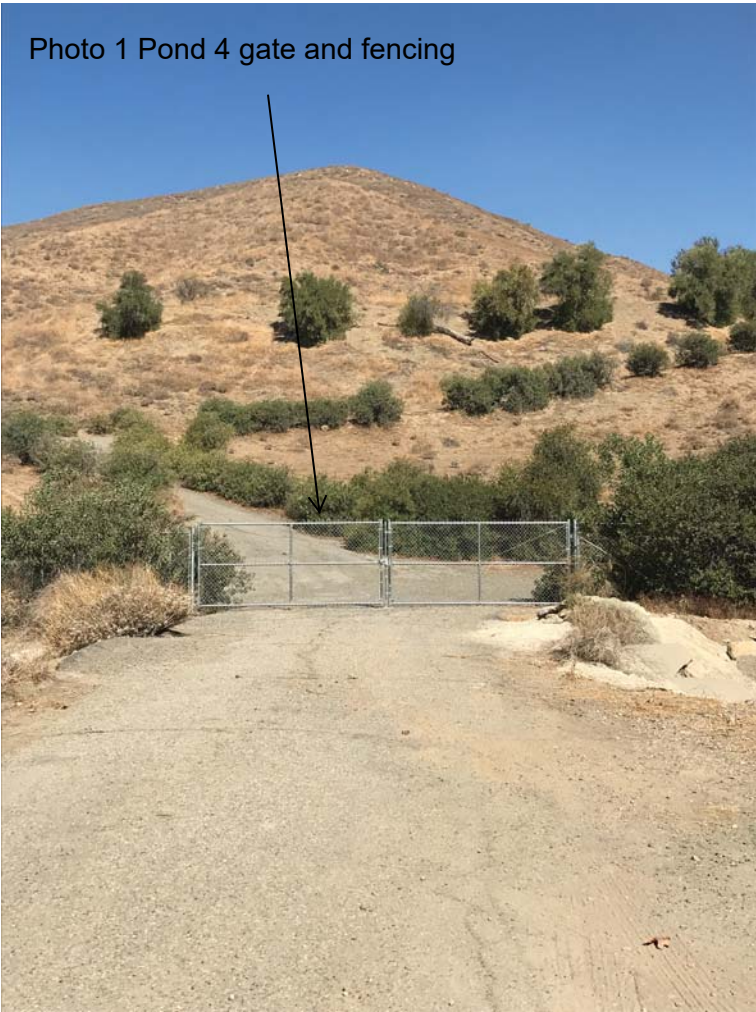
Photo 1 Pond 4 gate and fencing

- Pond 4 visual inspection:
 - Pond 4 gate and fencing- good condition, no litter (photo 1).
 - Pond 4 outside slope - good vegetative cover (photo 2).
- Drainage channel/culverts:

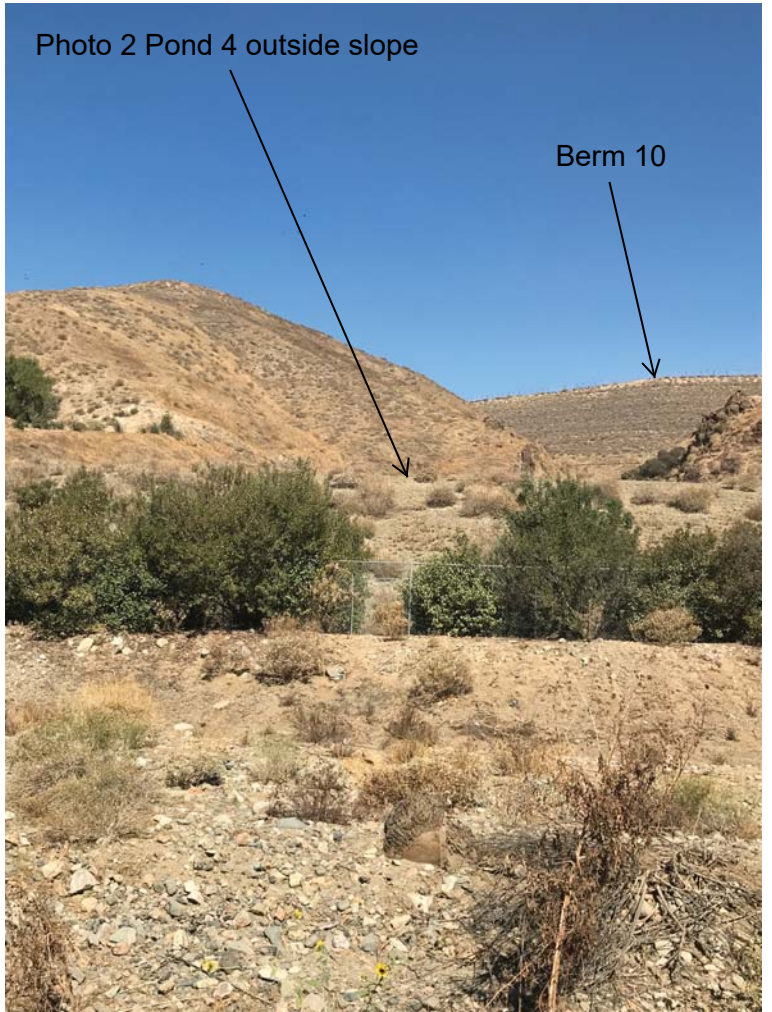
Photo 2 Pond 4 outside slope

- No major debris or blockage.
- Dawson Canyon Road condition:
 - Portions are paved; dirt section is serviceable. Road graded on 6-29-21.
- Berm 10/11:
 - No visible litter, good vegetative cover (photo 2-Berm 10; photo 3-Berm 11).

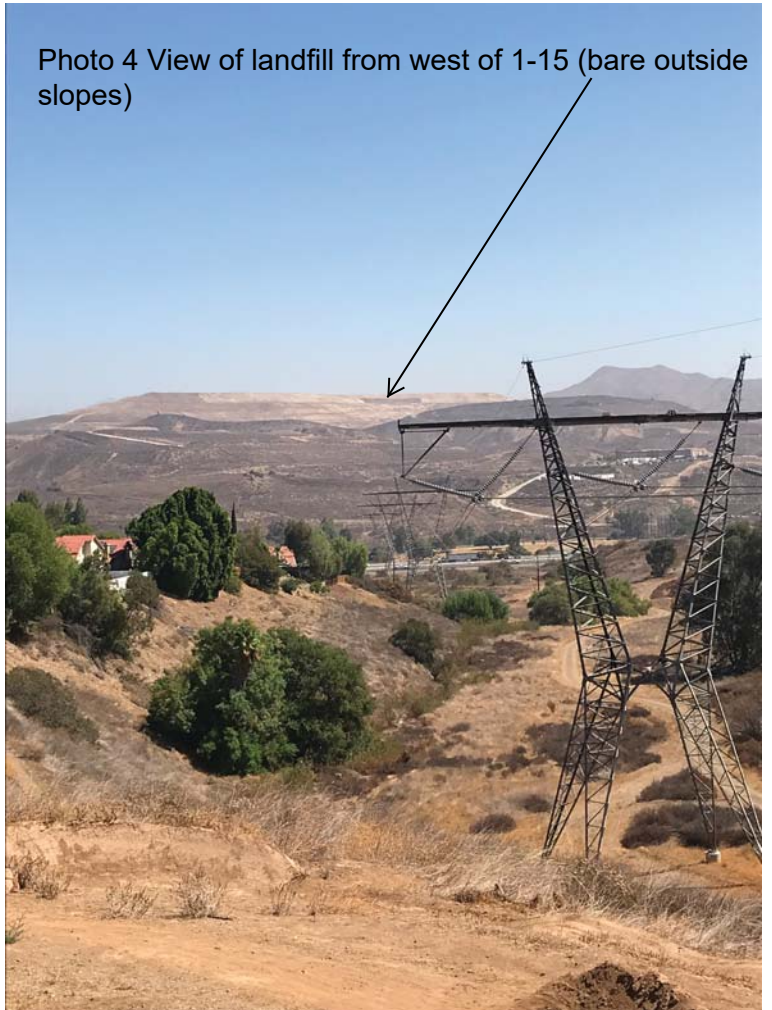
Photo 4 View of landfill from west of 1-15 (bare outside slopes)

- Landfill operations:
 - Not visible from Dawson Canyon area.
 - No landfill operations visible from communities west of I-15; bare outside slopes (photo 4); USA Waste/WMI developed draft plan to address the bare slopes

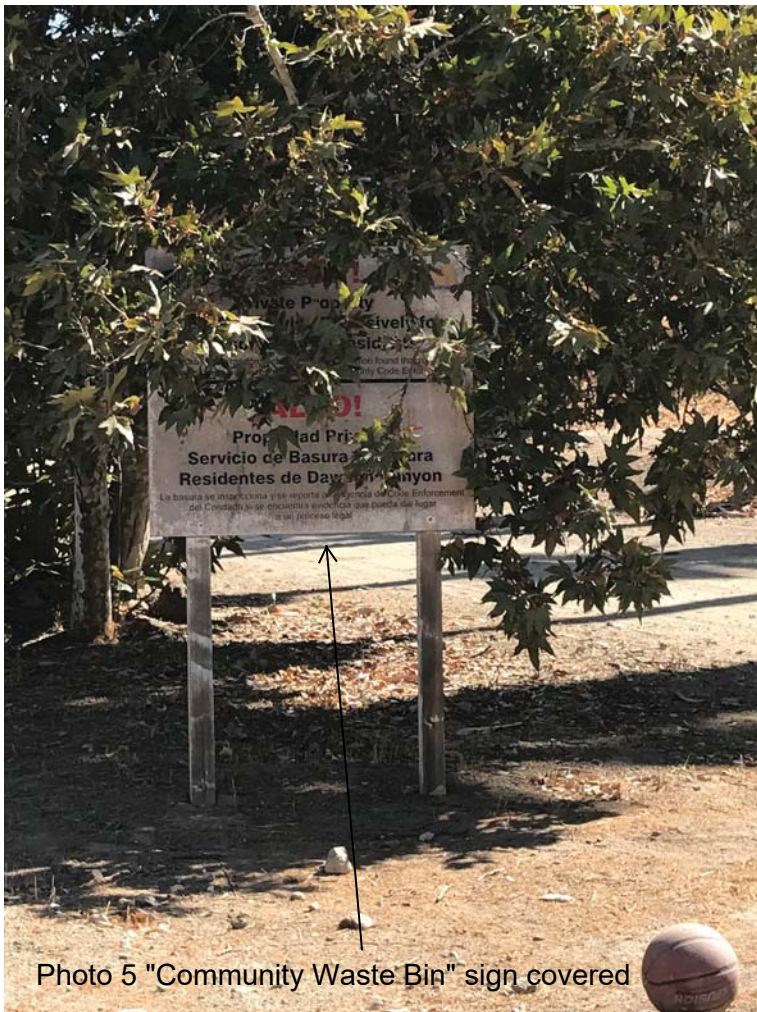
Photo 5 "Community Waste Bin" sign covered

- "Community Waste Bin" sign on Dawson Canyon Rd, not fully visible, covered by tree branches (photo 5). WMI notified and trimmed back vegetation (photo 6).

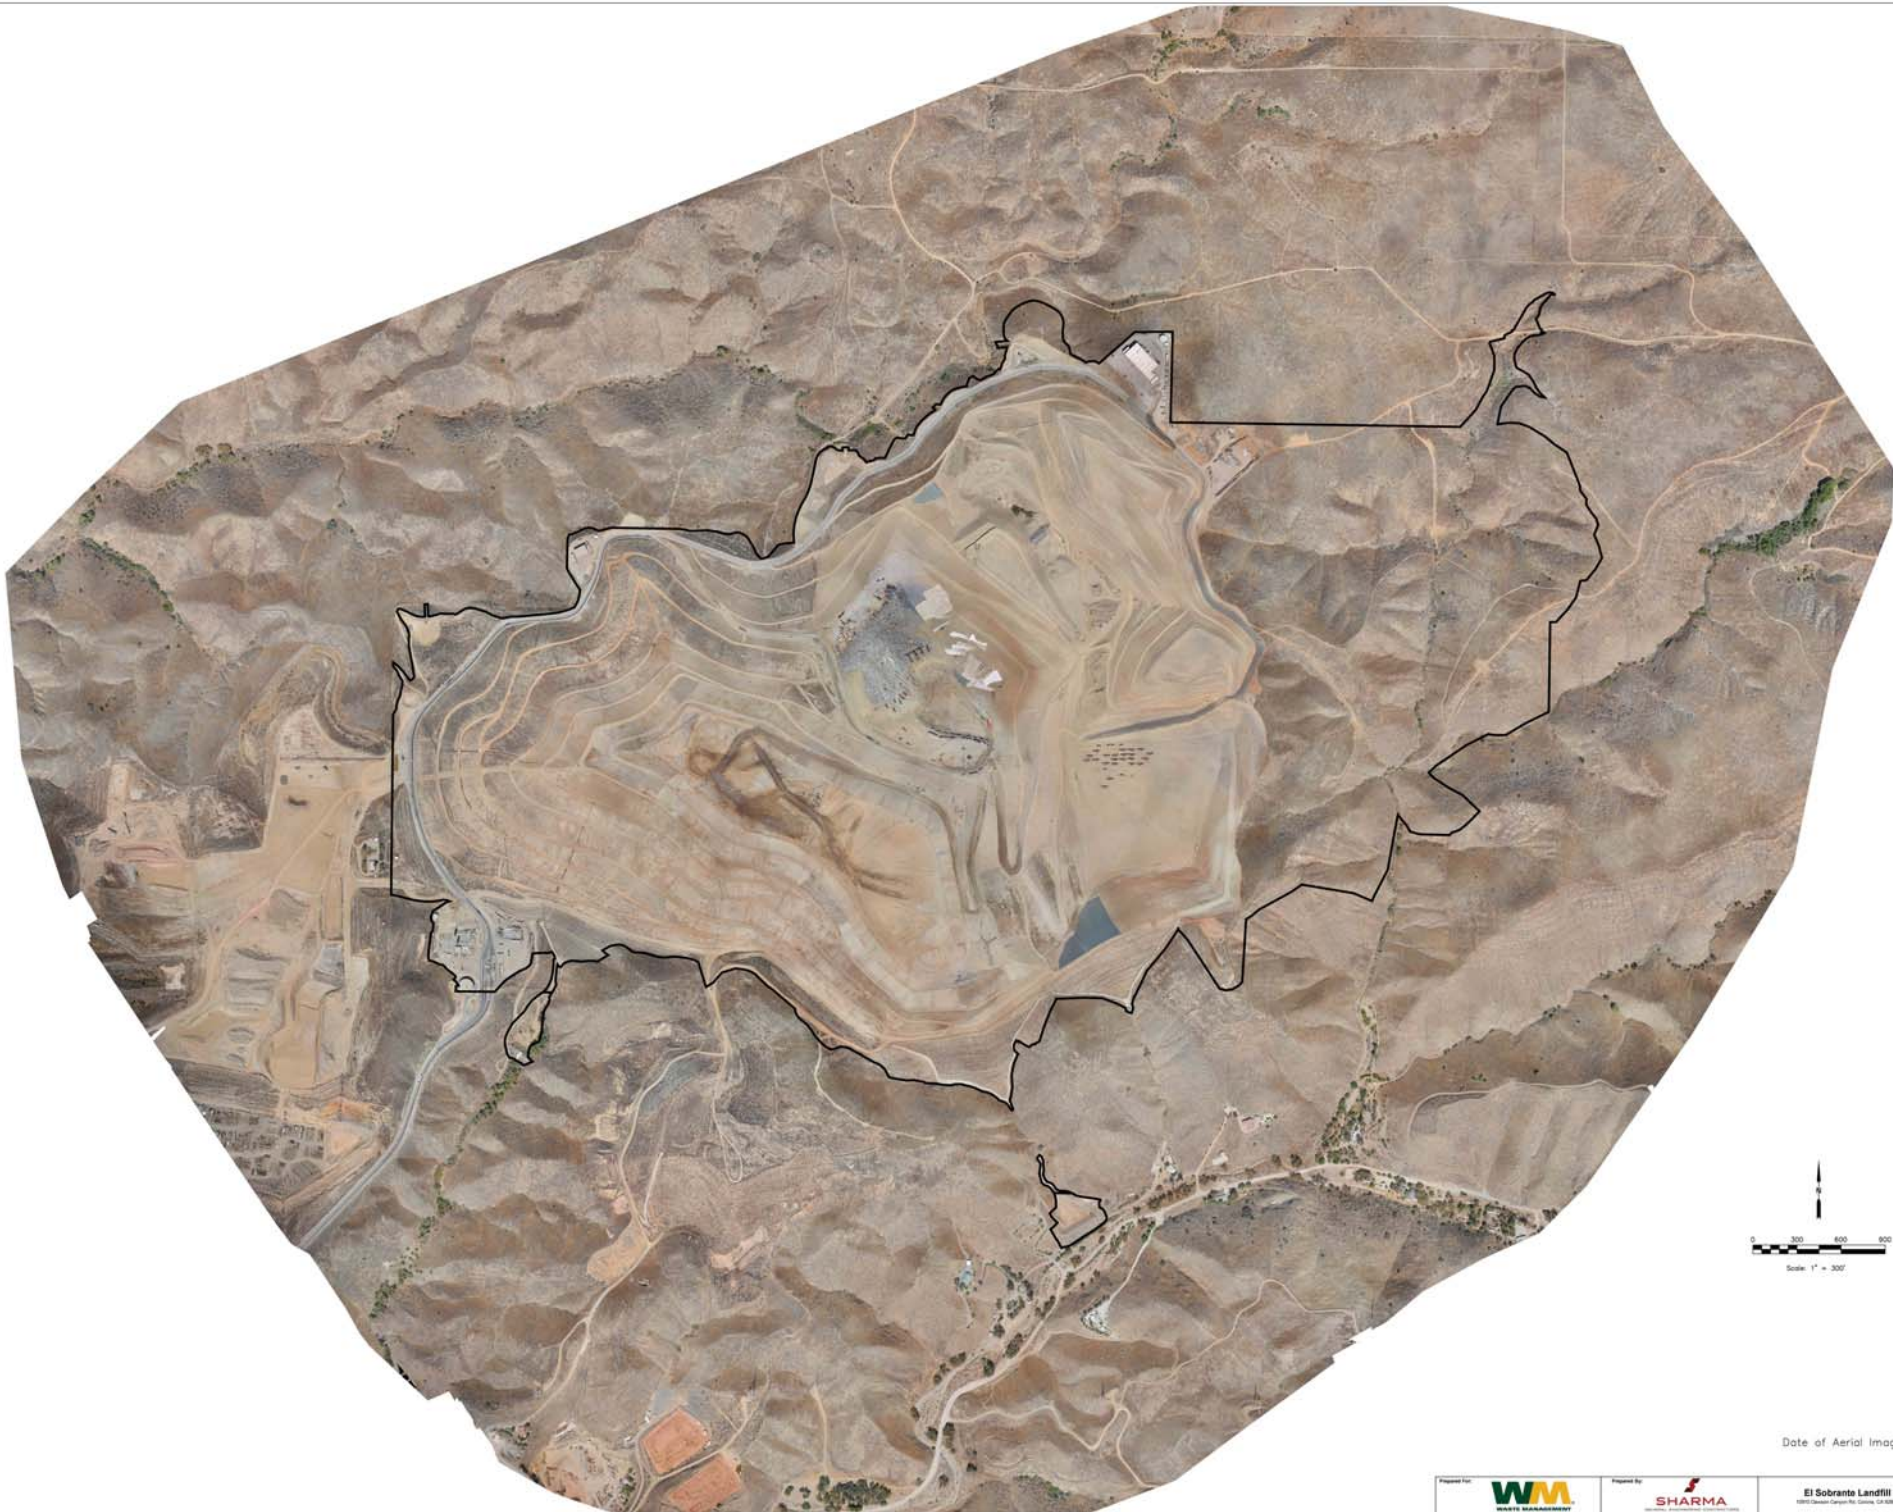
Photo 7 "No Right Turn" sign

- 'No Right Turn' on Temescal Canyon Road (TCR) from Dawson Canyon:
 - No violations observed. Monitored for 20 minutes, total of 15 trucks.
 - 'No Right Turn' sign in good condition and fully visible (photo 7).
