# Community Assessment

## El Sobrante Landfill: Community Assessment

Date: December 17, 2021 Arrival time: 11:45 am Prepared by: Jose Merlan, RCDWR

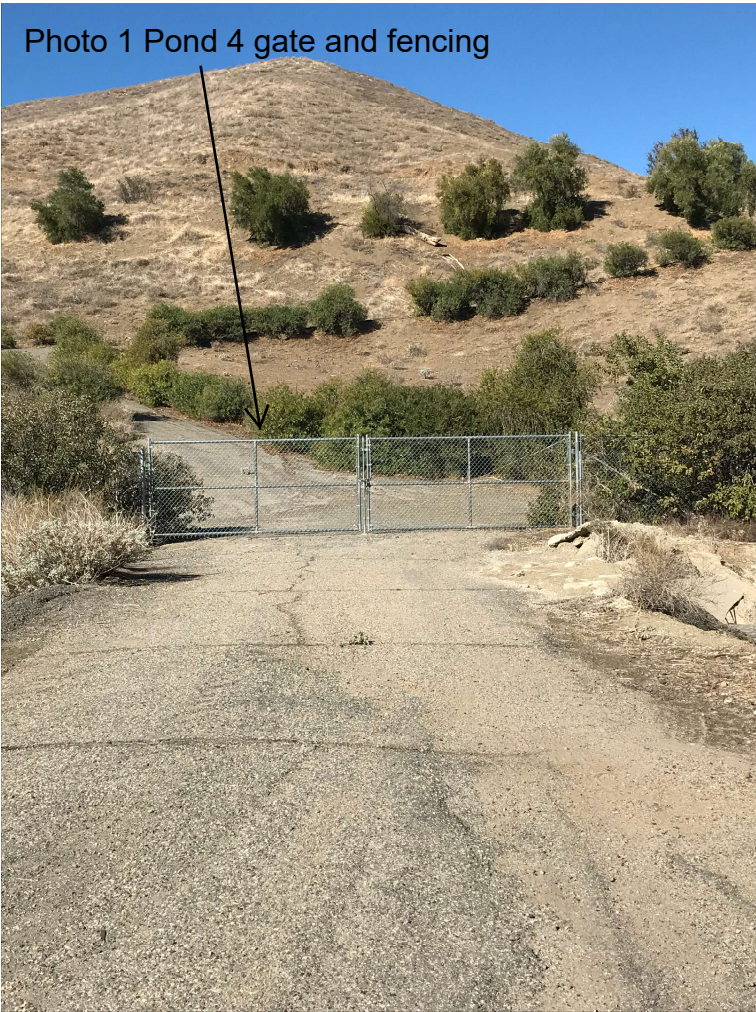
Photo 1 Pond 4 gate and fencing

- Pond 4 visual inspection:
  - Pond 4 gate and fencing- good condition, no litter (photo 1).
  - Pond 4 outside slope - good vegetative cover (photo 2).

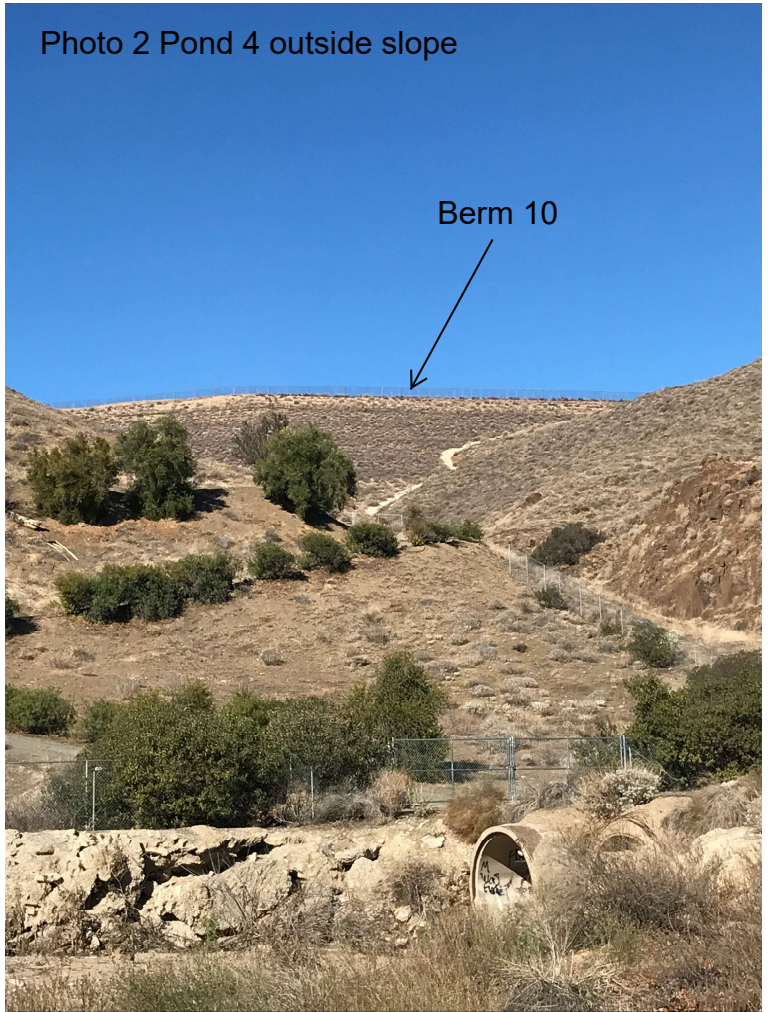
Photo 2 Pond 4 outside slope

- Ponding observed (see photo 3)
- Berm 10/11:
  - No visible litter, good vegetative cover (photo 2-Berm 10; photo 4-Berm 11).
- Landfill operations:
  - Not visible from Dawson Canyon area.

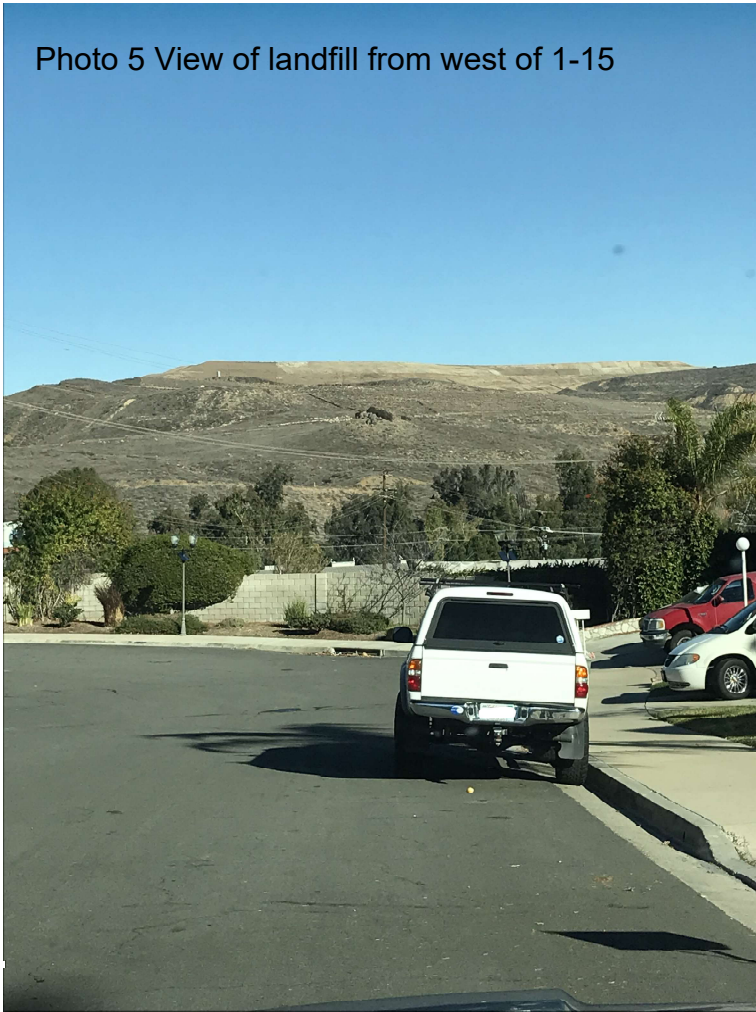
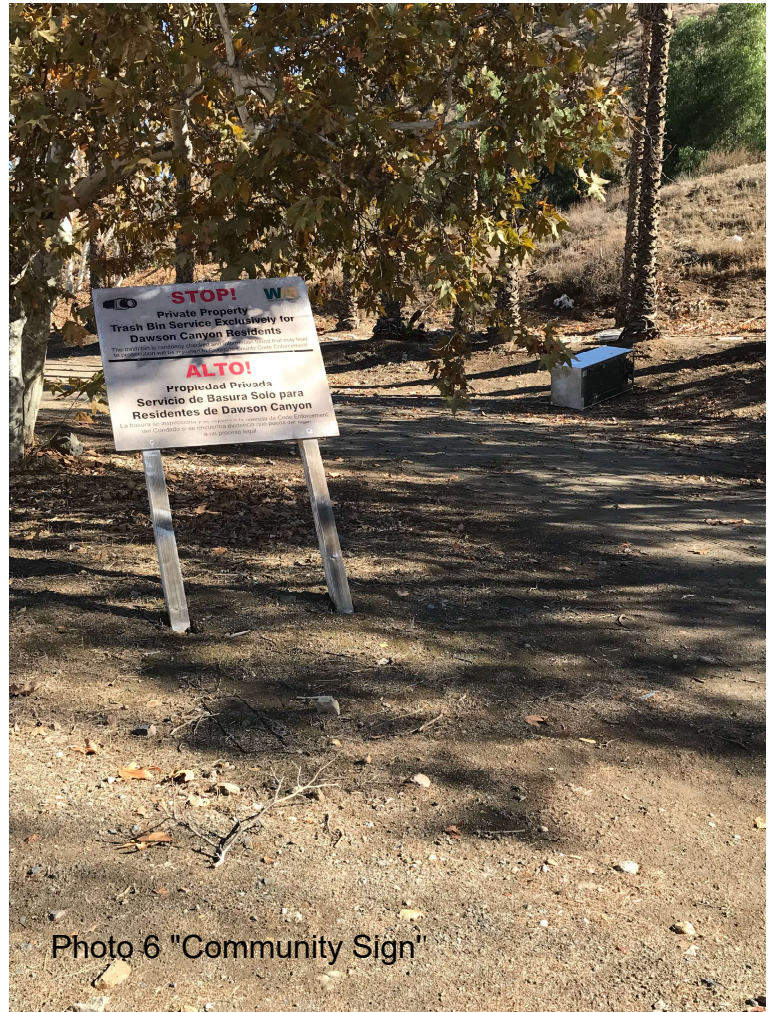
Photo 5 View of landfill from west of 1-15

- No landfill operations visible from communities west of I-15; bare outside slopes (photo 5); USA Waste/WMI implementing plan to address the bare slopes

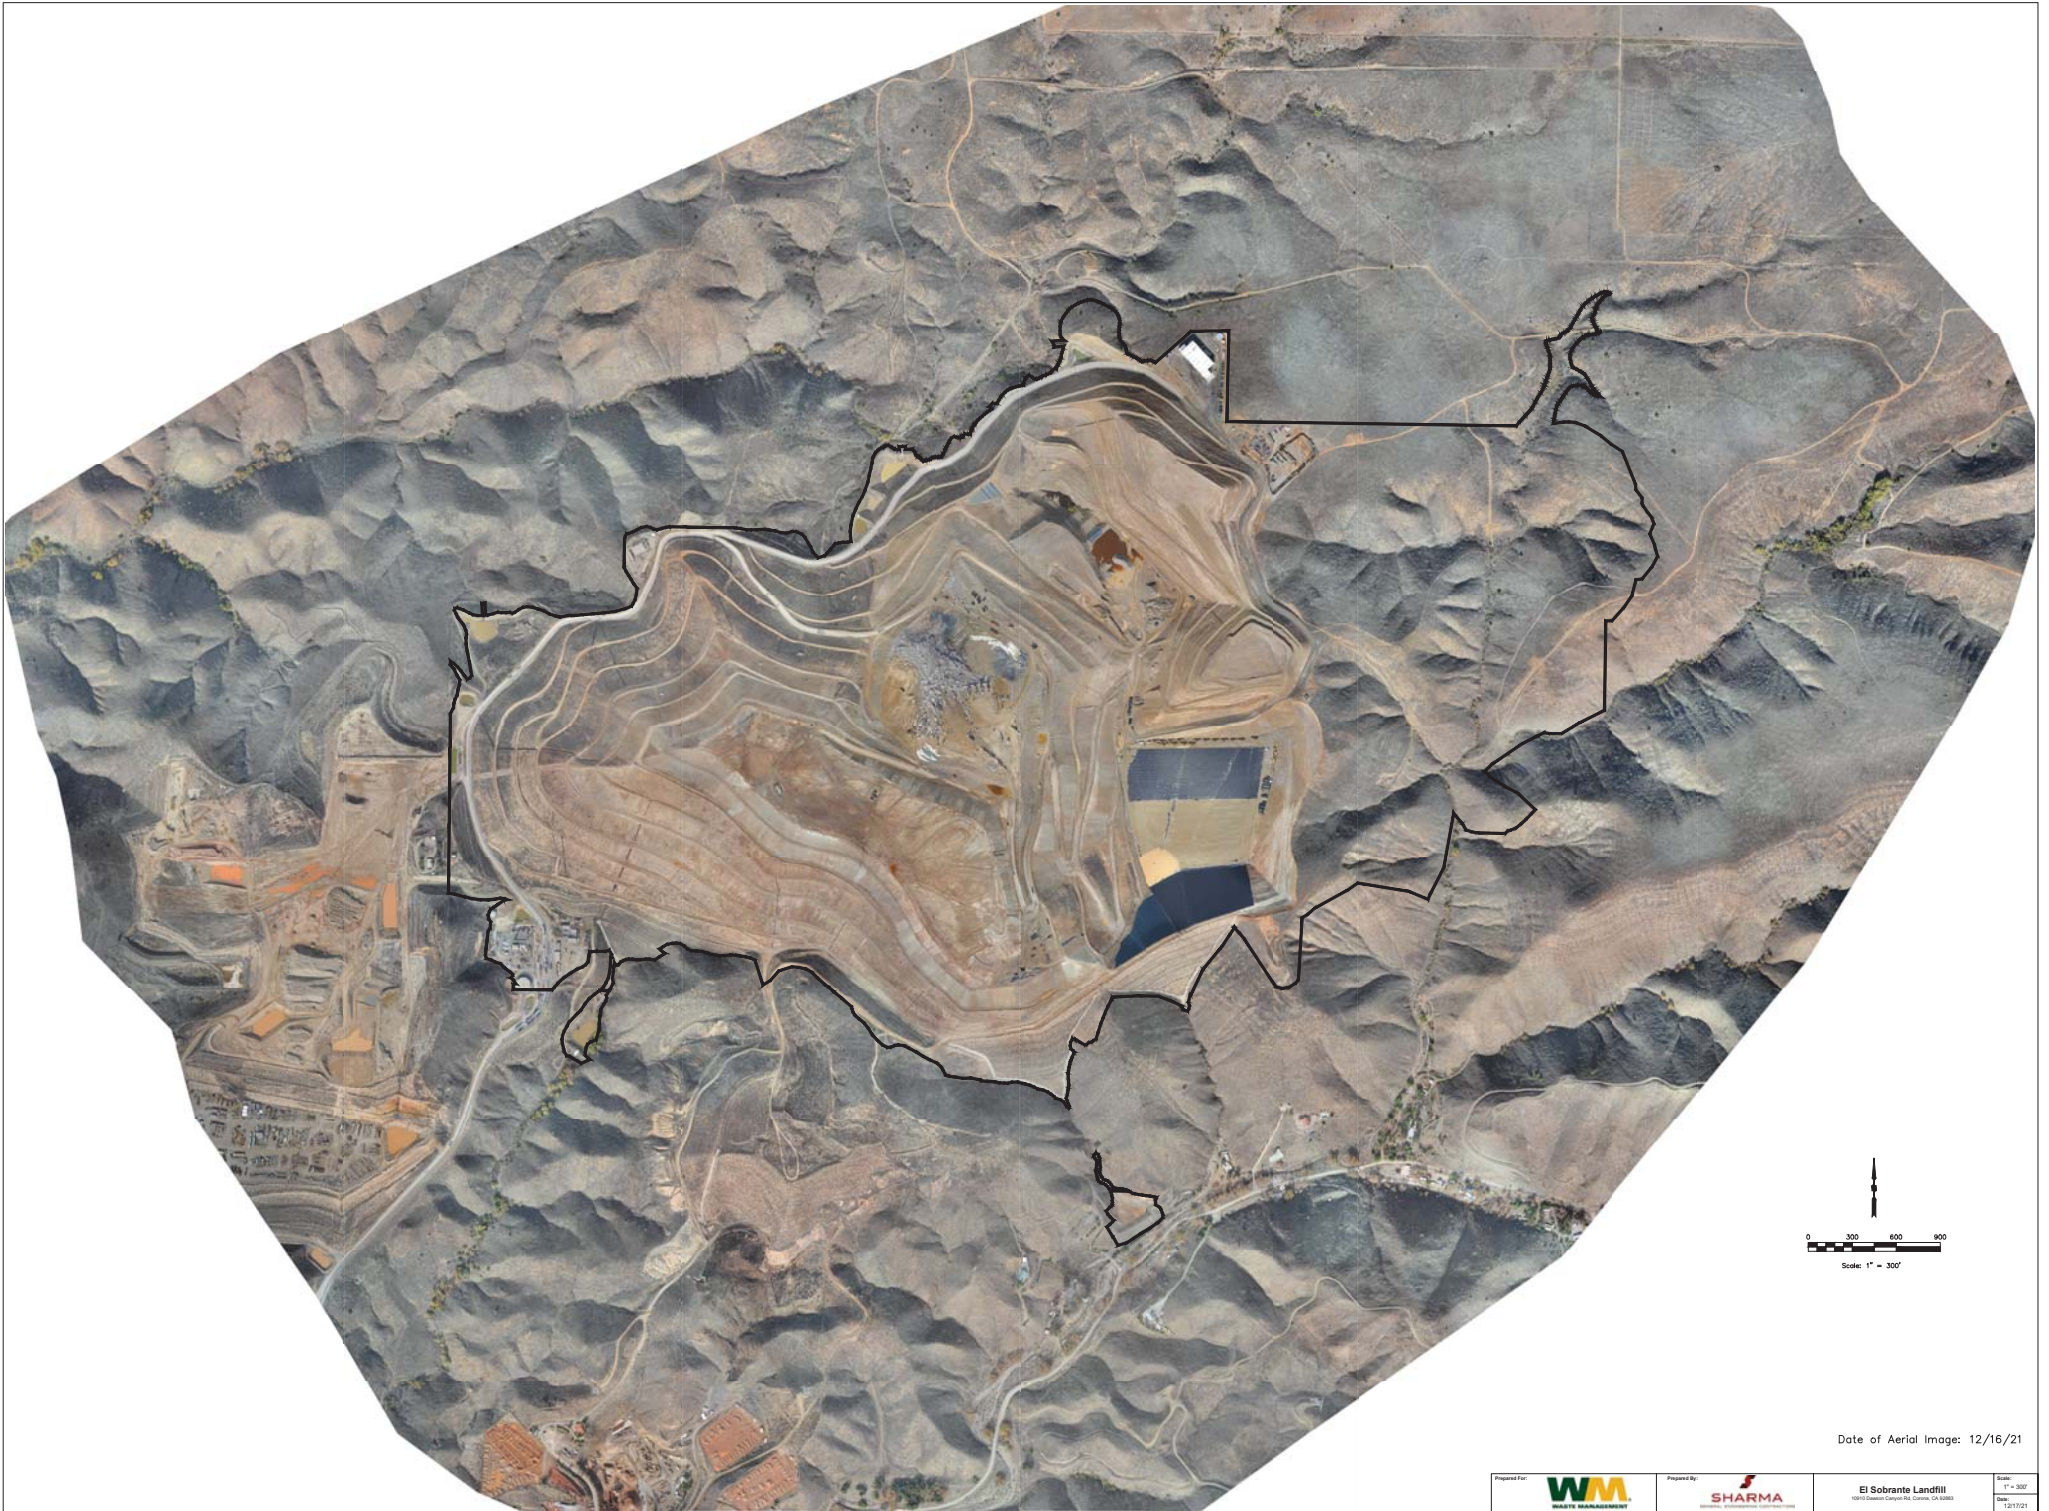
Photo 7 "No Right Turn" sign

- 'No Right Turn' on Temescal Canyon Road (TCR) from Dawson Canyon:
  - No violations observed. Monitored for 20 minutes, total of 13 trucks.
  - 'No Right Turn' sign in good condition and fully visible (photo 7).
