## El Sobrante Landfill: Community Assessment

Date: March 16, 2022 Arrival time: 10:18 am Prepared by: Jose Merlan, RCDWR

El Sobrante Landfill  
Quarterly Mitigation Monitoring Report

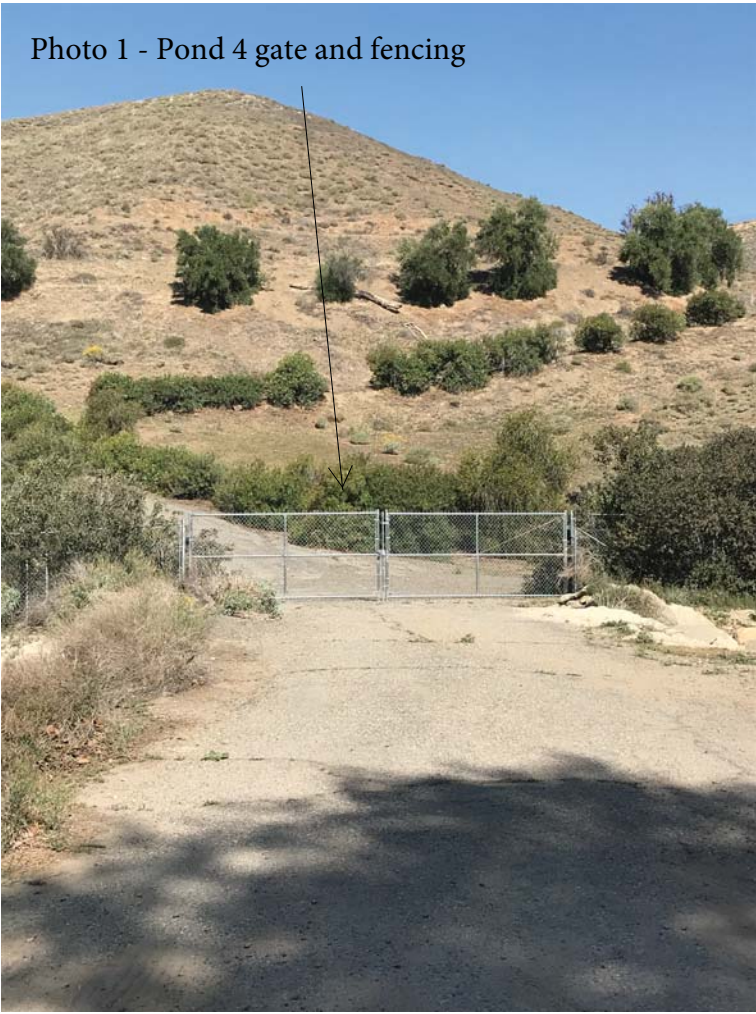
Photo 1 - Pond 4 gate and fencing

- Pond 4 visual inspection:
  - Pond 4 gate and fencing- good condition, no litter (photo 1).
  - Pond 4 outside slope - good vegetative cover (photo 2).

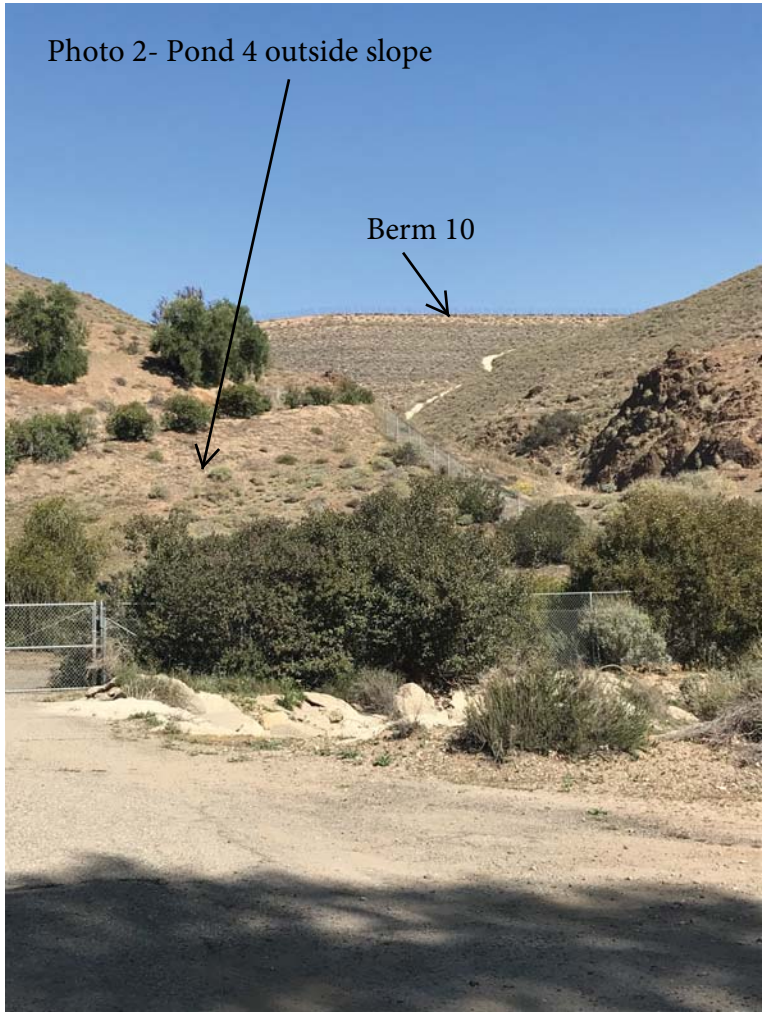
Photo 2- Pond 4 outside slope

- Berm 10/11:
  - No visible litter, good vegetative cover (photo 2-Berm 10; photo 3-Berm 11).
- Landfill operations:
  - Not visible from Dawson Canyon area.

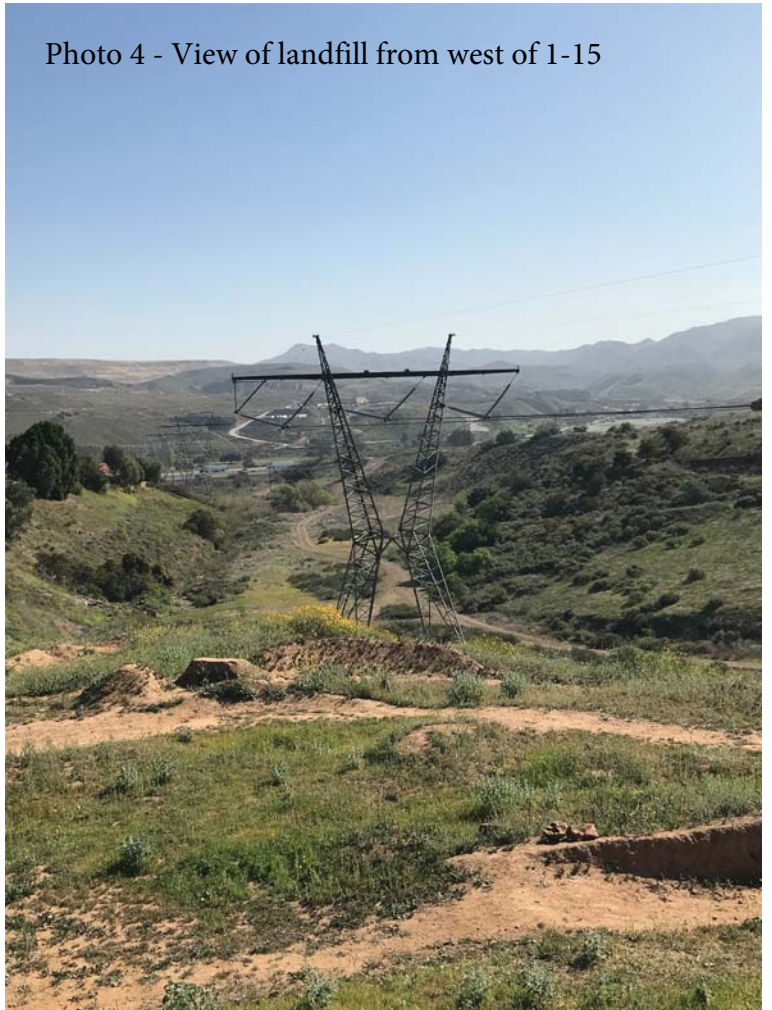
Photo 4 - View of landfill from west of 1-15

- No landfill operations visible from communities west of I-15; bare outside slopes (photo 4); USA Waste/WMI implementing plan to address the bare slopes

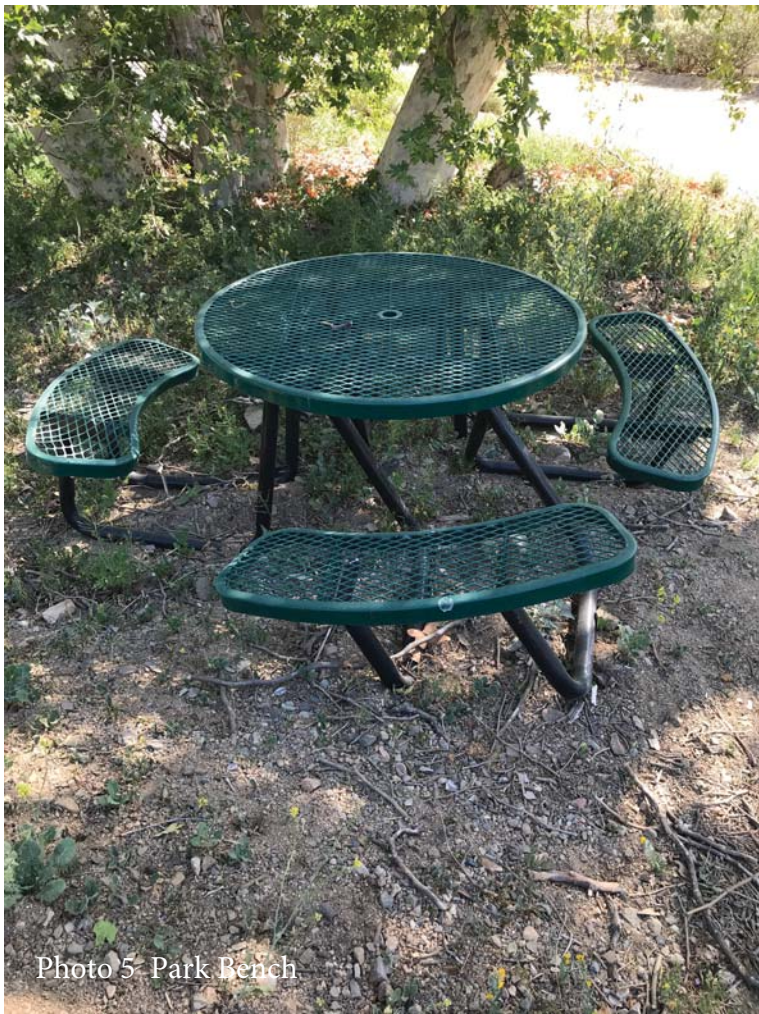
Photo 5 - Park Bench

- Community Amenities condition (park bench, table, gate/fencing, signage):
  - Park bench showing signs of damage (photo 5).

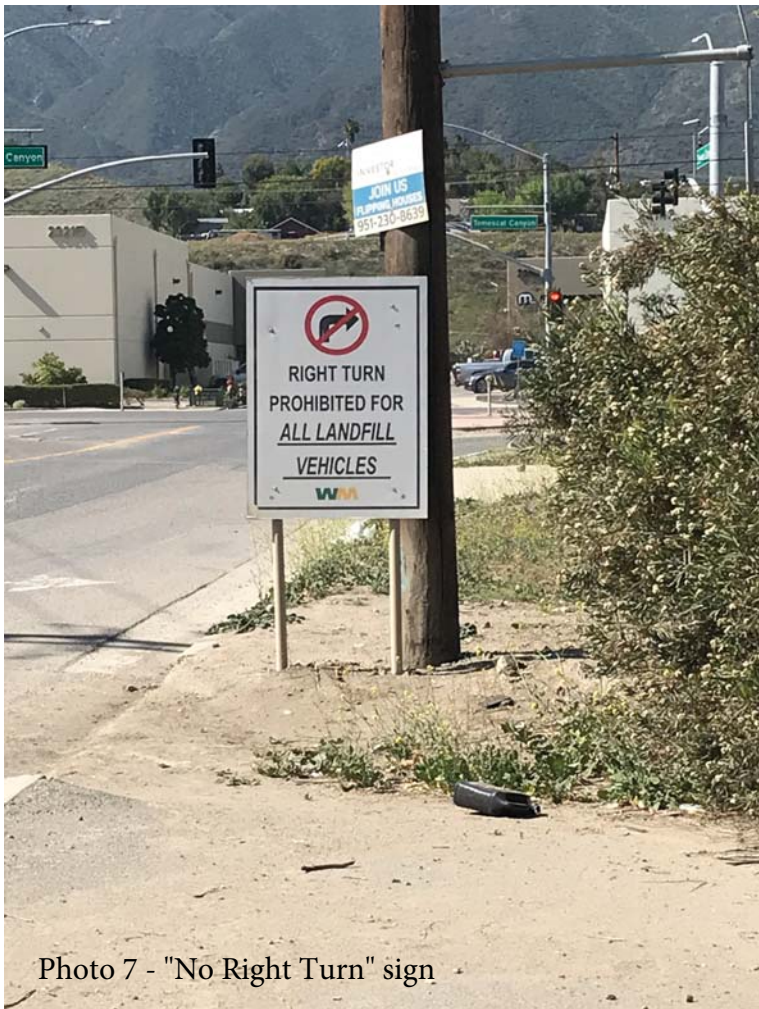
Photo 6 - WMI truck monitoring

- 'No Right Turn' on Temescal Canyon Road (TCR) from Dawson Canyon:
  - No violations observed. Monitored for 20 minutes, total of 15 trucks (photo 6).
  - 'No Right Turn' sign in good condition and fully visible (photo 7).
