Community Assessment

El Sobrante Landfill: Community Assessment

Date: December 6, 2022 Arrival time: 9:45 am Prepared by: Katherine Avila/Kinika Hesterly, RCDWR

El Sobrante Landfill Quarterly Mitigation Monitoring Report

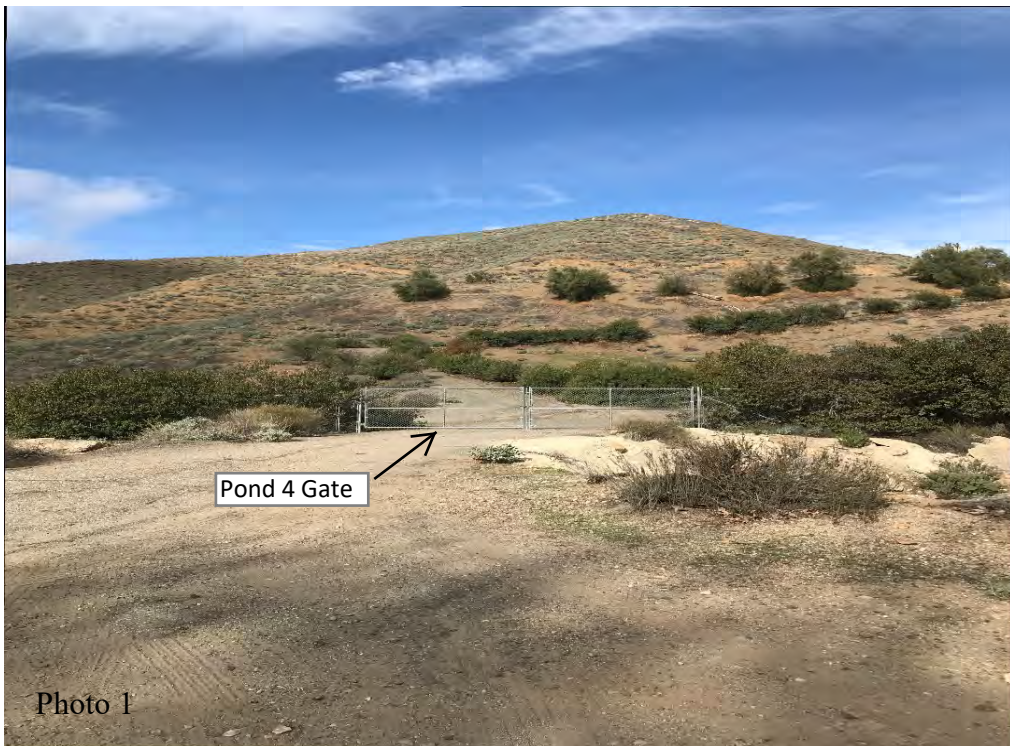
- Pond 4 visual inspection:
 - Pond 4 gate and fencing - good condition, no litter (photo 1).
 - Pond 4 outside slope - good vegetative cover.
 - Green park table with bench is damaged (photo 2).

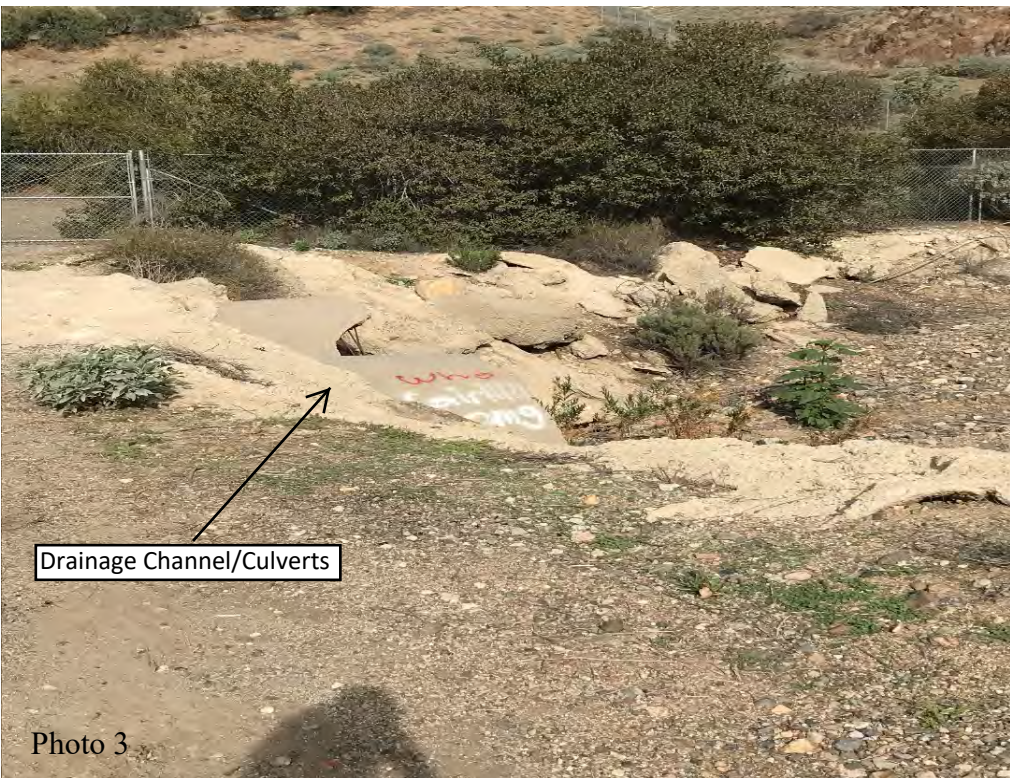
- Drainage channel/culverts:
 - No major debris or blockage.
 - Culvert chipping and graffiti (photo 3).
- Dawson Canyon Road condition:
 - Portions are paved (by Corona Clay) but large potholes have developed (photo 4); the dirt section subject to quarterly grading by WMI is serviceable. Due to equipment issues, the road was not graded this quarter. Per WM, two blading sessions are planned for 1st quarter 2023.

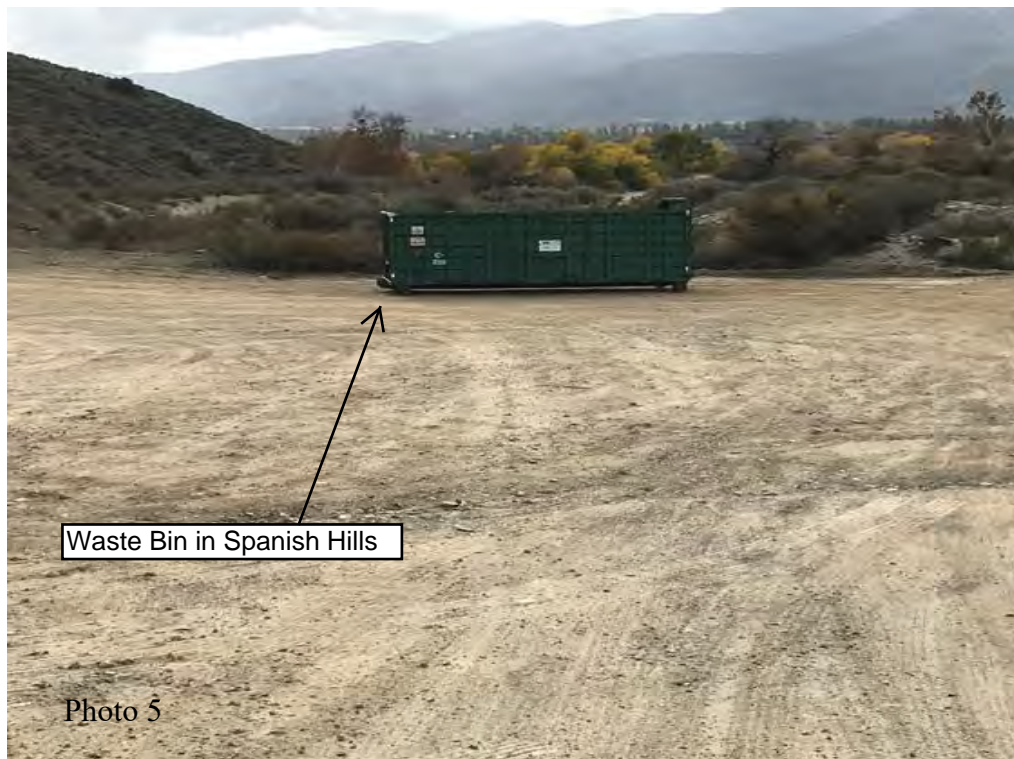
Photo 5

- Spanish Hills bin appears recently serviced (photo 5).
- Berm 10/11:
 - No visible litter, good vegetative cover (photo 6-Berm 10; photo 7 - Berm 11).

Waste Bin in Spanish Hills

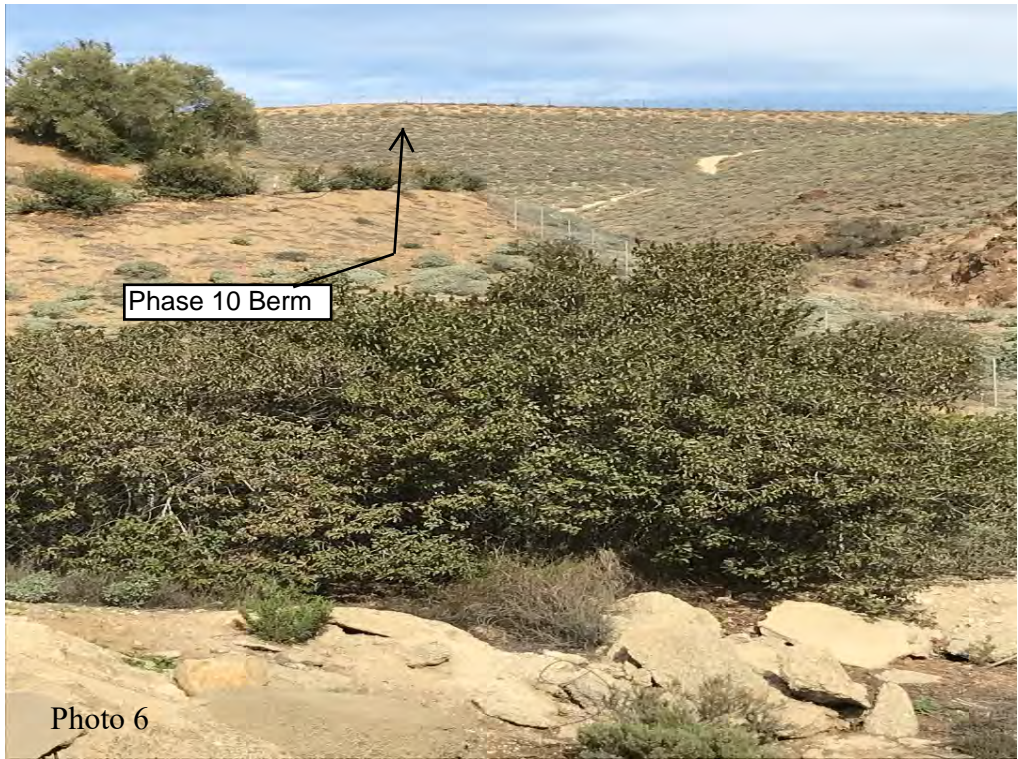
Photo 6

Phase 10 Berm

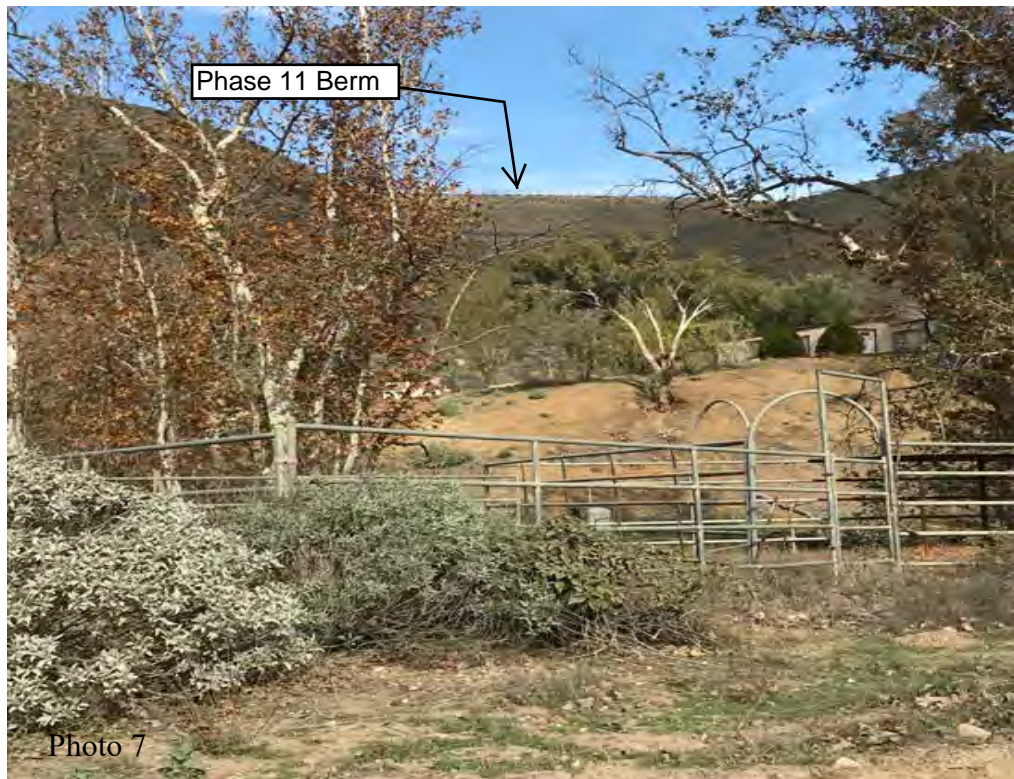
Photo 7

Phase 11 Berm

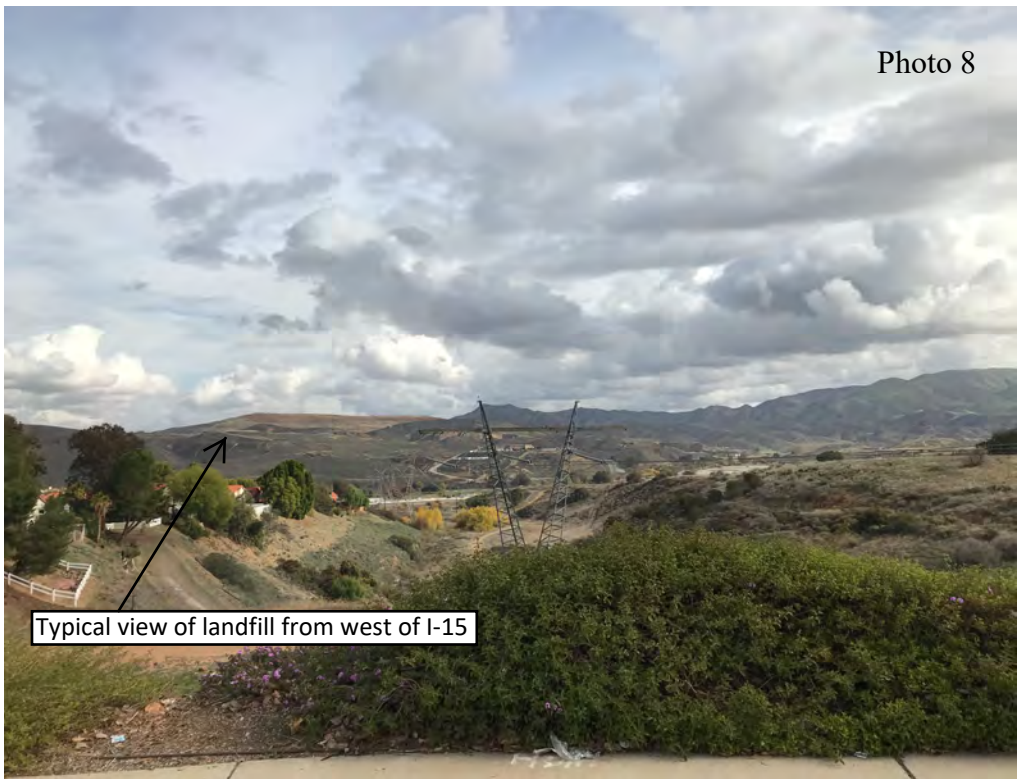
Photo 8

- Landfill operations:
 - Not visible from Dawson Canyon area.
 - Odor in Dawson Canyon (noticeable near Pond 4); no odor in Spanish Hills/Trilogy area.
 - Landfill operations not visible from communities west of I-15 (photo 8); bare outside slopes; USA Waste/WMI implementing plan to address the bare slopes.

Typical view of landfill from west of I-15

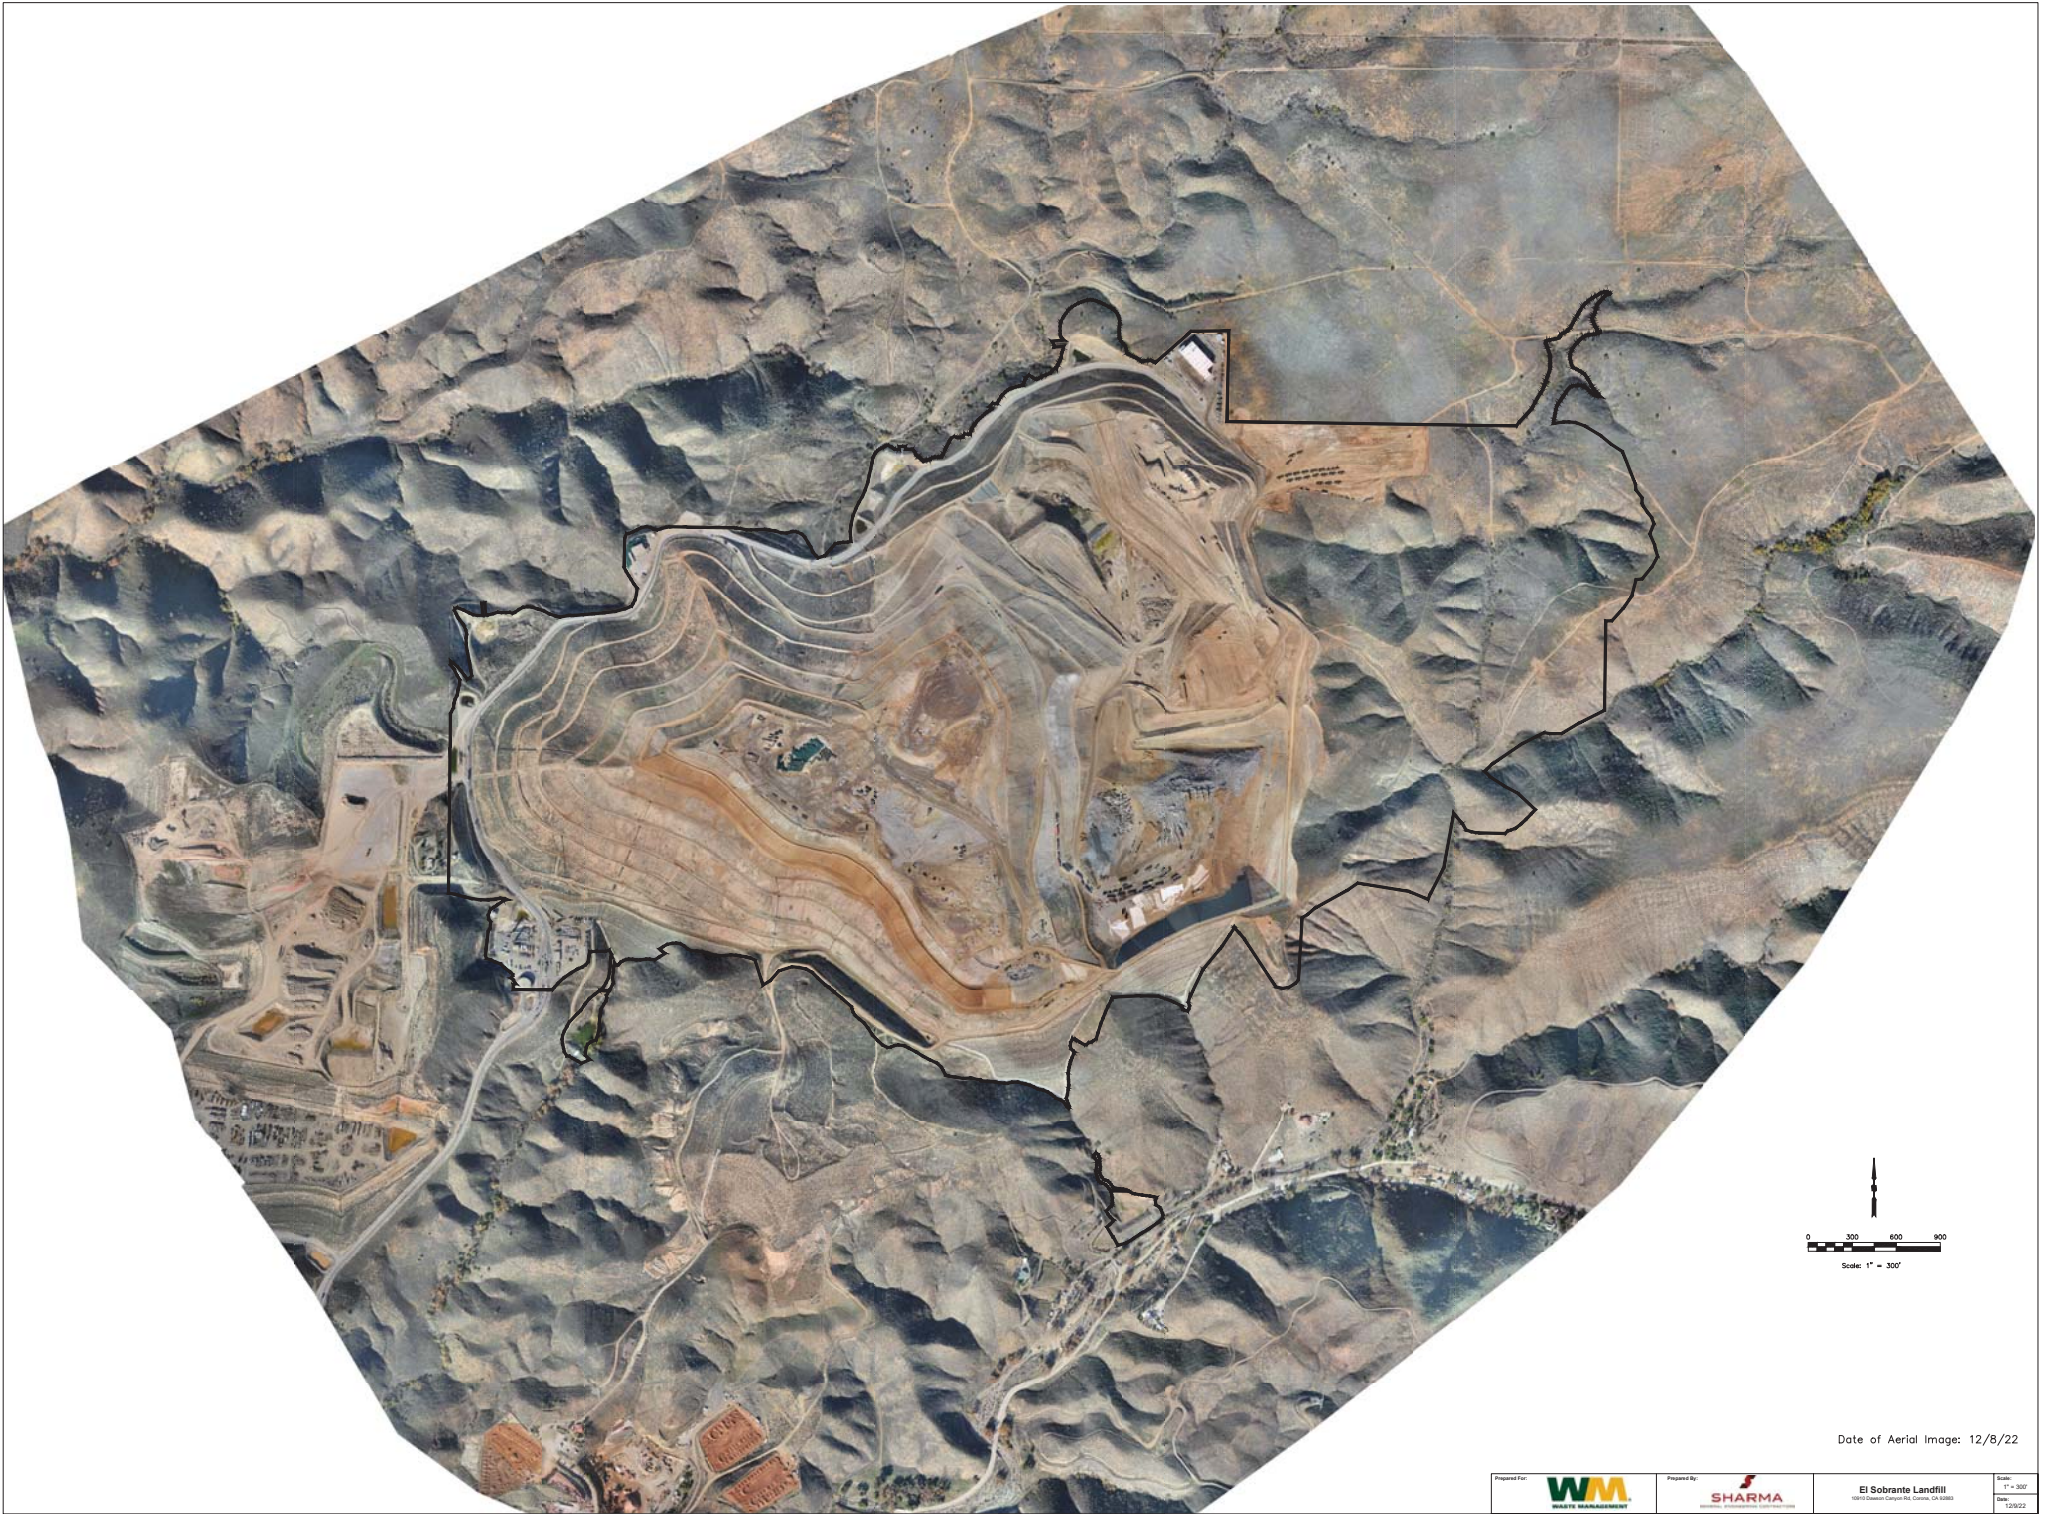
Date of Aerial Image: 12/8/22

- Reviewed 4th quarter 2022 site aerial (see attached).

- An updated aerial was taken on December 8th and showed no areas of offsite grading or operations.
