## El Sobrante Landfill: Community Assessment

Date: July 26, 2023 Arrival time: 9:45 am Prepared by: Katherine Avila/Kinika Hesterly, RCDWR

El Sobrante Landfill  
Quarterly Mitigation Monitoring Report

**Disposal Facility (Site) Inspection Report (52)**  
**El Sobrante Landfill (33-AA-0217)**  
7/6/2023

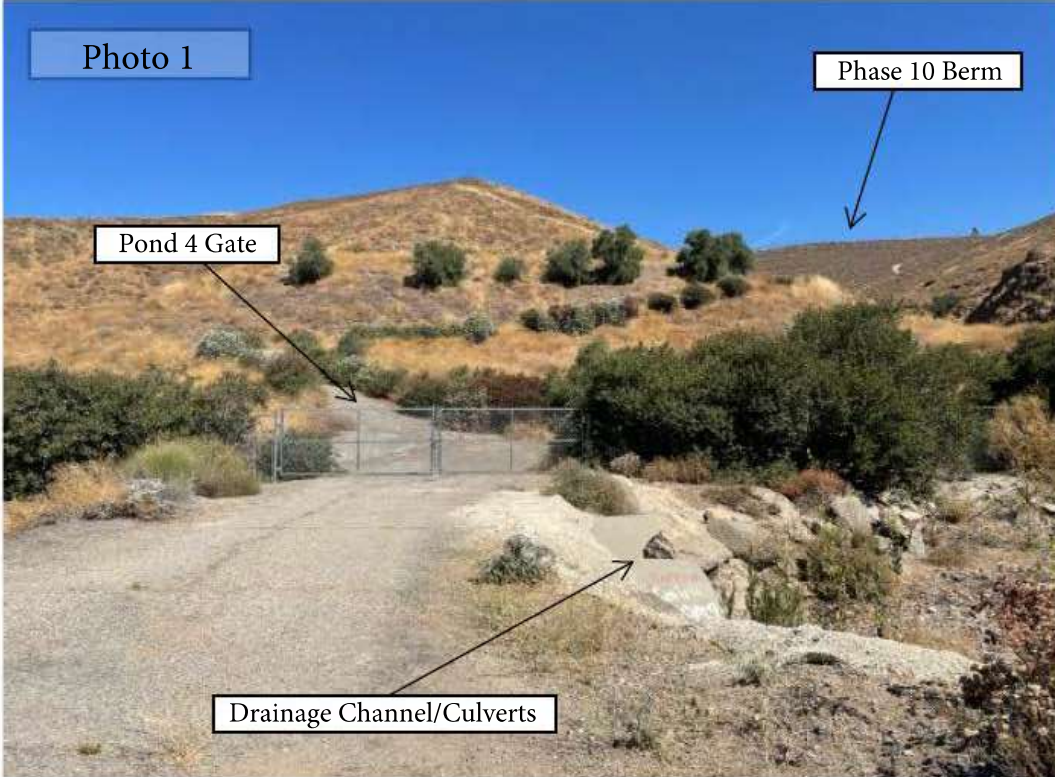
Photo 1

- Pond 4 visual inspection:
  - Pond 4 gate and fencing - good condition, no litter (photo 1).
  - Pond 4 outside slope - good vegetative cover.
  - Green park table with bench is still damaged (photo 2).

- Drainage channel/culverts:
  - Vegetation has grown in the drainage channel but does not cause major debris or blockage.
  - Culvert chipping and graffiti (photo 1).

- Berm 10/11:
  - No visible litter, good vegetative cover (photo 1 - Berm 10; photo 3 - Berm 11).
- Landfill operations:
  - Not visible from Dawson Canyon area.

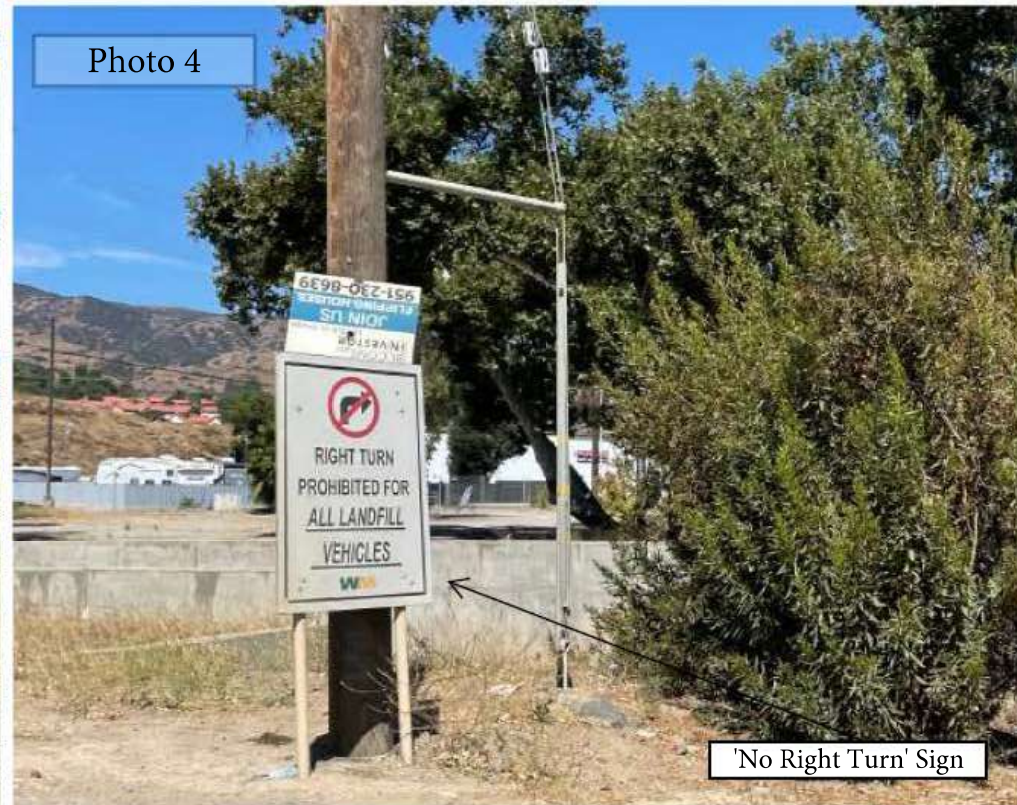
Photo 4

- 'No Right Turn' on Temescal Canyon Road (TCR) from Dawson Canyon:
  - No violations observed.
  - 'No Right Turn' sign is fully visible and in good condition (photo 4).

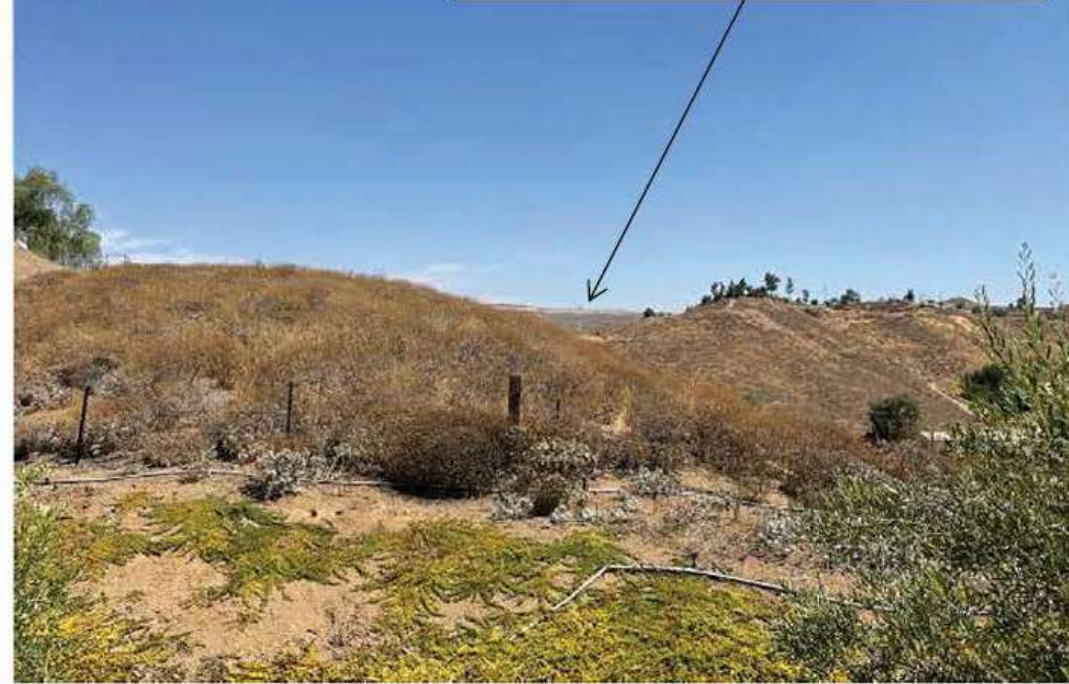
Photo 5

- No major odor in Dawson Canyon (near Pond 4); no odor in Spanish Hills/Trilogy area.
  - No major odor in the Terramor Community. Landfill operations visible from the Terramor Community, located south of the Landfill (photo 5).

View of the Landfill from the Terramor Community

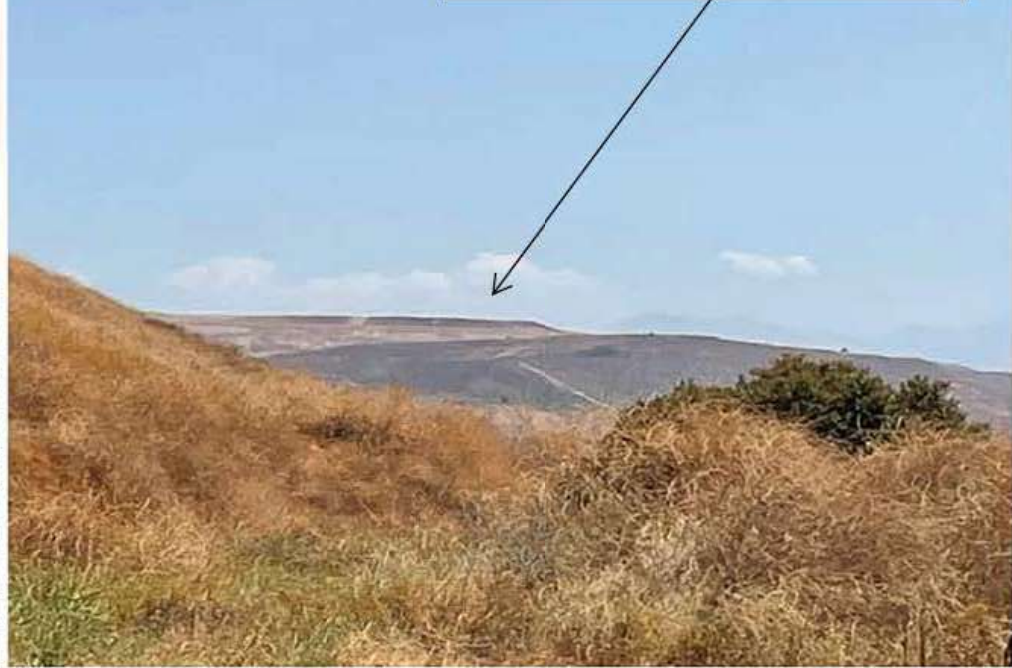
Photo 6

- Landfill operations not visible from communities west of I-15 (photos 6, 7, and 8); bare outside slopes; USA Waste/WMI implementing plan to address the bare slopes.

Typical view of the Landfill West of the I-15

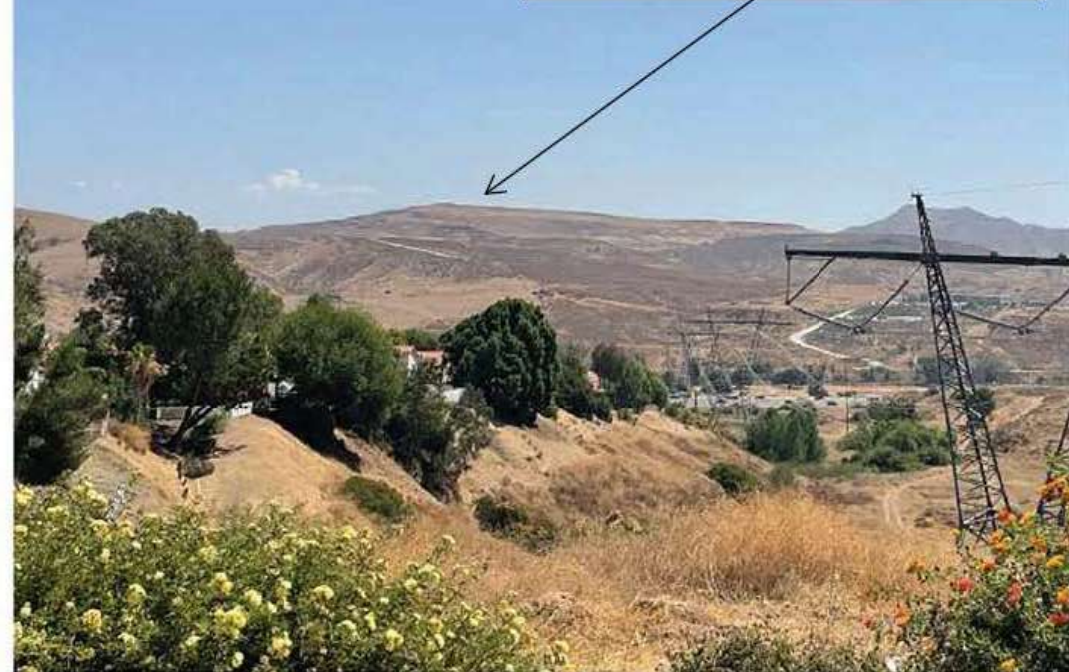
Photo 7

Typical view of the Landfill West of the I-15

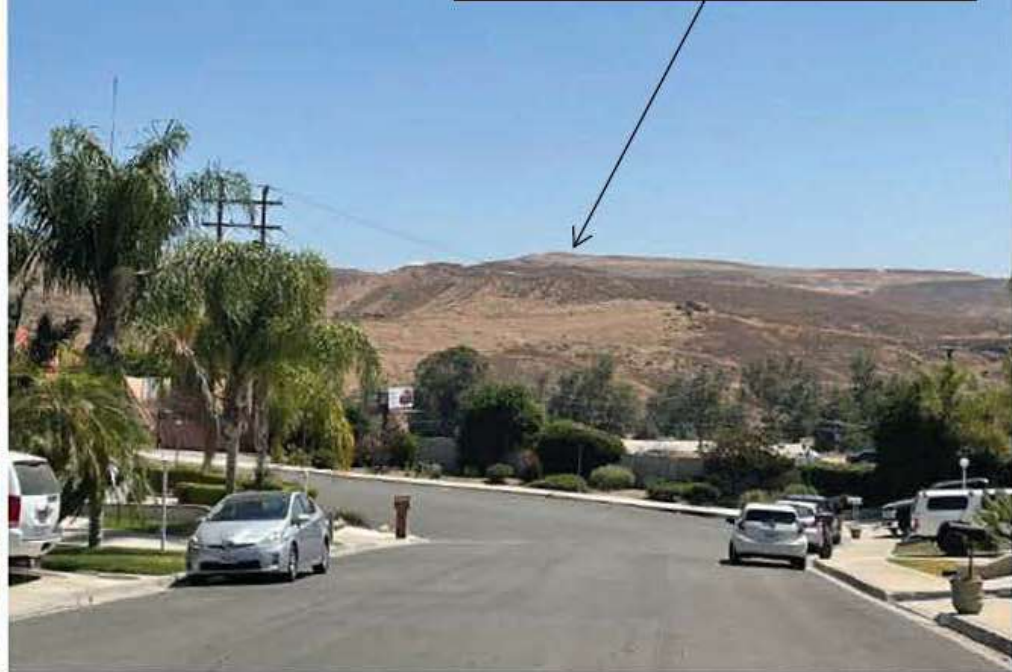
Photo 8

Typical view of the Landfill West of the I-15

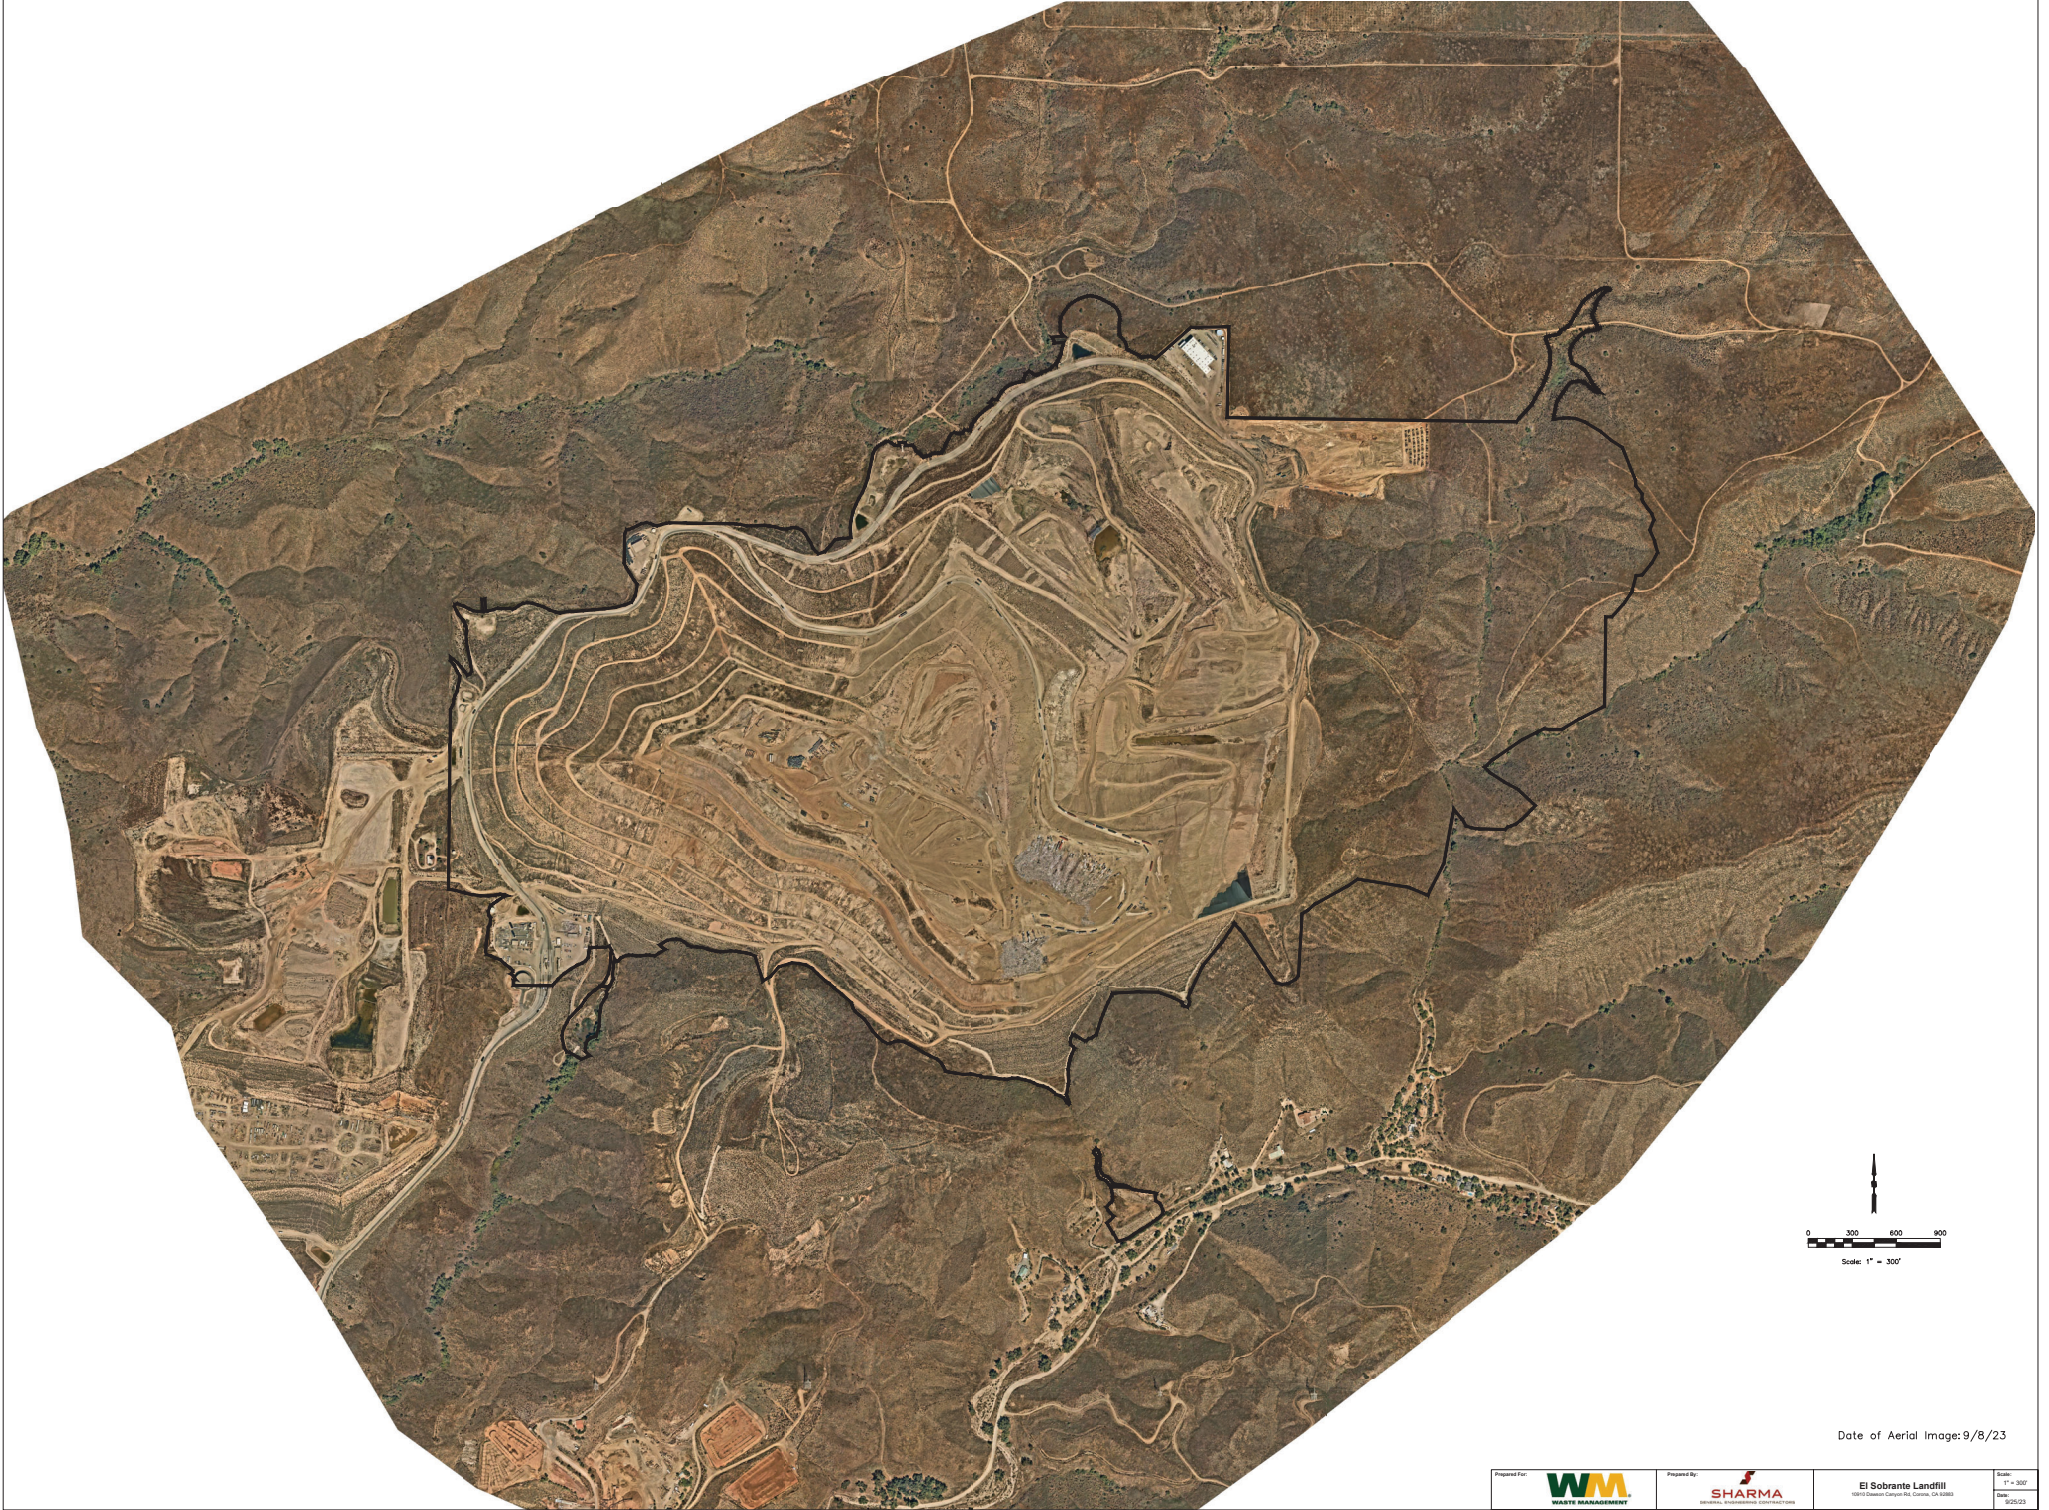
Date of Aerial Image: 9/8/23

- Reviewed 3<sup>rd</sup> quarter 2023 site aerial (see attached).

- An updated aerial was taken on September 8<sup>th</sup> and showed no areas of offsite grading or operations.
