Community Assessment

El Sobrante Landfill: Community Assessment

Date: March 30, 2021 Arrival time: 9:00 am Prepared by: Ryan Ross, RCDWR

El Sobrante Landfill
Quarterly Mitigation Monitoring Report

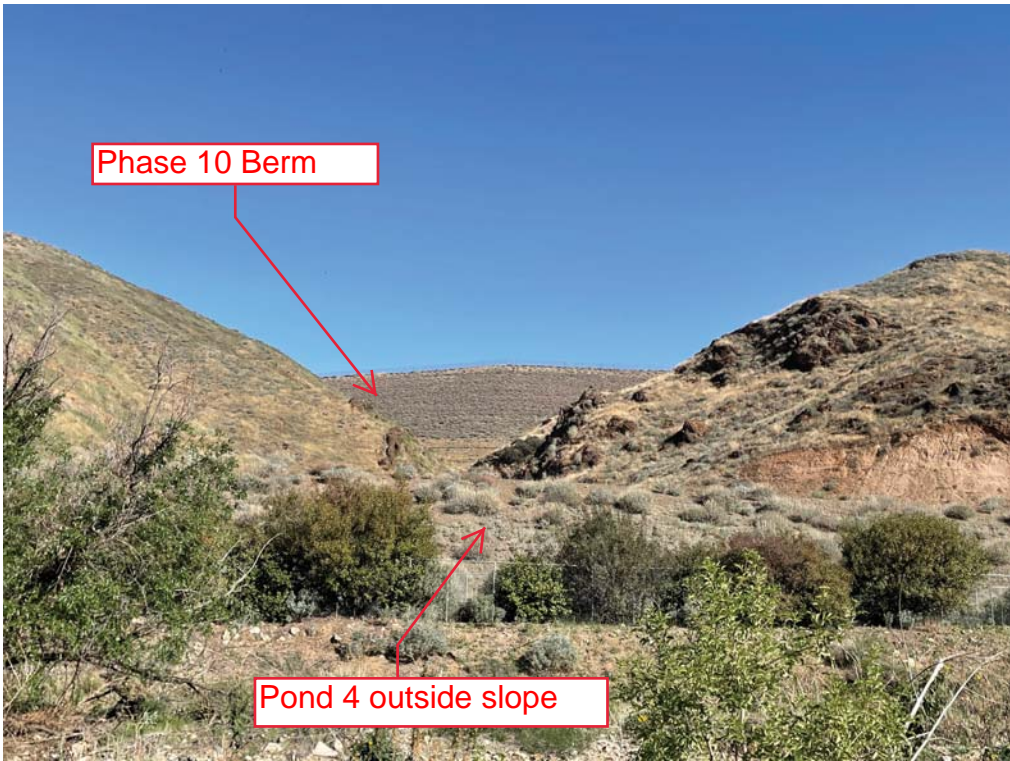
- Pond 4 visual inspection:
 - Pond 4 gate and fencing- good condition, no litter (photo 1).
 - Pond 4 outside slope- good vegetative cover.
- Drainage channel/culverts:
 - No major debris or blockage.
- Dawson Canyon Road condition:
 - Portions are paved; dirt section is serviceable.
- Berm 10/11:
 - No visible litter, good vegetative cover (photo 1-Berm 10; Photo 2-Berm 11).
- Landfill operations:
 - Not visible from Dawson Canyon area.
 - No landfill operations visible from communities west of I-15; bare outside slopes; USA Waste/WMI is developing a plan to address the bare slopes; WMI addressing RCDWR comments.
 - Slight detectable odor in Dawson Canyon; no visible off-site litter.
- Signage:
 - Inspected landfill address and directional signs. Good condition; visible and placed at numerous locations along Dawson Canyon Road.

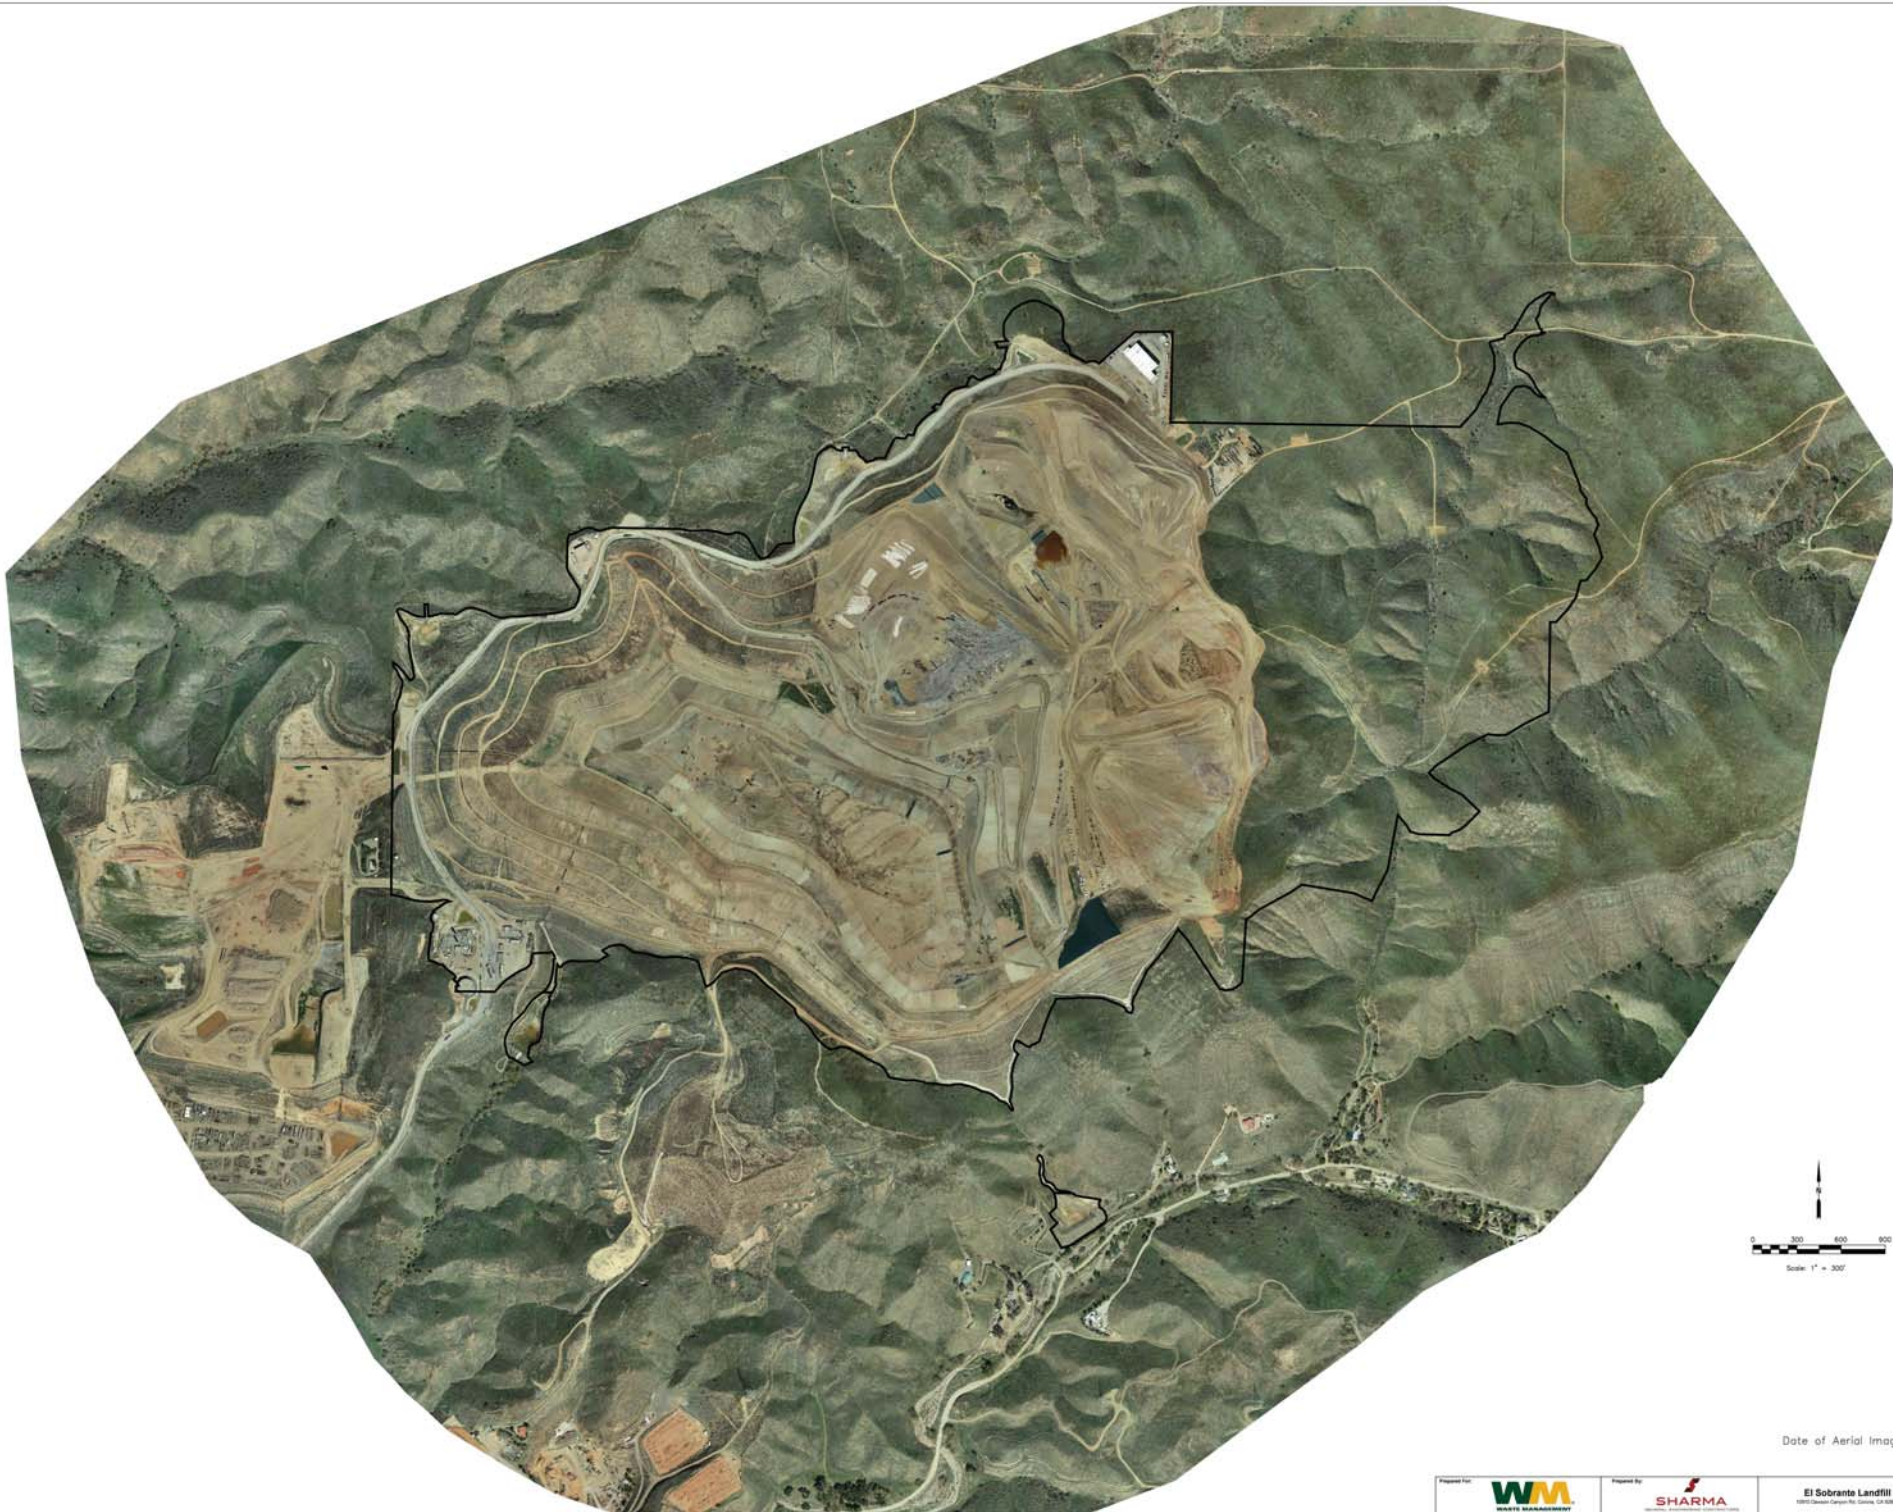
Date of Aerial Image: 3/18/21

- Reviewed 1st quarter 2021 site aerial (see attached).

- An updated aerial was taken on March 18th and showed no areas of offsite grading or operations.
