Community Assessment

El Sobrante Landfill: Community Assessment

Date: June 24, 2021 Arrival time: 10:50 am Prepared by: Ryan Ross/Jose Merlan, RCDWR

El Sobrante Landfill
Quarterly Mitigation Monitoring Report

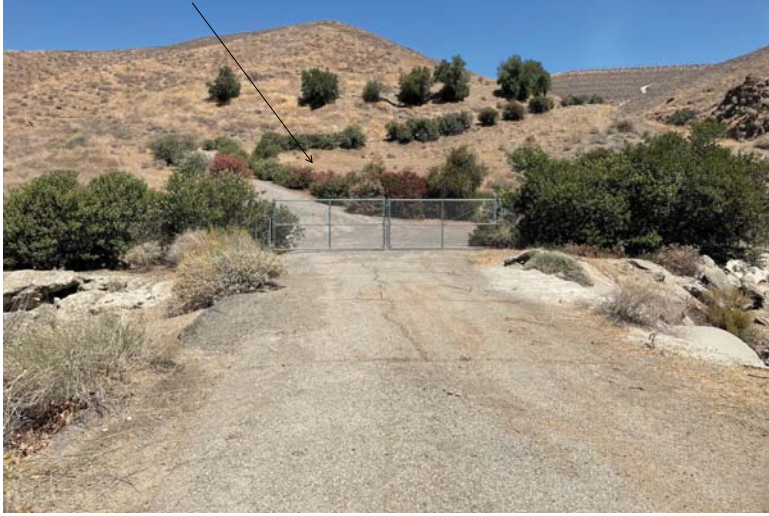
Photo 1 Pond 4 gate and fencing

- Pond 4 visual inspection:
 - Pond 4 gate and fencing- good condition, no litter (photo 1).
 - Pond 4 outside slope- good vegetative cover (photo 2).
- Drainage channel/culverts:
 - No major debris or blockage.
- Dawson Canyon Road condition:
 - Portions are paved; dirt section is serviceable. Road graded on 6-29-21.
- Berm 10/11:
 - No visible litter, good vegetative cover (photo 2-Berm 10; photo 3-Berm 11).
- Landfill operations:
 - Not visible from Dawson Canyon area.
 - No landfill operations visible from communities west of I-15; bare outside slopes (photo 4); USA Waste/WMI developed draft plan to address the bare slopes
 - No visible off-site litter.
- Signage:
 - Inspected landfill address and directional signs. Good condition; visible and placed at numerous locations along Dawson Canyon Road .

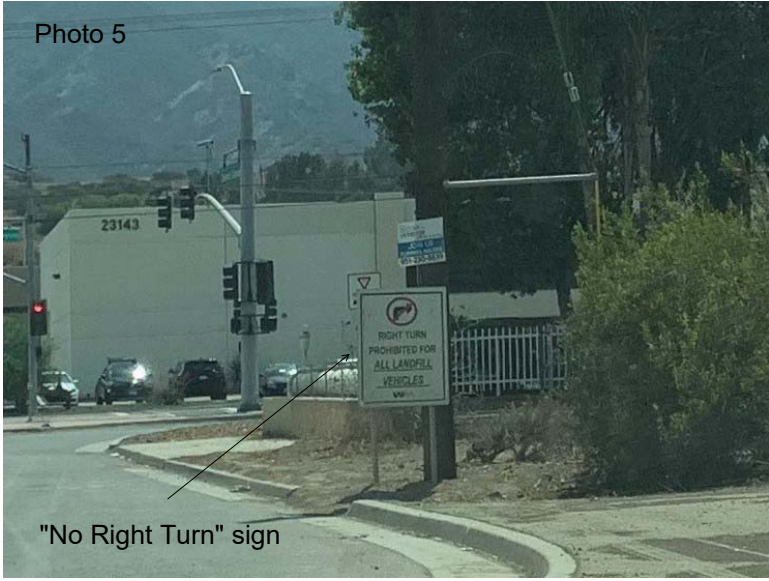
Photo 5

- 'No Right Turn' on Temescal Canyon Road (TCR) from Dawson Canyon:
 - No violations observed.
 - 'No Right Turn' sign partly covered by shrub. WMI notified. Shrub was trimmed back to allow full visibility of sign (photo 5).

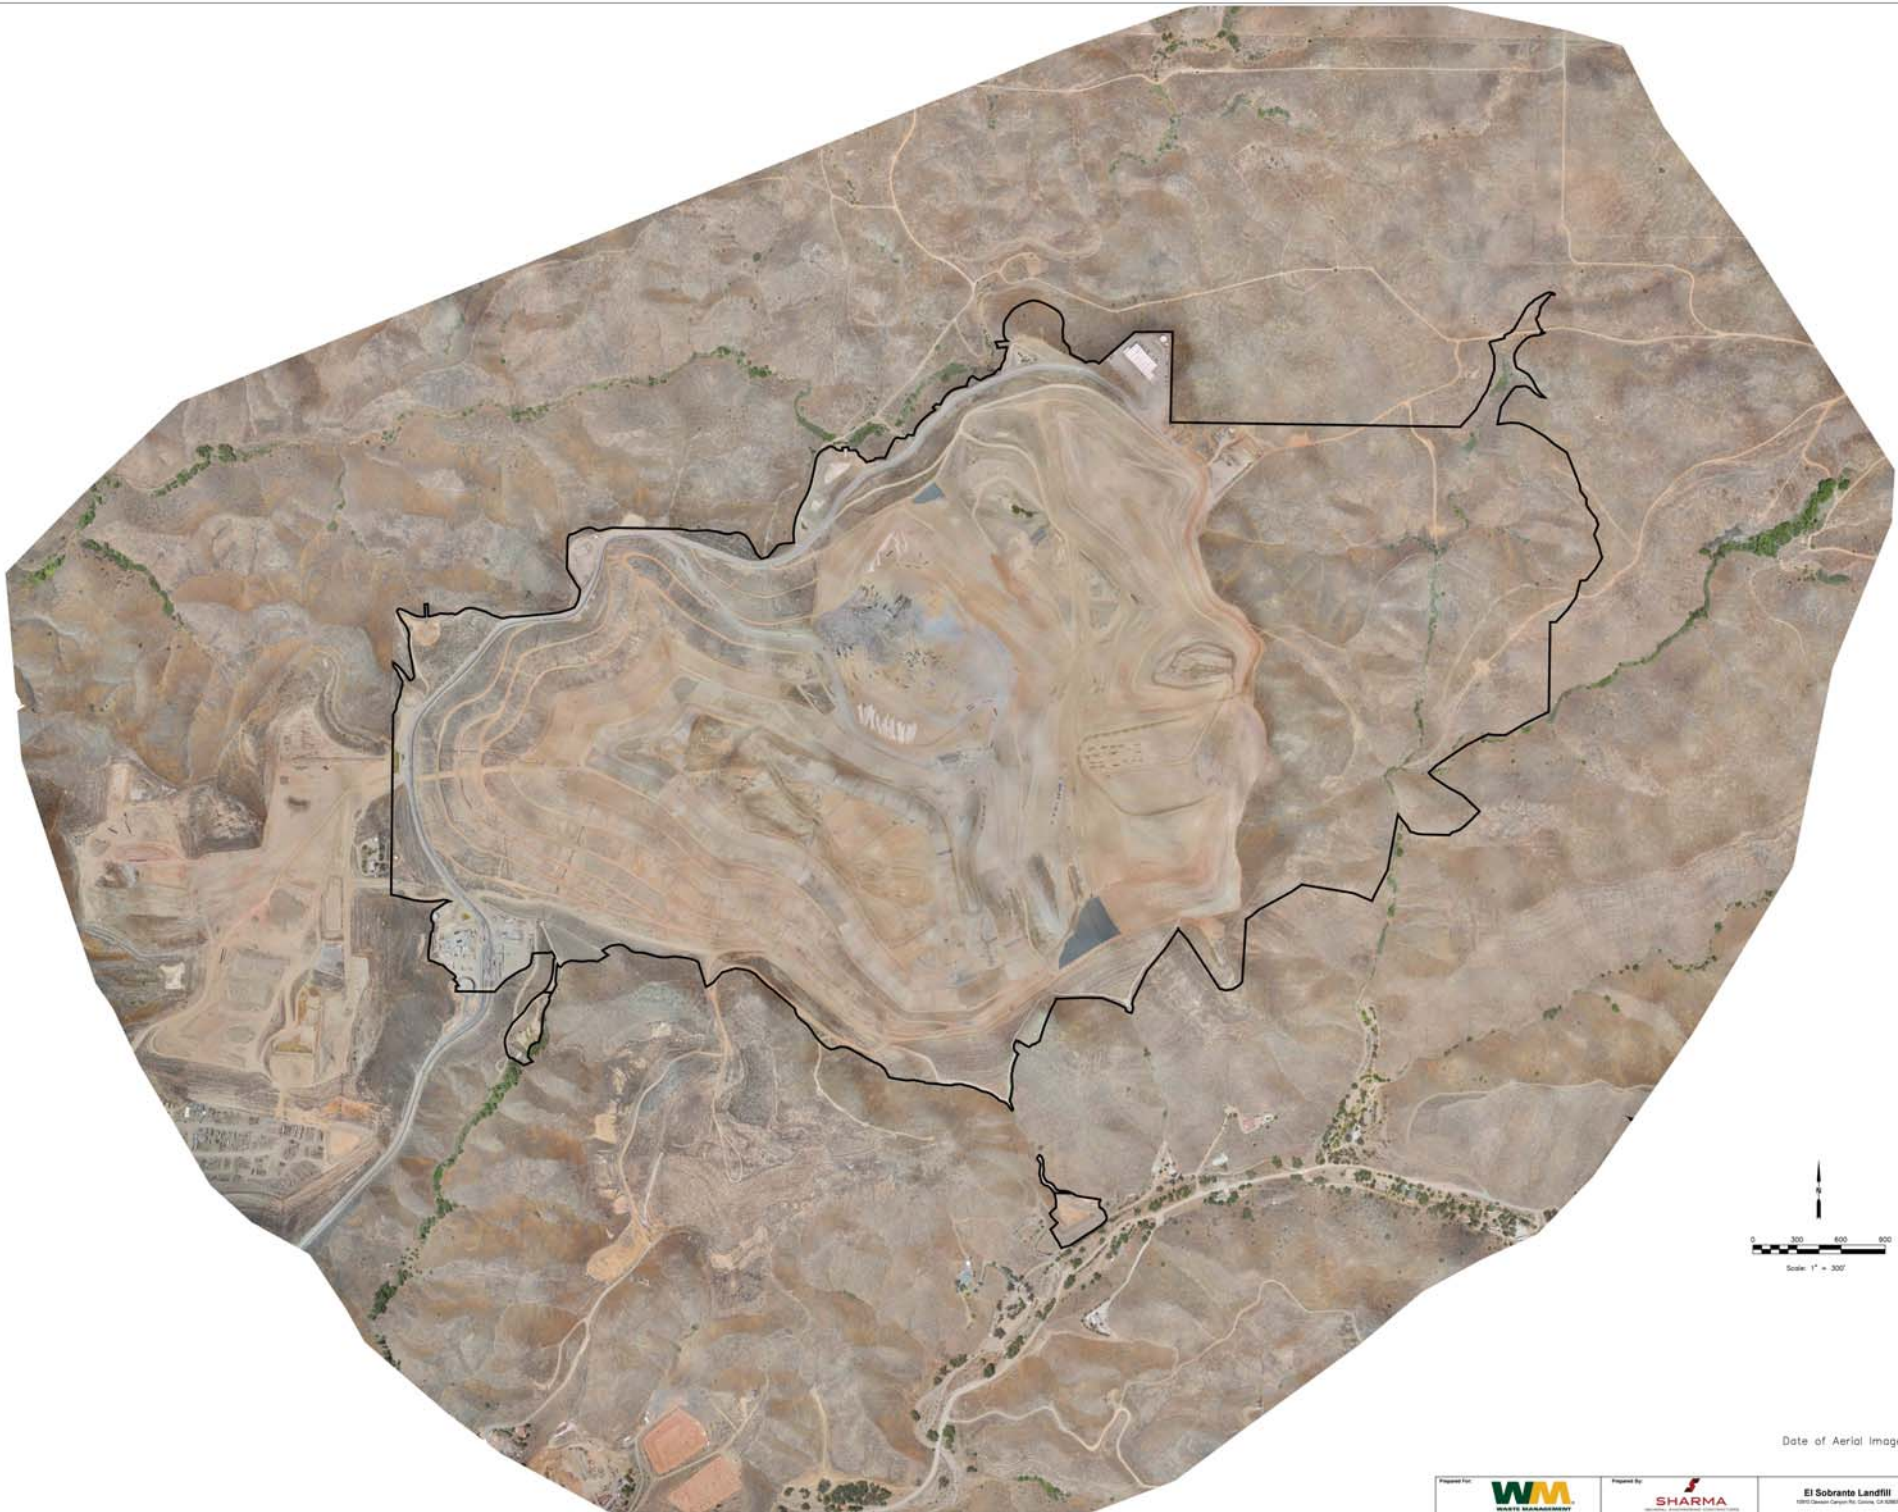
Date of Aerial Image: 6/10/21

- Reviewed 2nd quarter 2021 site aerial (see attached).

- An updated aerial was taken on June 10th and showed no areas of offsite grading or operations.
