Community Assessment

El Sobrante Landfill: Community Assessment

Date: May 12, 2022 Arrival time: 12:29 pm Prepared by: Jose Merlan, RCDWR

2022
AESTHETICS REPORT
FOR THE
EL SOBRANTE LANDFILL

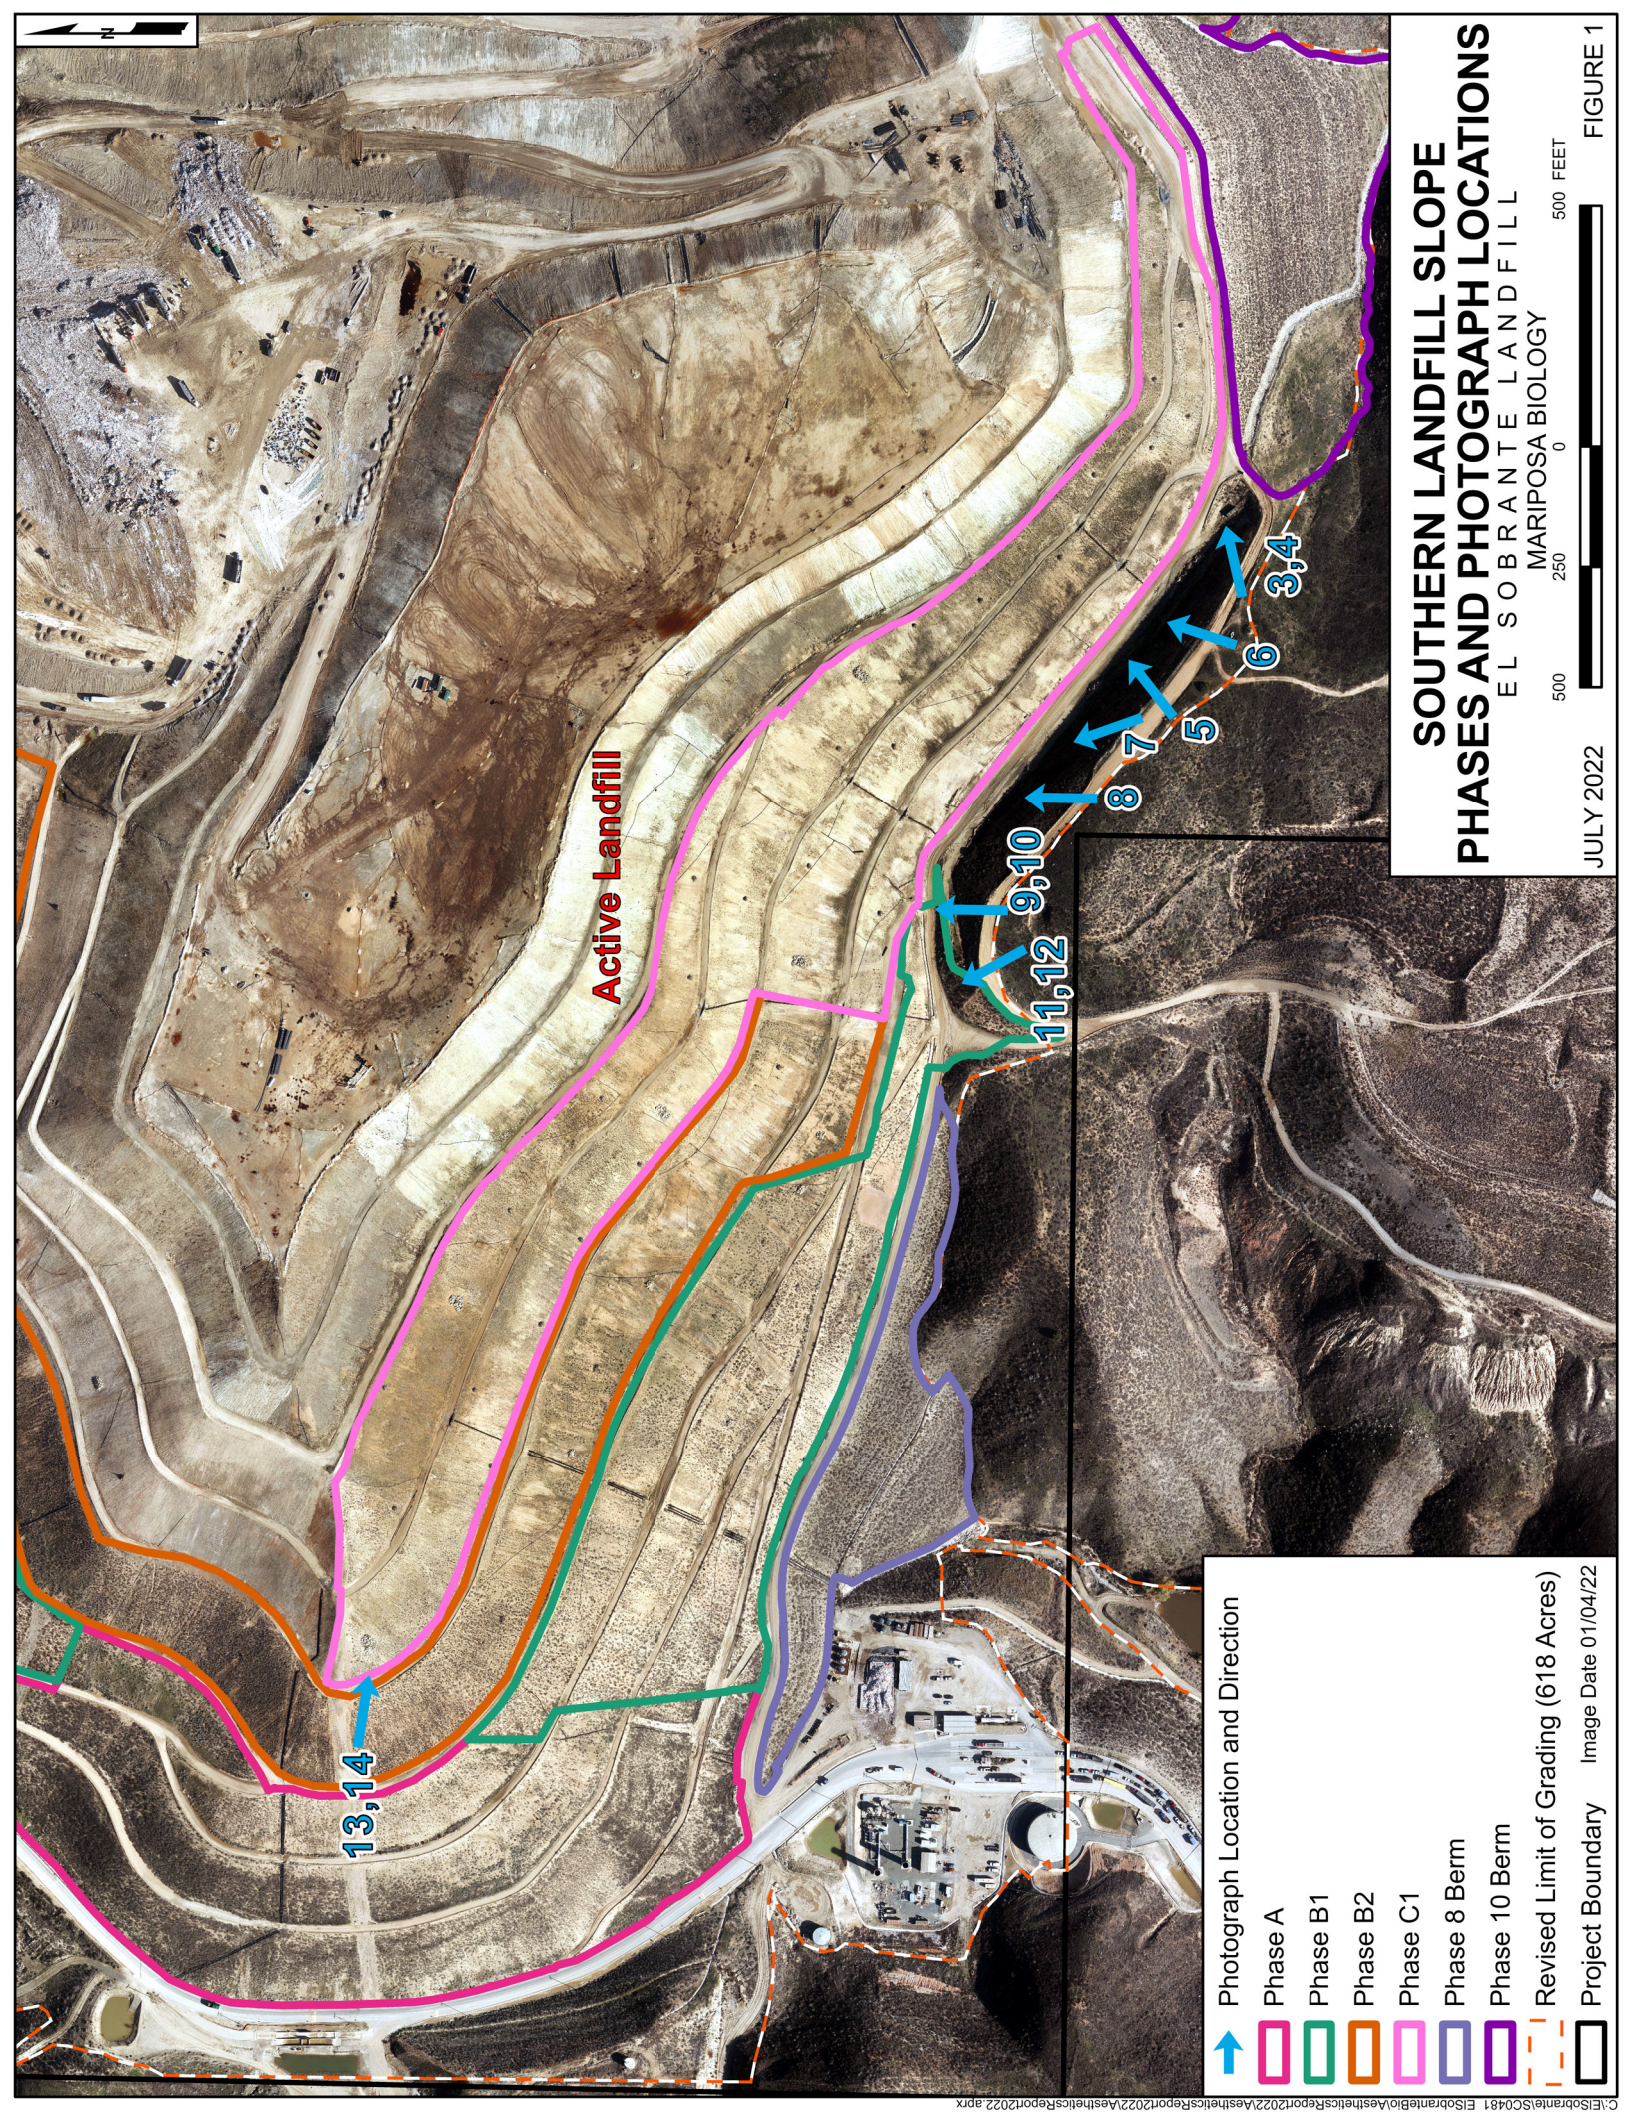
SOUTHERN LANDFILL SLOPE
RSS REPAIR AREAS 2015 - 2022
 EL SOBRANTE LANDFILL
 MARIPOSA BIOLOGY
 JULY 2022
 500 250 0 500 FEET
 FIGURE 2

Erosion repairs were needed on some of the south slopes in 2022. Repairs require using earth-moving equipment to repair the soil surface and the vegetation is also removed. Repair areas are obvious in the photographs because all vegetation is missing. Differing sizes of shrubs in the photographs show where repairs have taken place in the past. Figure 2 shows the repairs that have been done since 2015.

Phase A and the Phase 8 Berm are mature and require no additional aesthetics work. Phases B1 and B2 that were not repaired will also mature without irrigation. Portions of Phase C1 will mature without any irrigation. Other parts of Phase C1, B1, and B2 have been repeatedly repaired and the vegetation growth in these areas was disrupted. These areas will be provided irrigation.
